# **ARBORICULTURAL REPORT & Impact Assessment to BS 5837:2012 at:**

***Carlton Road,  
Carlton,  
Barnsley  
S71 3JE***

Report Date: *April 2025*

Reference: *AWA6579*

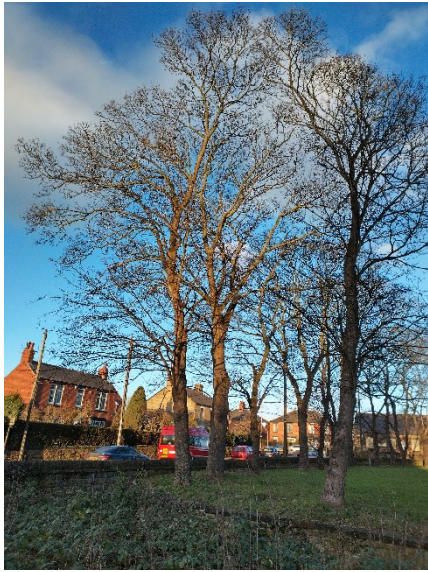
Photo 1: T1 and T2 from southwest

| | Tree Species | | | Measurements | | | Crown (m) | | | | Tree Condition | | | | | | | Value | | Management | | |
|---|---|---|---|---|---|---|---|---|---|---|---|---|---|---|---|---|---|---|---|---|---|---|
| T1 | Sycamore | Acer pseudoplatanus | Semi-mature | 16 | 1 | 470 | No | 2 | 4 | 3 | 3 | 5 | No visual defects | Single stemmed. Slight lean north. Stubs. Old pruning wounds | Minor deadwood | Adjacent but accessible. On slightly higher ground than site with retaining wall between tree and site 1.5m to south west. Historic crown lifting works undertaken. | Good | Good | >40 yrs | Moderate | B | No works required to facilitate development |
| T2 | Sycamore | Acer pseudoplatanus | Semi-mature | 16 | 1 | 480 | No | 2 | 2.5 | 4 | 4 | 3 | No visual defects | Single stemmed. Slight lean south east. Epicormic growths. Old pruning wounds. Stubs | Unbalanced | Adjacent but accessible. Historic crown lifting works undertaken. Unbalanced crown to south east. On slightly higher ground than site with retaining wall between tree and site 1.5m to south west. | Good | Good | >40 yrs | Moderate | B | No works required to facilitate development |

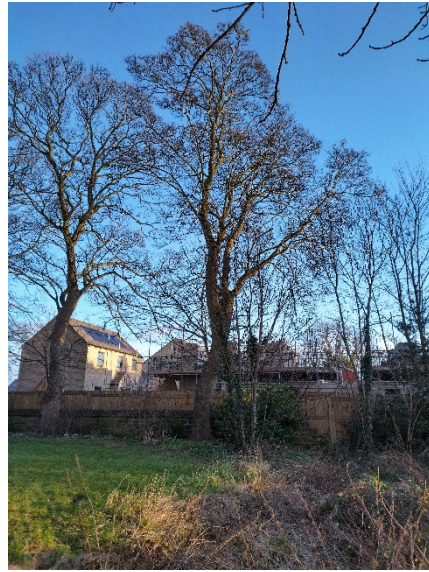
Photo 2: G3, T4 and T5 from northwest

- 3.2.6 Ash T5 has symptoms of the fungal disease Ash Dieback and is recommended for removal regardless of development at the site. The Ash within G6 and G8 also likely have limited future prospects due to Ash Dieback.

| | Tree Species | | | Measurements | | | Crown (m) | | | | Tree Condition | | | | | | | Value | | Management | | |
|---|---|---|---|---|---|---|---|---|---|---|---|---|---|---|---|---|---|---|---|---|---|---|
| G3 | Sycamore | Acer pseudoplatanus | Young | 8 | 10+ | 60 avg. | No | 0 | 4 | 2 | 2 | 3.5 | Limited access around base | Multiple stemmed at base. Ivy covered | Normal | Several young Sycamore forming a single crown. On slightly higher ground than site with retaining wall between trees and site 1.5m to south west. | Good | Good | >40 yrs | Low | C | No works required to facilitate development |
| T4 | Sycamore | Acer pseudoplatanus | Early-mature | 18 | 1 | 760 | No | 2 | 5 | 8 | 7 | 5 | No visual defects | Single stemmed. Slight lean south. Old pruning wounds. Stubs | Overhanging into the site | Adjacent but accessible. On slightly higher ground than site with retaining wall between tree and site 4m to south west. Historical crown lifting works undertaken. Twin stemmed at 4m. | Good | Good | >40 yrs | Moderate | A | No works required to facilitate development |

| | Tree Species | | | Measurements | | | Crown (m) | | | | Tree Condition | | | | | | | Value | | Management | | |
|---|---|---|---|---|---|---|---|---|---|---|---|---|---|---|---|---|---|---|---|---|---|---|
| T5 | Ash | Fraxinus excelsior | Young | 9 | 2 | 120, 120 | No | 1.5 | 2.5 | 3 | 2 | 2.5 | Limited access around base | Twin stemmed at base. Ivy covered. Stubs. Bark damage. Old pruning wounds | Minor deadwood. Minor dieback | Ivy prevented detailed inspection. Metal fence at base in contact with stem. Debris around base. Retaining wall 1.5m to east and 0.5m to south. Stage 1 Ash Dieback. | Fair | Fair | <10 yrs | Low | U | Removal recommended regardless of development |

| <i>Tree/<br/>Group<br/>Ref</i> | <i>Value</i> | <i>Impact Type</i> | <i>Description of Impact</i> | <i>Impact Level</i> | <i>Mitigation /<br/>Solution</i> |
|---|---|---|---|---|---|
| T5 | U<br>(Unsuitable) | Direct -<br>Removal | Unsuitable to retain<br>regardless of<br>development | Not<br>applicable | Work to British<br>Standard<br>3998:2010 |

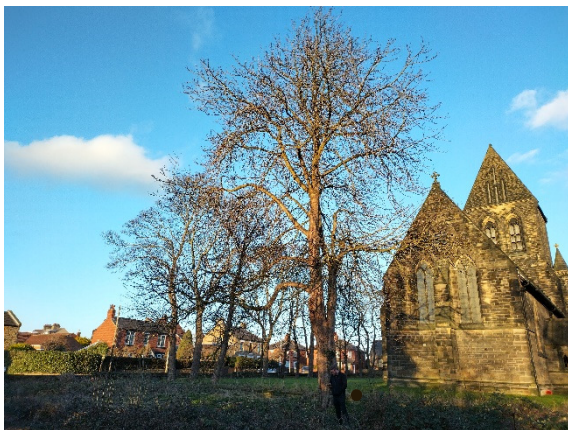
Photo 3: T9 from southwest

- 3.2.4 The most significant tree within site boundaries is Horse Chestnut T9, a mature tree in good condition and of high value.
- 3.2.5 T5 to G8, G11 and T12 are also situated within site boundaries. T5 to G8 border the site's southeastern boundary and G11 and T12 border the site's southwestern boundary. These trees and tree groups are of low value but provide some screening between the site and the adjacent land.

- 4.3.2 Potentially damaging activities are proposed in the vicinity of retained trees. The new development encroaches close to and into the edge of the RPA of T9 and T12. Construction within the RPA, can have negative impacts on tree roots. However, the encroachment is very minor, and the detailed RPA for these trees is likely to be a slightly exaggerated representation of the trees actual rooting area. As such, it is unlikely that significant roots will be within these areas and the retained tree should remain largely unaffected by the works, provided care is taken during construction.

| | Tree Species | | | Measurements | | | Crown (m) | | | | Tree Condition | | | | | | | Value | | Management | | |
|---|---|---|---|---|---|---|---|---|---|---|---|---|---|---|---|---|---|---|---|---|---|---|
| T9 | Horse Chestnut | Aesculus hippocastanum | Mature | 18 | 1 | 780 | Yes | 2 | 8.5 | 5.5 | 6 | 8 | Girdled roots. Exposed roots | Single stemmed. Vertical. Moderate cavity. Moderate decay. Epicormic growths. Old pruning wounds. Stubs | Minor deadwood | Twin stemmed at 4m with co-dominant stems. Retaining wall to east. | Good | Good | >40 yrs | Moderate | A | No works required to facilitate development |

| <i>Tree/<br/>Group<br/>Ref</i> | <i>Value</i> | <i>Impact Type</i> | <i>Description of Impact</i> | <i>Impact Level</i> | <i>Mitigation /<br/>Solution</i> |
|---|---|---|---|---|---|
| T9 | A (High) | Indirect –<br>Minor RPA<br>Incursion | Minor encroachment<br>by building footprint | Negligible | Care taken<br>during<br>construction in<br>RPA |

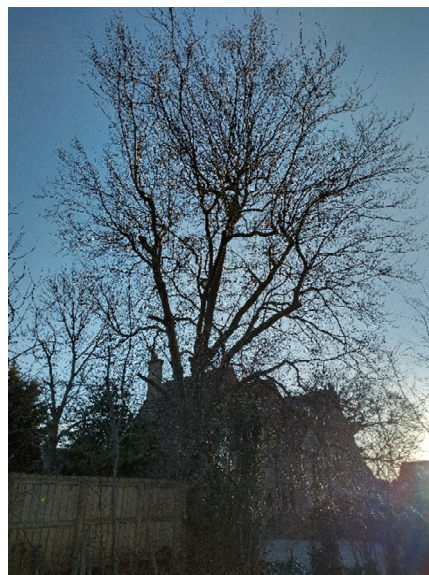
Photo 4: T10 from northeast

while T10 and T13 were inaccessible. Of these adjacent trees T4 and T10 are of high value and T1, T2 and T13 are of moderate value.

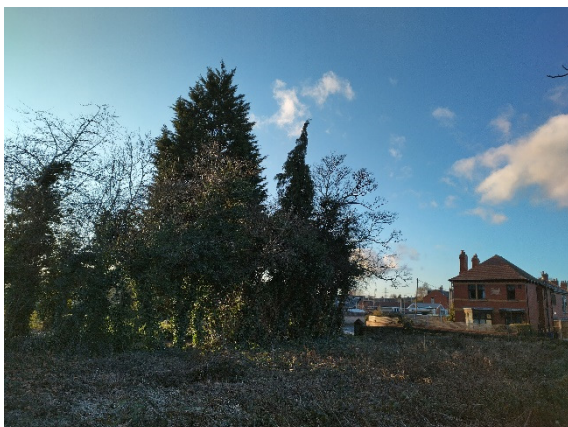
Photo 6: G11, T12 and T13 from southeast

- 3.2.7 G11 would tolerate heavy pruning works if required to facilitate a proposed new development at the site.
- 3.2.8 T1 to T4, T10 and T13 are situated in adjacent land. T1 to T4 are situated within the grounds of St John the Evangelist Church and were accessible,

| | Tree Species | | | Measurements | | | Crown (m) | | | | Tree Condition | | | | | | | | Value | | Management | |
|---|---|---|---|---|---|---|---|---|---|---|---|---|---|---|---|---|---|---|---|---|---|---|
| T12 | Lawson Cypress | Chamaecyparis lawsoniana | Semi-mature | 10 | 1 | 220 | No | 4 | 1 | 1.5 | 1.5 | 1.5 | Limited access around base | Single stemmed. Vertical. Ivy covered | Ivy covered | Single semi mature Cypress within G11. Ivy prevented detailed inspection. | Good | Fair | 10 to 20 yrs | Low | C | No works required to facilitate development |
| T13 | Sycamore | Acer pseudoplatanus | Mature | 16 | 1 | 800 | Yes | 3 | 6 | 9 | 6 | 7 | Limited access around base | Single stemmed. Vertical. Ivy covered | Old pruning wounds. Minor deadwood | Adjacent, no access. Very Ivy covered. Adjacent streetlight below crown to northwest. Crown slightly overhangs site. Minor previous pruning works undertaken. Driveway between site and tree. | Fair | Fair | >40 yrs | Moderate | B | No works required to facilitate development |

| <i>Tree/<br/>Group<br/>Ref</i> | <i>Value</i> | <i>Impact Type</i> | <i>Description of Impact</i> | <i>Impact Level</i> | <i>Mitigation /<br/>Solution</i> |
|---|---|---|---|---|---|
| G11 | C (Low) | Direct –<br>Partial<br>Removal | Within footprint of<br>development area | Low | Mitigation<br>planting |
| T12 | C (Low) | Indirect –<br>Minor RPA<br>Incursion | Minor encroachment<br>by building footprint | Negligible | Care taken<br>during<br>construction in<br>RPA |

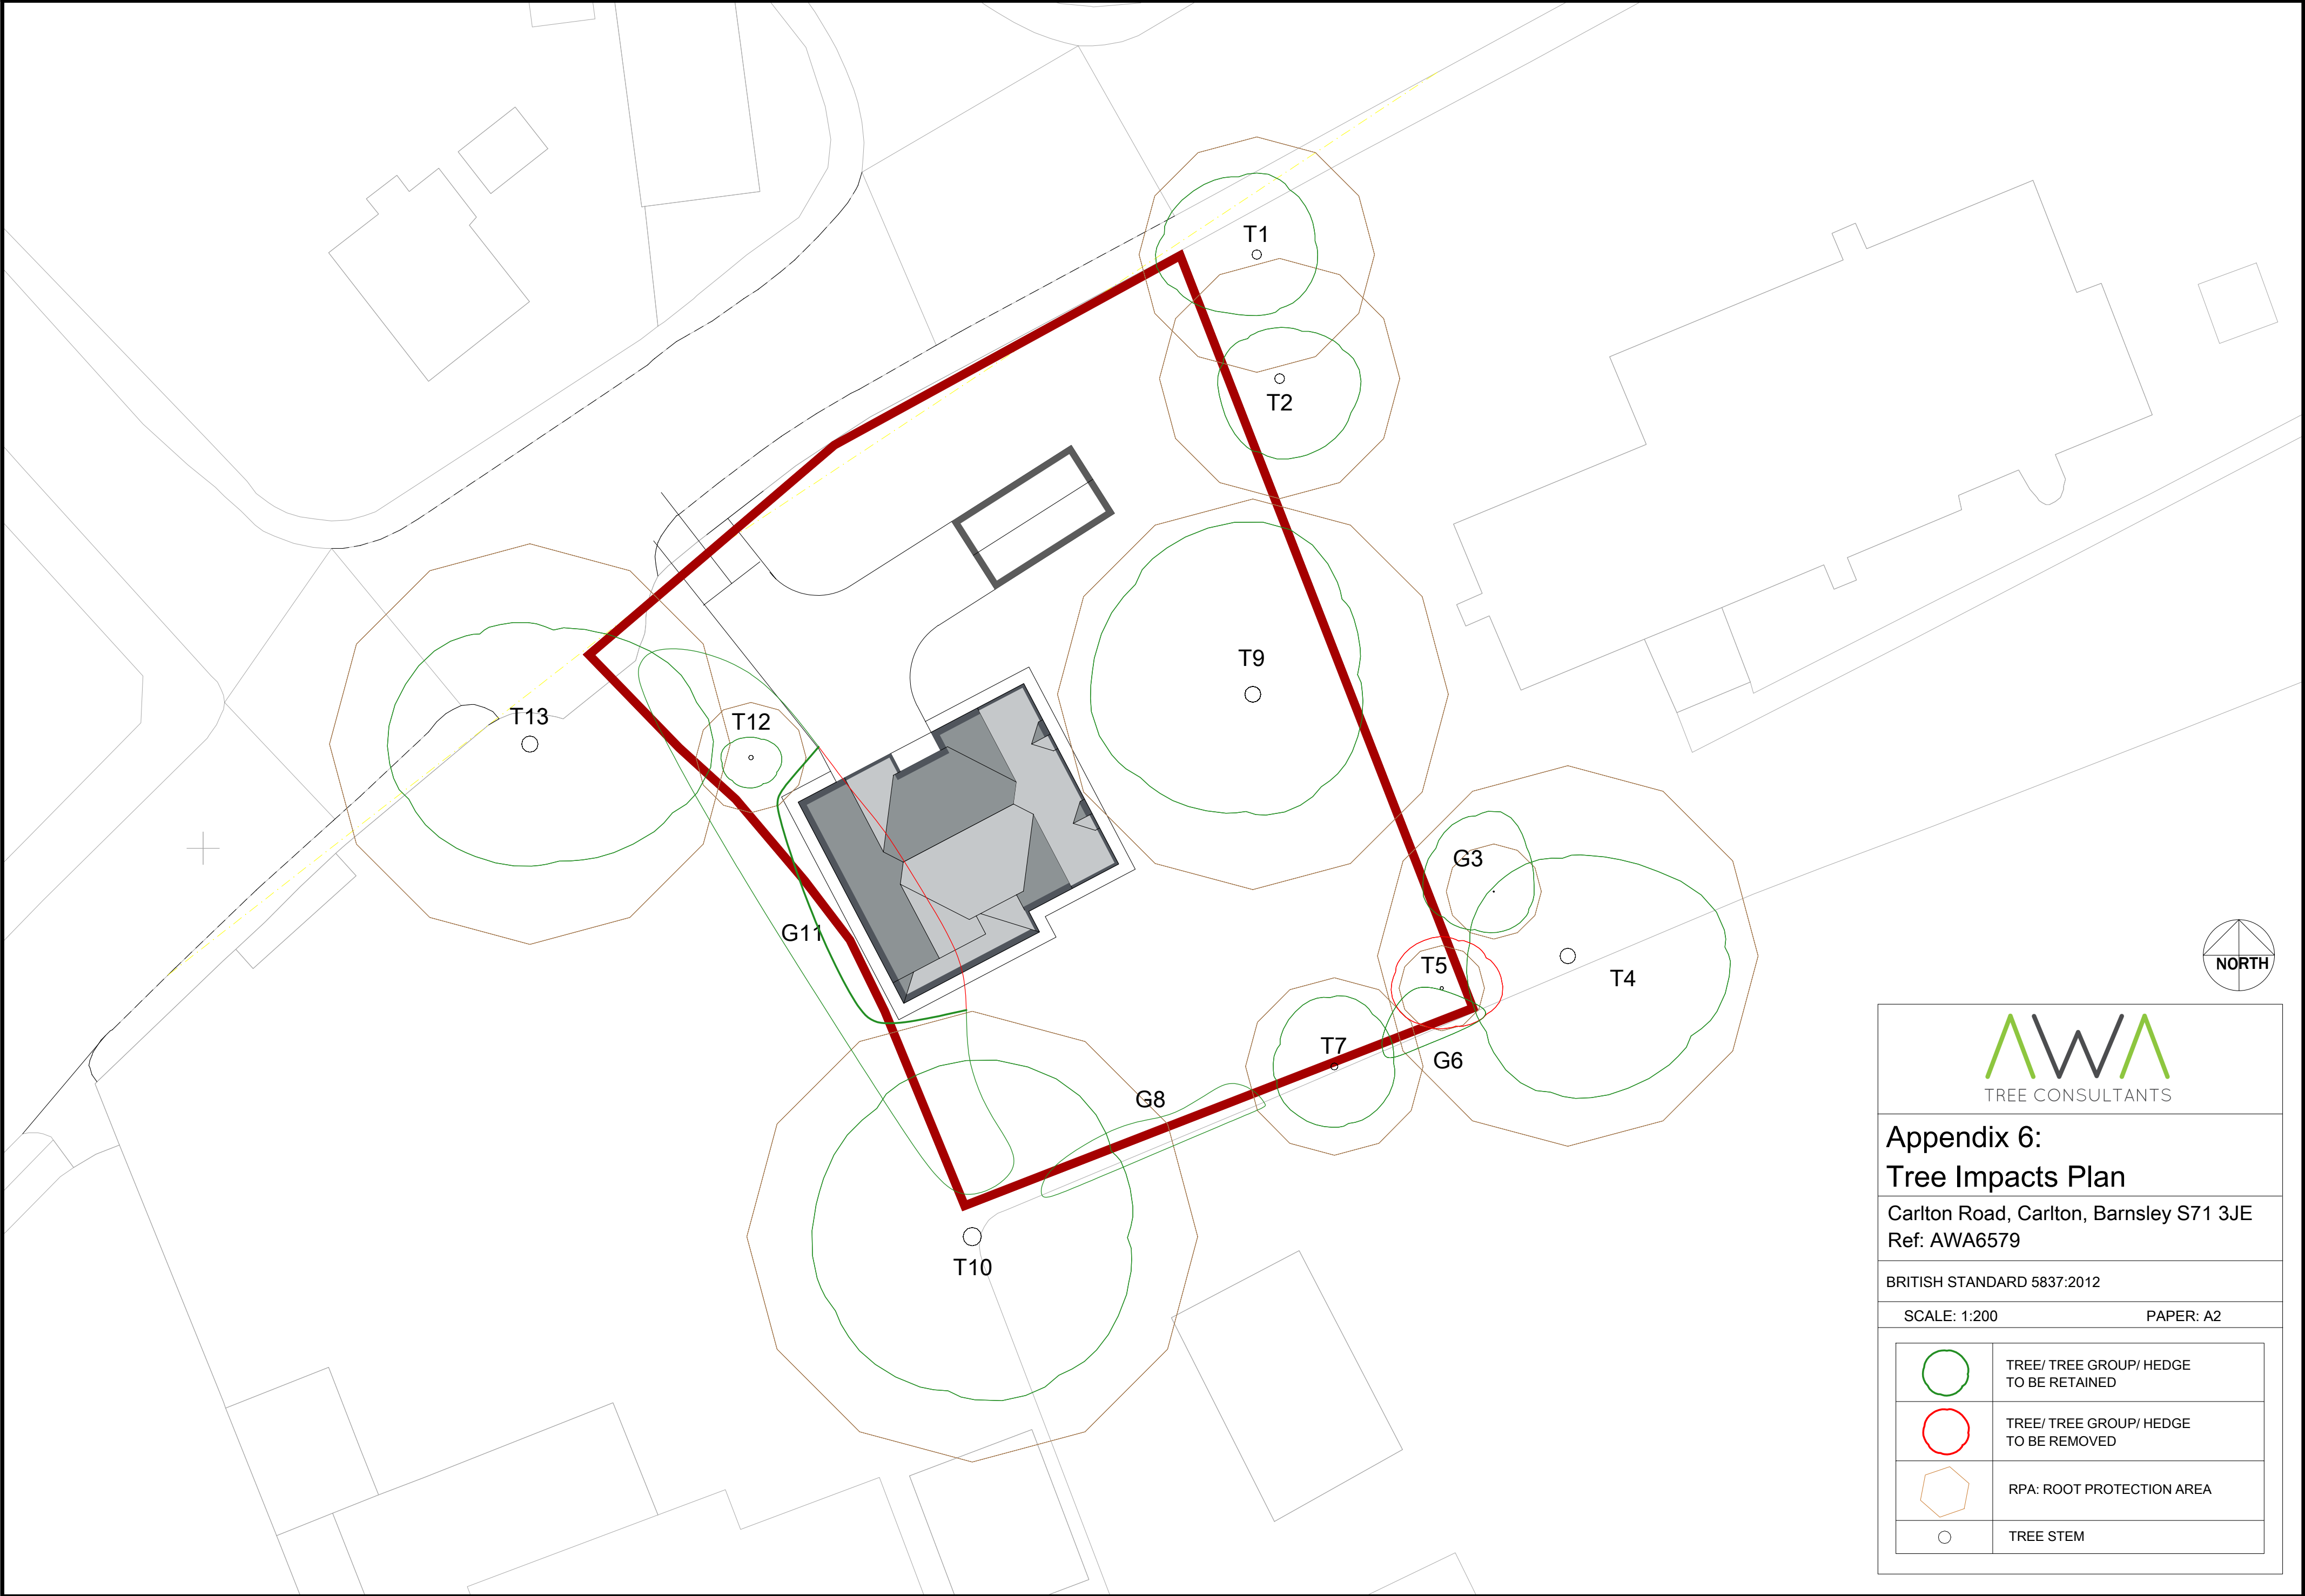
Appendix 6:  
Tree Impacts Plan

- 4.2.1 From assessing the new development proposals, 1 tree group will require partial removal to facilitate the development as it is partially situated in the footprint of the development or their retention and protection throughout the development is not suitable.
- 4.2.2 The hedge that requires partial removal to facilitate the development is G1.
