## **Oaks Farm Darton**

### **Bat Survey**

November 2010

# **Report of Bat Survey Oaks Farm, Darton**

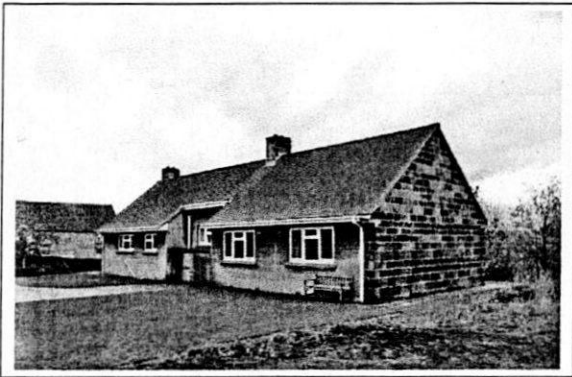
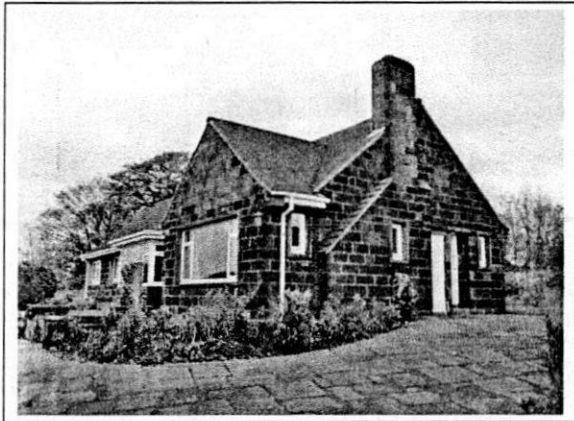
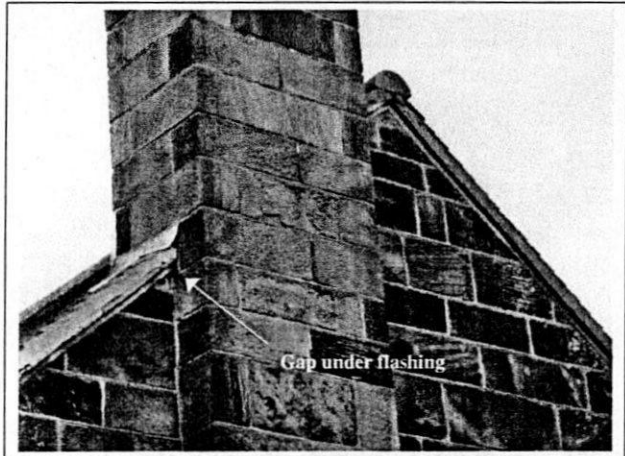
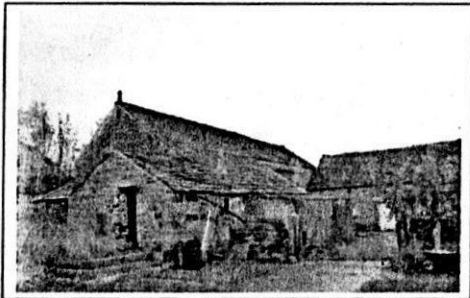
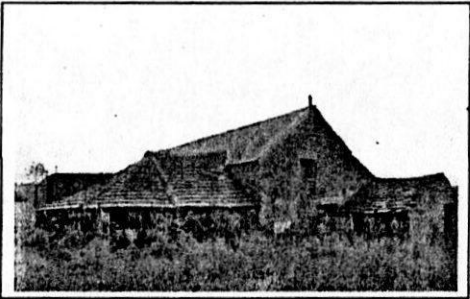
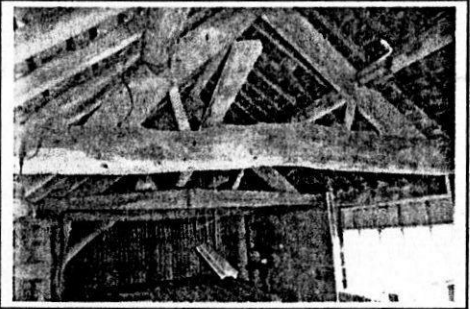
FIG 1

Key	Description
A	<p>Bungalow with stone walls and small clay tile roof covering. The building was oriented east –west with gables at both ends and on the south side. The east gable contained an external chimneystack. Flashing on the south side of the chimney was slightly raised providing a potentially attractive access for bats but there were no signs of actual use such as droppings and fur staining round the opening. The other two gables were well pointed with no suitable openings.</p> <p>The eaves had plastic fascias and soffits with the soffit/wall joint sealed with no suitable openings.</p> <p>Internally the loft was fully accessible and inspected. The roof was lined with traditional underfelt and the loft floor covered with clean insulation material. The inside gable walls and the loft floor below the ridge were checked but no signs of droppings or urine spotting etc. were found.</p>

11.1 The survey produced no evidence to suggest the possible presence of a bat roost in any of the buildings. The house showed one potential opening under flashing at the chimneystack on the eastern gable but there were no signs of actual use.

Building A - Bungalow

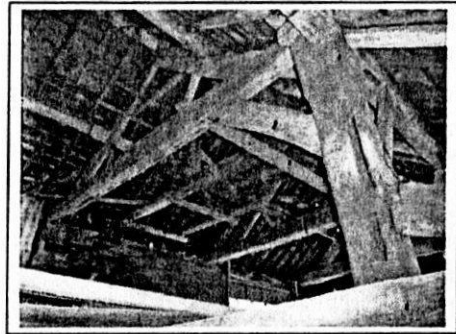
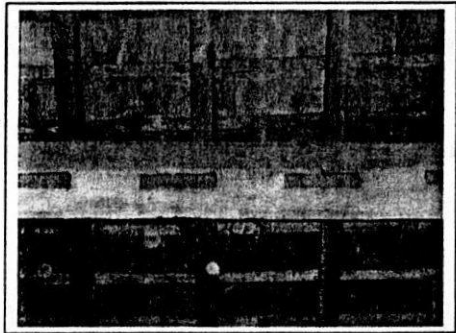
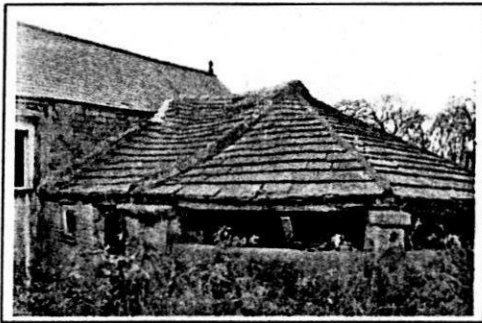
FIG 2

B	<p>Two-storey stone barn with part stone slate and part blue slate roof. The barn was rectangular and oriented east –west but with the roof extending on the south side over an attached building. A flat roofed extension was attached to the south wall and a small pitched roof building attached to the west gable.</p> <p>The west gable verge was pointed but some gaps were present between the stone roof slates. A small rectangular “owl” window was located in the apex above a bricked-up window opening. The wall contained numerous open joints and cavities but no signs were found.</p> <p>The east gable was also pointed with no gaps. The upper parts of the gable wall were also pointed with open joints only at lower levels.</p> <p>The eaves walls were mainly masked by attached or adjacent buildings. On the south side a full eaves height timber doorway occupied most of the open wall. The adjacent walls were pointed but there was potential for gaps under the edge of the slates at wall top level. On the north side there was a similar door opening with glazed panels missing from the upper part allowing potential access to the inside of the barn.</p> <p>No signs of bats were found on any of the external surfaces.</p> <p>Internally the roof was supported on four queen-post trusses, the truss at the west end supported on a timber post. The ridge, purlins, truss cross-beams and door lintel timbers contained numerous socket holes, most passing right through the timbers but some enclosed as cavities. These were inspected and no signs of fur staining were found to suggest use by bats. The west wall and the north west corner were clad with corrugated sheet material.</p> <p>Stored timber on both sides of the access doors created a loft floor in practical terms. This was checked for signs of droppings or urine spotting that would indicate the presence of a bat roost in the ridge area or trusses but no signs were found.</p> <p>Similarly the internal gable walls were also checked for signs of droppings or discarded insect remains but none were found.</p>

11.2 Internally the barns showed some potential with socket holes in the main timbers of barn B in particular but no signs of actual use were found for species such as Brown Long-eared bat which favour the internal spaces of traditional barns. Droppings in particular can persist for several years in undisturbed areas where there is no weathering. Barn E was much less suitable because of the condition of the ridge area.

Barn B

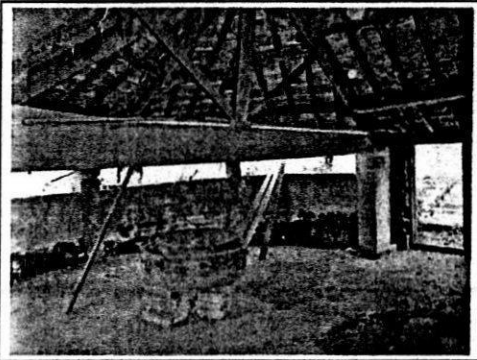
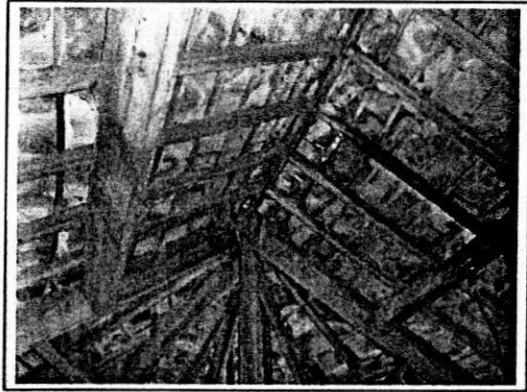
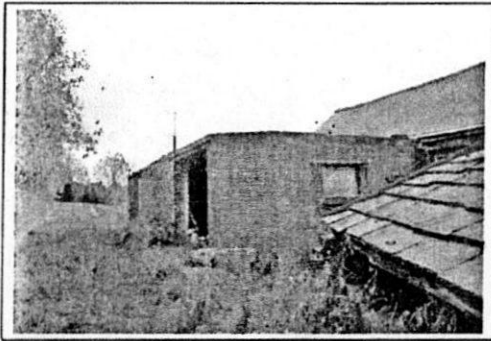
FIG 3

Key	Description
C	<p>Small brick and render outbuilding with stone slate roof. The outer eaves were low at approximately 1.5 metres with large uncovered window openings. The roof was hipped at the outer end and with a central ridge breaking into the main barn roof slightly above eaves level. No signs were found externally.</p> <p>The roof was supported on a single king-post truss and cross beam. The ridge was relatively gappy and probably too drafty for bats but the inner apex appeared to offer some access to the barn roof. The window and door openings were uncovered. The floor and various surfaces were checked for signs of droppings, urine spotting or discarded insect remains but no signs were found.</p>
D	<p>Single-storey flat-roofed outbuilding with brick and render walls. The roof was an in-situ concrete slab. There was a large opening in the north wall and in the east wall. No suitable opportunities for bats and no signs found externally.</p> <p>Internally the roof was a flat concrete slab supported on steel beams. This provided no suitable roosting crevices apart from a few boards, electrical boxes etc which were checked and no signs found.</p>

11.3 Barn C, because of the window openings had some potential but again there were no signs of actual use. The remaining buildings were either too small or of unsuitable construction to be attractive to bats.

Barn C

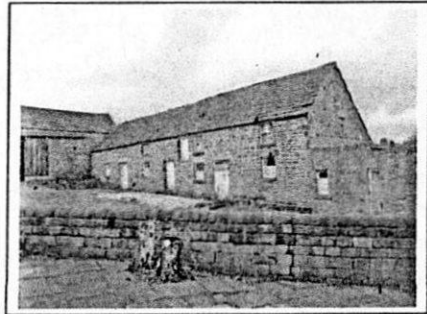
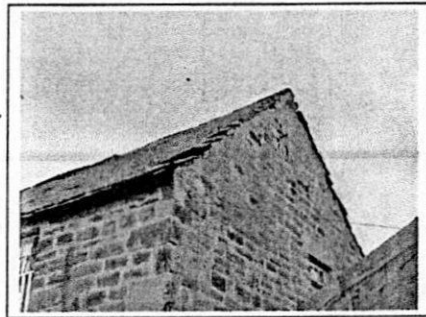
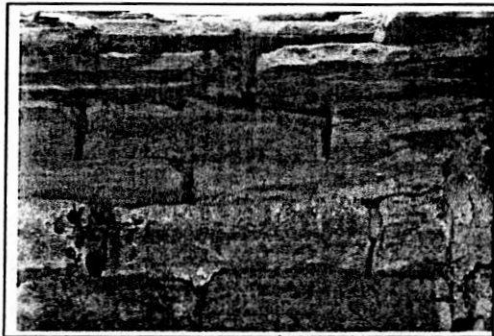
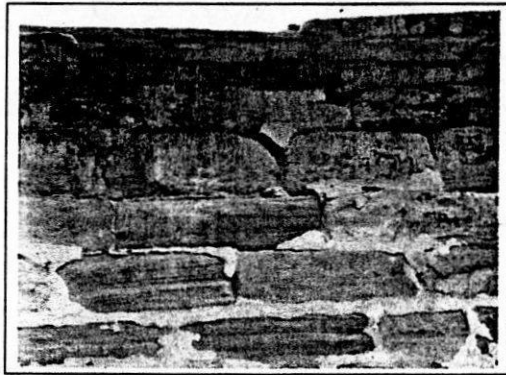
FIG 5

E	<p>Two-storey stone barn with stone slate roof. The north gable was obstructed by barn B. The south gable was well pointed but gaps were present in the verge pointing, mostly quite large and probably more attractive to birds than bats. The roof at the rear (east side) extended over an attached building. The roof on the east side contained a number of holes and the whole of the ridge line was displaced and open.</p> <p>The west (yard) wall contained covered window and door openings on two floors. The walls were generally sound but some crevices, cracks and open joints were noted at the north end. The east wall was limited by the attached building but a large hole was noted in the wall at the north end and potential openings under the edge of roof tiles at wall top level.</p> <p>No signs of bats were found on any of the external surfaces.</p> <p>Internally the first floor was in two sections with a central staircase. The southern end contained an enclosed loft space with a single "A" frame truss with struts. No sockets or mortise joints were found. The ridge was open because of the displaced ridge tiles and most unlikely to be attractive to bats. The floor was clear and checked for signs of droppings, urine spotting or discarded insect remains. None were found.</p> <p>On the east side a ground floor area extended above the loft floor level and was connected to the loft space with an uncovered window opening. No signs were found in this area./</p> <p>The northern end was more open and in poorer condition with larger roof gaps and the floor was unsafe to access directly but was easily visible from the stacked timber at the south end. No signs of droppings, urine spotting or discarded insect remains were found.</p> <p>The ground floor showed evidence of past use by nesting swallows but there were no signs of droppings etc to indicate recent use.</p>

- 11.4 The ground floor area of barn E showed signs of old swallows nests but no indications of recent use. The buildings were also checked for signs of species such as Barn Owl. These would be owl pellets, "whitewash" excreta staining or moulted feathers etc. No such signs were found.
- 11.5 Externally barns B and E had open joints, cracks etc in the mortar joints providing potential access to the rubble filled core of the walls. Bats will hibernate in such areas and the actual roosting location might be a distance from the opening and impossible to see externally.

Barn E

East wall

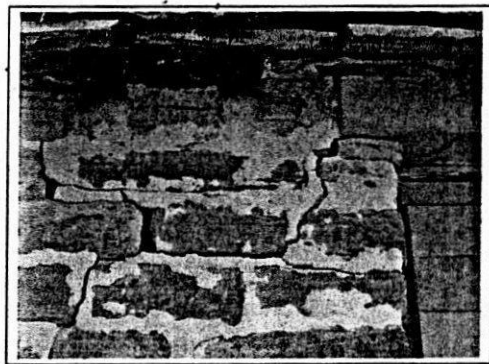
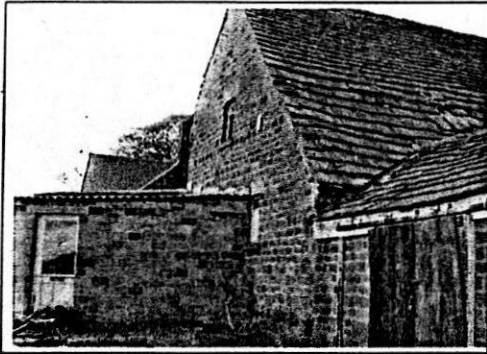
FIG 6

Barn E

West (courtyard) wall

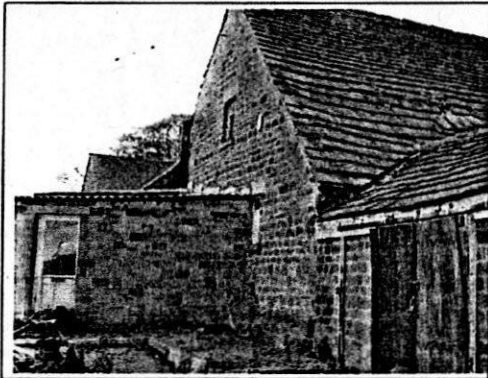
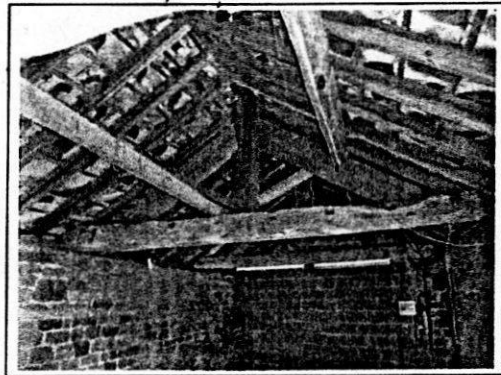
FIG 7

F	<p>Small outbuilding, farm office. Stone walls with mono-pitch corrugated sheet roof covering. The edges were well pointed with no suitable openings. No signs found and not generally suitable.</p> <p>Roof lined with boarding internally. No opportunities for bats.</p>

Key	Description
G	<p>Range of small single-storey outbuildings, sheds. Stone walls and pitched stone slate roof. The east gable verge was well pointed with no suitable openings. The apex of the wall contained a narrow rectangular ventilation slot. The north wall was plain with potential for openings under the edge of roof slates but generally too low at approximately 1.8 metres to be likely to be attractive to bats. The west wall contained two large sliding timber doors. There was a timber fascia to the eaves with no suitable openings.</p> <p>No signs of bats were found on any of the external surfaces.</p> <p>The roof was supported on three king-post trusses. The ridge was cobwebby. No signs of droppings, urine spotting or discarded insect remains were found on the floor or inside walls.</p>

Buildings F & G
