**DESIGN & ACCESS STATEMENT**

**OAKS FARM, OAKS WOOD DRIVE  
DARTON, BARNESLEY**

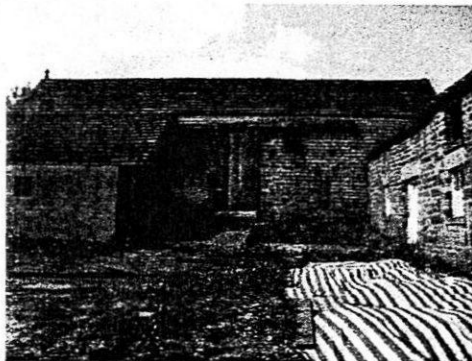
Barn A to the north is seventeenth century Grade II Listed with a later nineteenth century engine house addition to the rear. It includes relatively recent flat roof brick and block additions which detract from its appearance. There is a small, single storey building attached at the south western corner which is worthy of retention historically but is in poor structural condition.

Fig 3 South elevation – Barn A

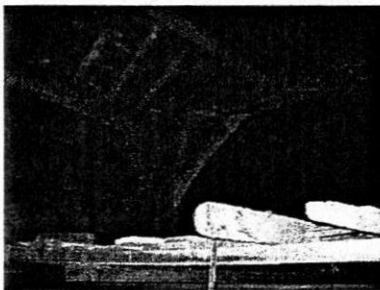
A two storey barn of regularly coursed rubble stone walling with quoins to corners, with a mix of blue slate (north) and stone slate (south) roof having "cat slide" to south elevation, and later rear engine house extension to rear. The principal barn has five equal bays sub-divided by trusses and the two bays at the west extend to form an aisle with a timber post and half truss supporting the lower roof. The ground floors are generally level and partly covered by stone flags. The roof structure is generally of oak trusses and purlins with oak wall plates supporting oak rafters as shown in Figs 13 and 14.

Fig 13 Barn A roof structure

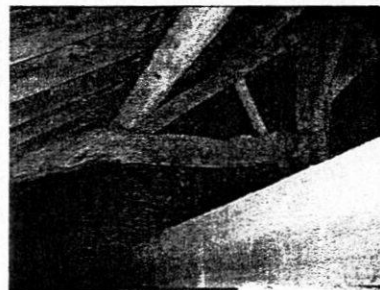
Fig 14 Half truss from timber post

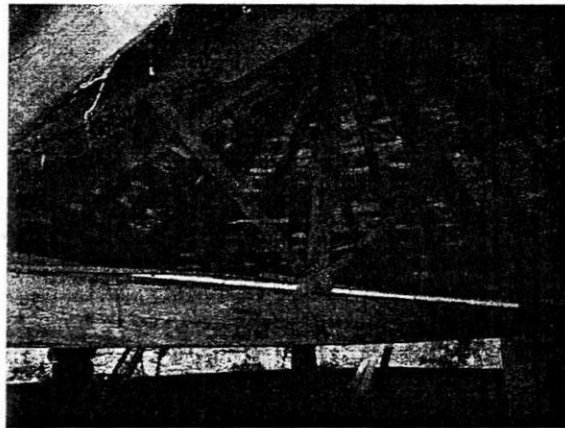
To the rear (north) is a single storey later extension referred to as "the engine house". Constructed originally of monolithic stone piers, it forms a four sided, semi-octagonal structure supporting a timber roof structure with a single queen post truss and radiating hip rafters with purlins. The roof is of stone slates. The principal truss is of large span and shows signs of deflection.

Fig 16 Internal view of roof structure to engine house

Some attempt to reduce the span and overcome the rot at the bearing ends has been made by the addition of brick piers at both bearing ends of the truss. Rot has occurred within the ends of the timber purlins and to the wall plate. The roof structure will require significant repair/replacement of structural members and it would be advisable to consider introducing mid-point support to the principal truss. The monolithic capped stone columns will need to be re-set. Some have been damaged or badly weathered and need to be replaced. It is anticipated that the later addition of infill brickwork between the piers has helped to stabilise the building and a greater degree of reconstruction may be necessary following removal of the brickwork. This could involve re-setting the stone piers onto new foundations to ensure that the structure is stable.

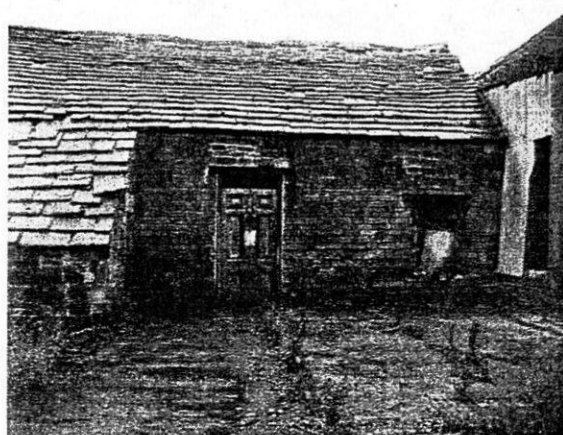
The northern end is sub-divided into three bays by two oak trusses. Some of the ridge and slates over this section of roof have slipped allowing water ingress. The most southerly of the two trusses at the north end has failed and temporary support has been provided to prop the tie beam. The most northerly truss appears to be in good condition, although some rot at the bearing ends cannot be discounted. Large sections of this truss would need to be replaced if it is to be retained or, alternatively, the timber roof purlin could be supported by a new structural wall to replace the truss. There is a first floor structure which is of sub-standard timber beams spanning east to west supporting timber joists throughout the two storey barn. There is a stone staircase supported by a half brick wall giving access to the first floor. This is in poor condition and should be removed or replaced.

Fig 17 East elevation – Barn B – north end

The external walls of Barn B are generally in good condition. There is a minor amount of partial collapse and loosening of stonework on the east elevation where an opening in the external wall has been poorly formed; see Fig 17. In addition, there is a crack and some displacement of a section of stone walling above first floor level at the north end of the west elevation. It is likely that this has been caused by the failure of the roof truss previously mentioned.

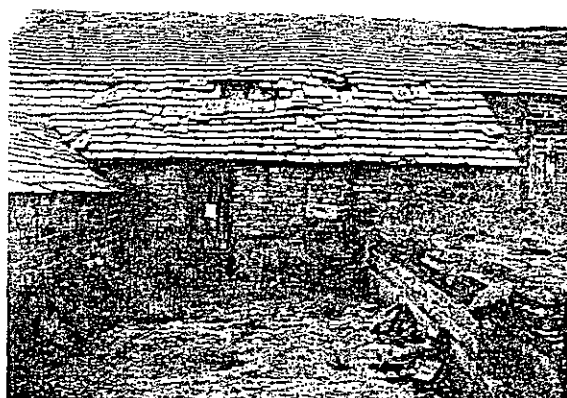
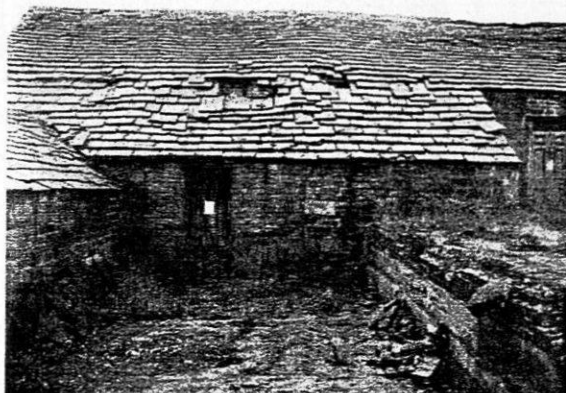
At the southern end, the two storey barn is divided into two bays by a single truss, which is in good condition. The eastern bearing end of the truss is supported onto a timber post, at which point the roof sweeps down to form the cat slide. A half truss supports the lower roof of similar design to Barn A.

Fig 18 Cat slide roof to the rear of Barn B

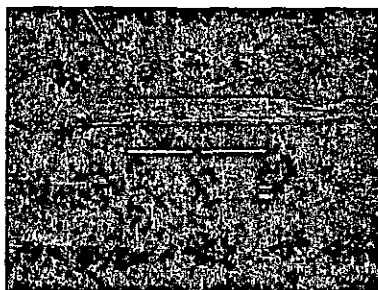
Fig 20 End truss looking east

The gable wall (east) was re-built in cavity construction (see Fig 20) when the land was released for residential development and is constructed at an oblique angle. The south elevation, as shown in Fig 21, has two large openings with sliding doors.

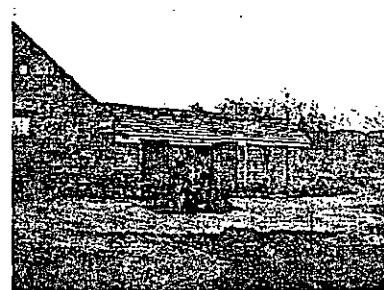
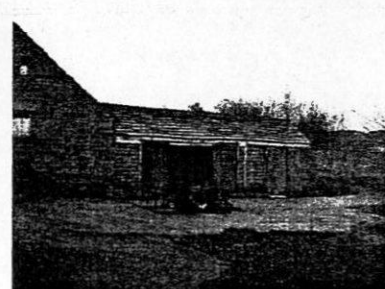
Fig 21 South elevation
