ARBORICULTURAL REPORT

& Impact Assessment

***Lee Lane,
Royston,
Barnsley,
South Yorkshire,
S71 4ER***

Reference: *AWA1741*

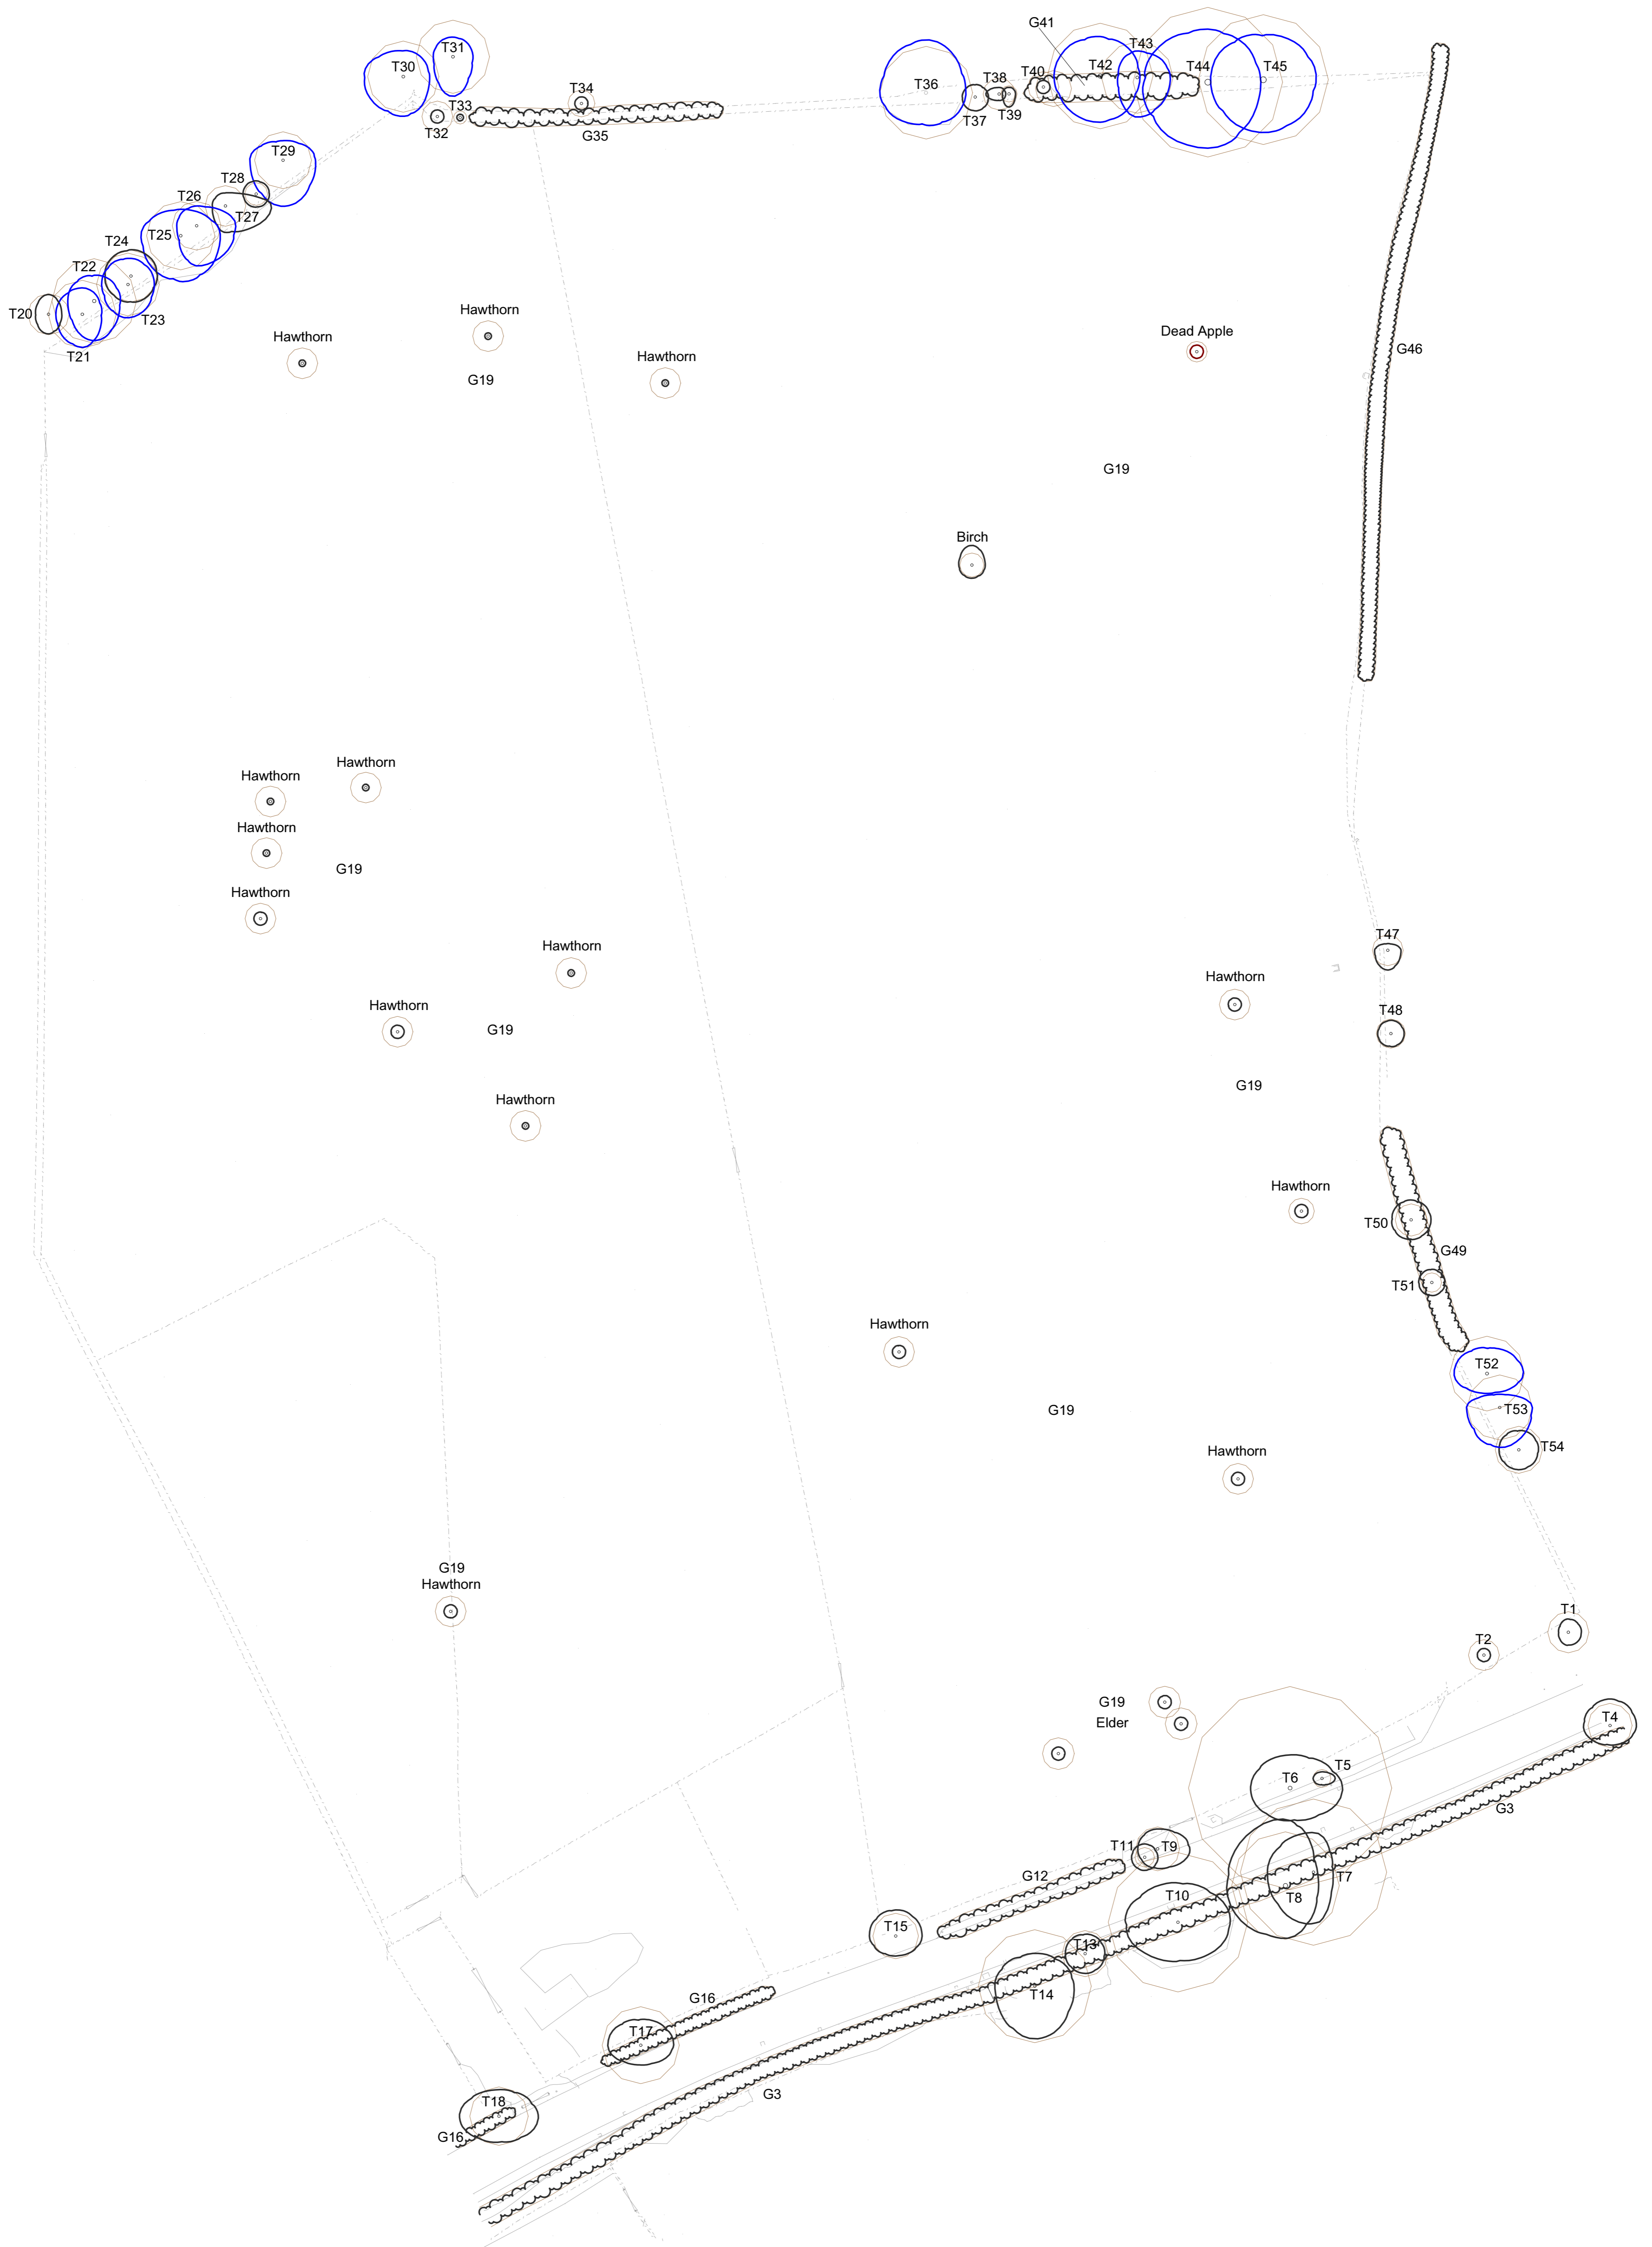
Appendix 5:
Tree Constraints Plan
 Lee Lane, Royston
 Ref: AWA1741

- 3.2.9 The tree Root Protection Area (RPA) detailed on the Tree Constraints Plan at Appendix 5, is a layout design tool, to inform on the area around a tree where the protection of the roots and soil structure is treated as a priority.
- 3.2.10 The RPA for each tree has been plotted as a polygon centred on the base of the stem. Due to the presence of roads, structures, topography (and past tree management) the RPA is likely to be a simplified representation of the tree roots actual morphology and disposition. However, detailed modifications to the shape of the RPA would largely be based on conjecture and so have been avoided.

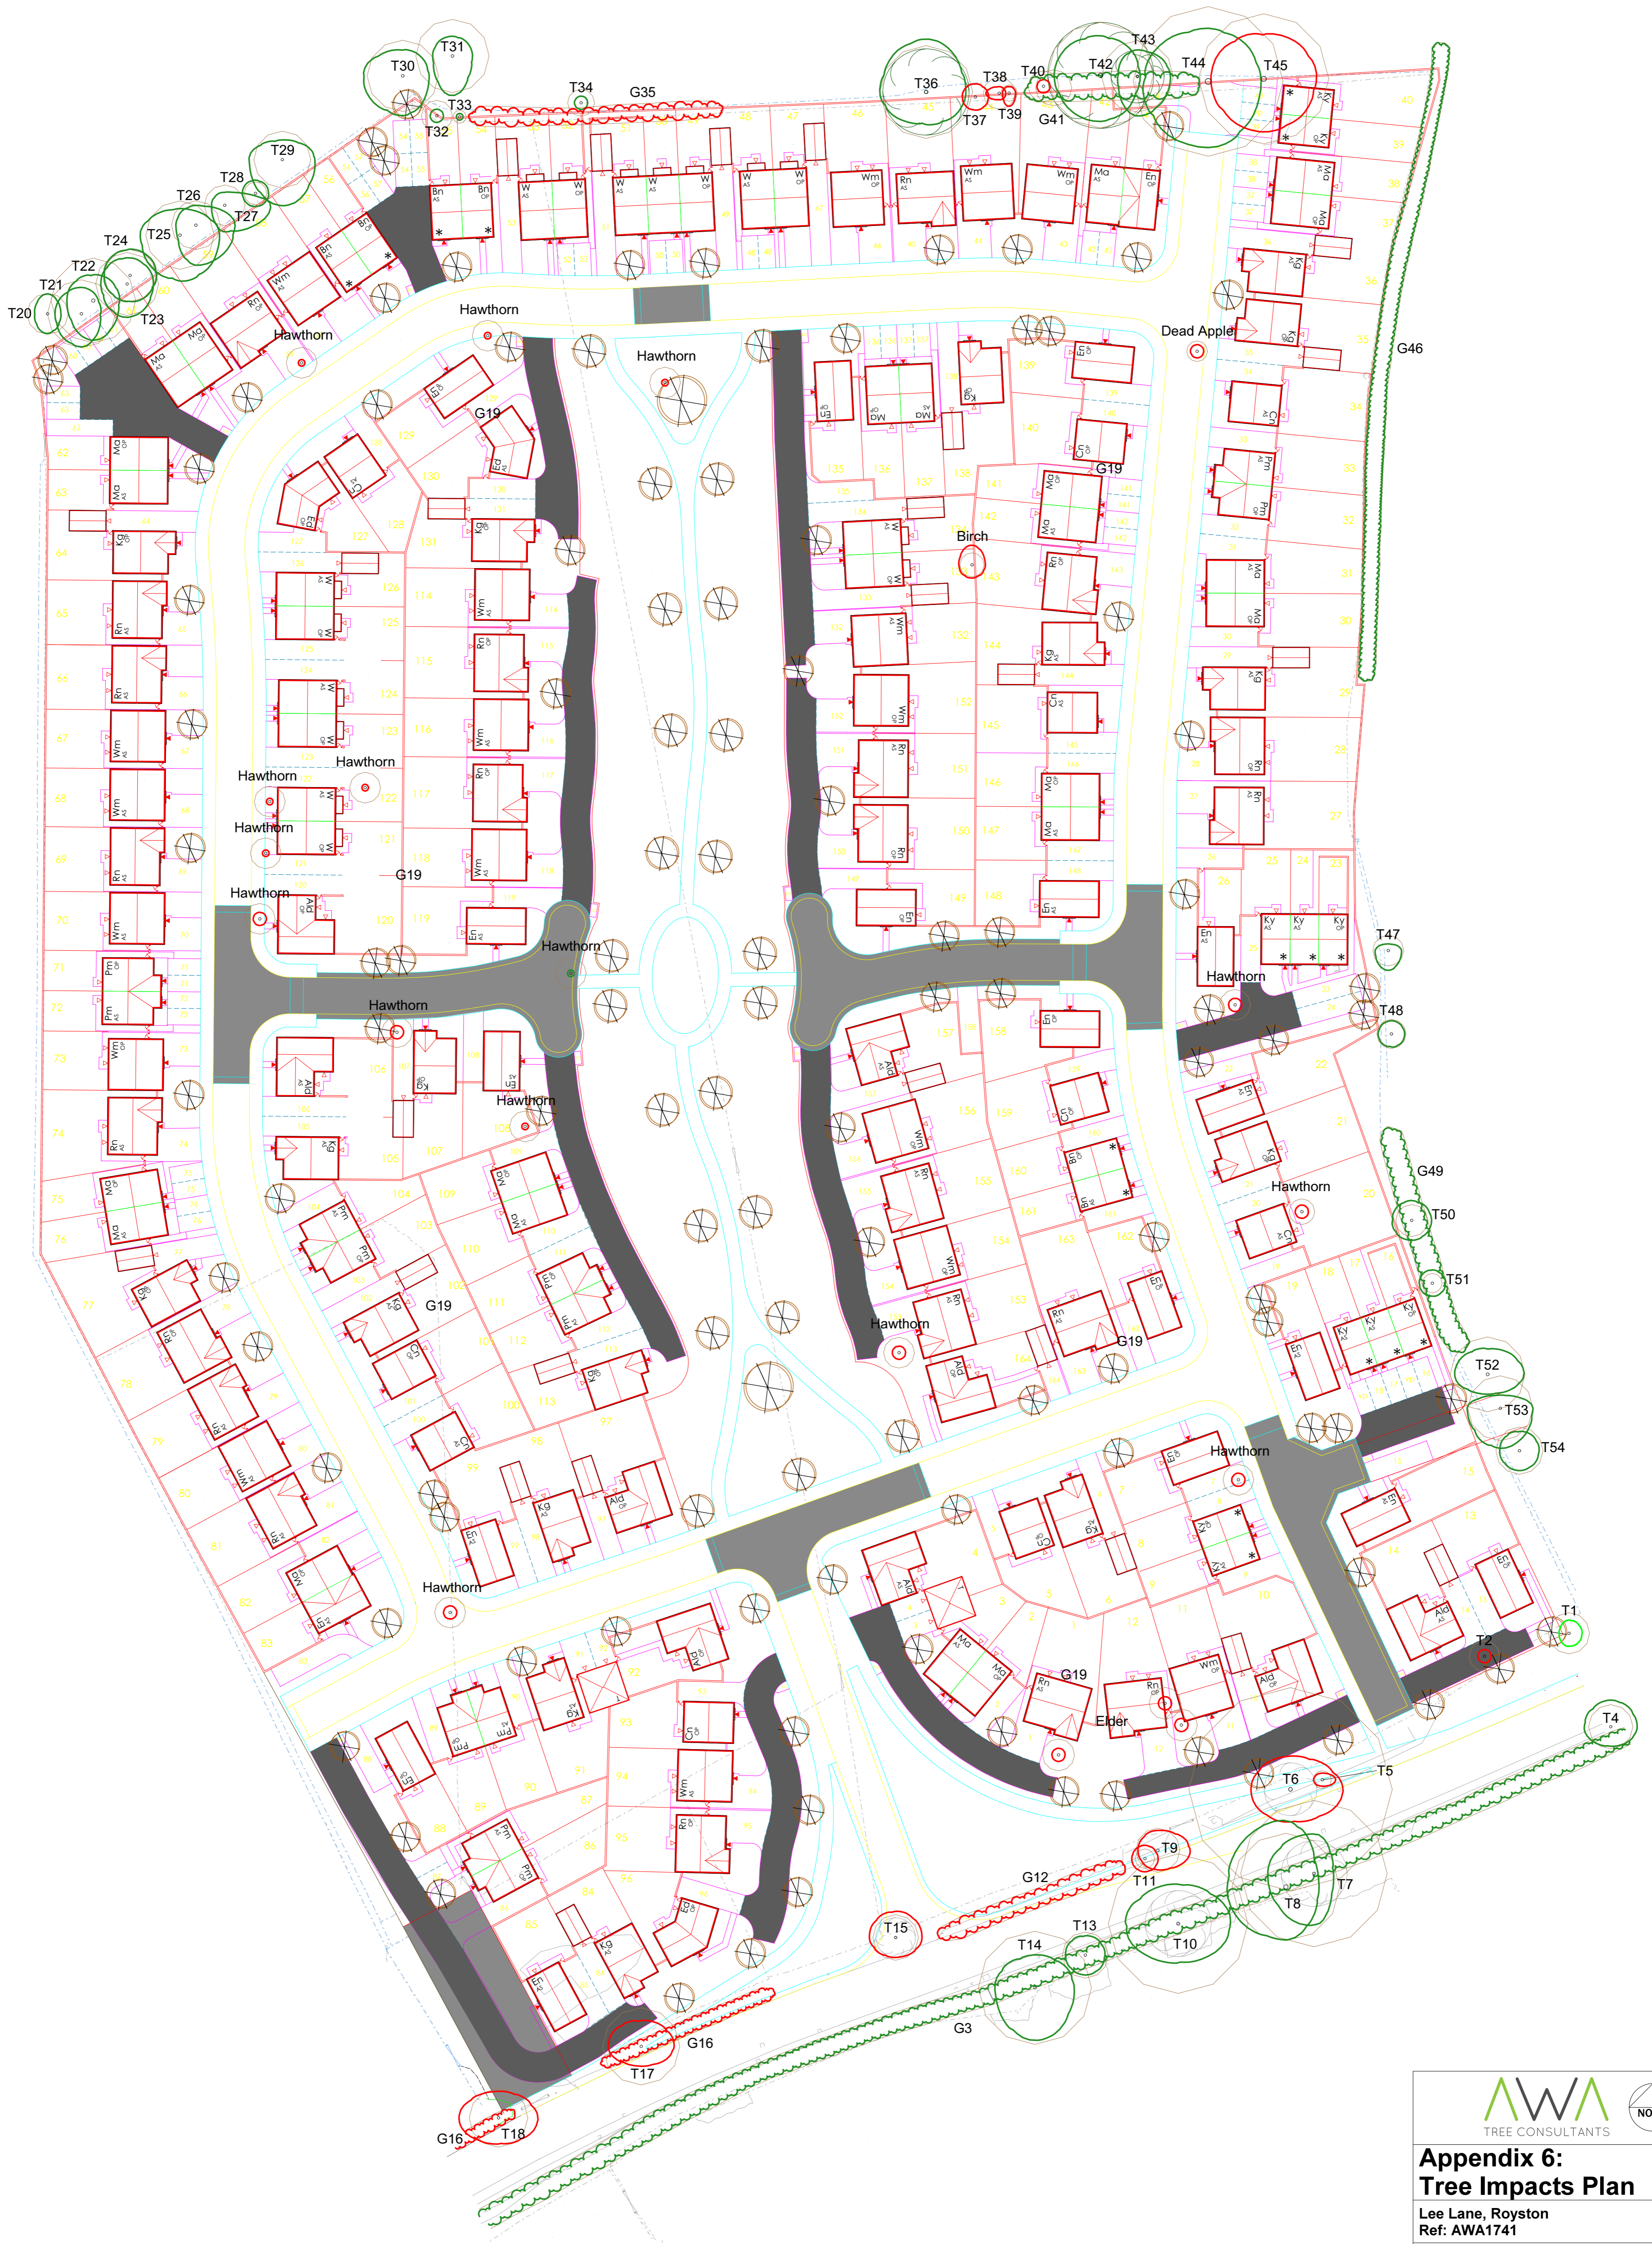
Appendix 6:
Tree Impacts Plan

- 4.2.1 From assessing the new development proposals, 13 trees or groups will require removal as they are situated in the footprint of the structure or their retention and protection throughout the development is not suitable.
- 4.2.2 Most of the trees that require removal are lower value, retention category 'C', and the removals will have only negligible negative arboricultural impact.
- 4.2.3 The removal of the large, mature Oak situated at the site's north eastern corner (T45) will have a more significant negative arboricultural impact on the site and will create a loss of visual amenity in the short to medium term.
- 4.2.4 The removal of the small, shrubby Hawthorn and Elder trees situated throughout the central area of the site (G19) are of very little consequence as they are all low value trees which are easily replaceable with new plantings at the site.

- 4.2.5 The removal of the trees and hedges adjacent to the road at the site's southern boundary (T2, T5, T9, T11, G12, T15, G16, T17 and T18) will have some minor negative visual impact and a loss of visual amenity in the short term, but the screening the trees currently provide can be replaced with new plantings in this area.
- 4.2.6 In addition, the shrubs and hedges to the north of the site (T32, T33, G35, T38, T39, T40 and G41), may need cutting back so as to facilitate the new boundary fencing for the new development. This work is unlikely to impact of the visual amenity or future prospects of the trees.

- 4.3.2 Potentially damaging activities are proposed in the vicinity of retained trees. New hard-surfaces are proposed that encroach into the RPA of T21, T22, T42 to T44. Construction of hard surfaces within the RPA, can have negative impacts on tree roots. However, the potential negative impacts can often be overcome or minimised by employing a 'no-dig' type construction methods with a porous final surface.

- 4.5.1 The retained trees will require protection by fencing in accordance with BS 5837: 2012, during the development phase.
- 4.5.2 If required by the Local Planning Authority, an associated Arboricultural Method Statement, detailing protective fencing specifications and construction methods close to the retained trees can be provided.
