Berrywell, Springvale

Bat Survey Report

3rd November 2025

Document ref: MBE/BAT/2025/106/01				
Purpose and Description	Originated	Checked	Reviewed	Date
For Planning	G Slack MCIEEM <i>Greg Slack</i>	P Middleton MCIEEM <i>P Middleton</i>	G Slack MCIEEM <i>Greg Slack</i>	03/11/2025

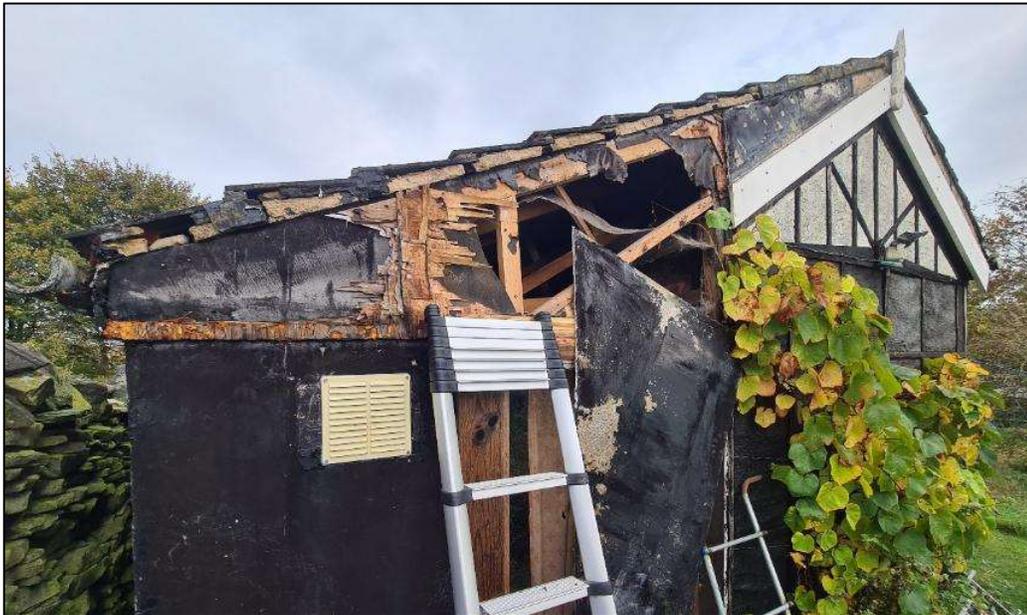
Plate 5. Removed panel allowing access to the void

- 5.2.3 A void was present over the rear extension. Although no hatch was present to allow access into this area, a panel at the southeast gable was removed during the inspection to allow this space to be checked (Plate 5 and 6).

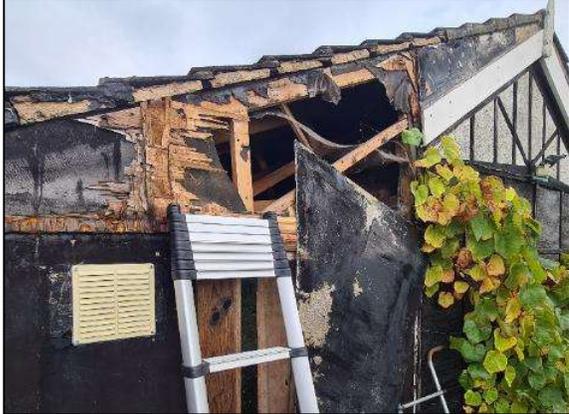
PRF	Example Photo	Description
B

<p>Lose cladding panel (removed for inspection in photo).</p>

- 6.2.2 Delaying planning permission for this low-suitability building is considered disproportionate to the risk of finding a bat roost. Therefore, instead, it is proposed that a destructive survey of the potential bat roost features is undertaken in order to check for bats and/or signs of bats. The destructive survey should be completed by, or under the supervision of a suitably qualified ecologist following a toolbox talk given to the roofing team. A suitable toolbox talk is given in Appendix 2. The tiles in key areas should be removed while the ecologist is supervising the work.

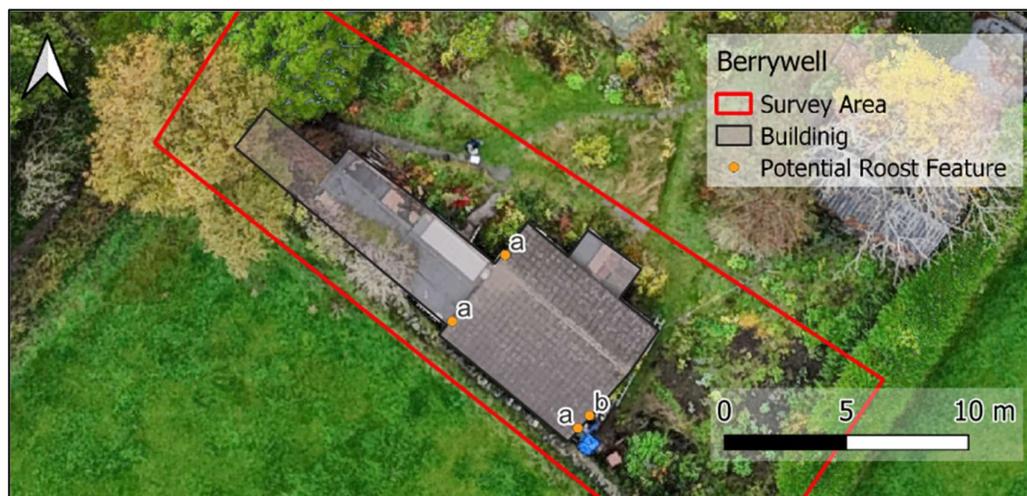
Figure 2. Potential roost feature locations

5.2.4 The potential bat roost features present were limited to missing verge mortar, and a loose cladding panel. The potential roost features are shown in Table 3, and their locations shown on Figure 2.

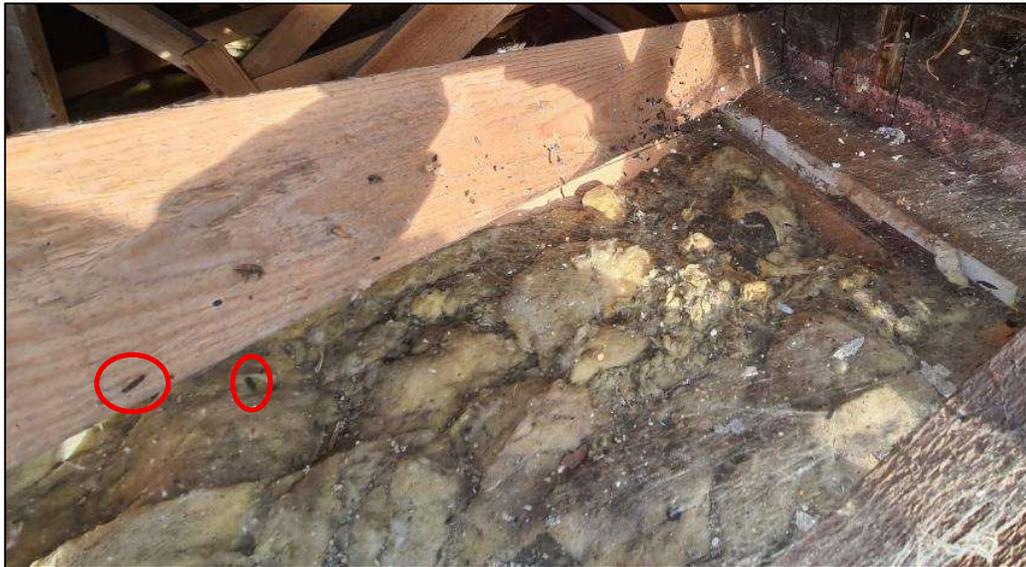
Plate 7. Two of the mouse droppings within the roof void

5.2.5 No bats or signs of bats were present within the building. Approximately 20 mouse droppings were found within the roof void (Plate 7), and an old bird's nest was found at the northwestern gable but the client reported that it hadn't been used in recent years as the smoke from the adjacent flue tended to blow into the roof void when the log burner was used.

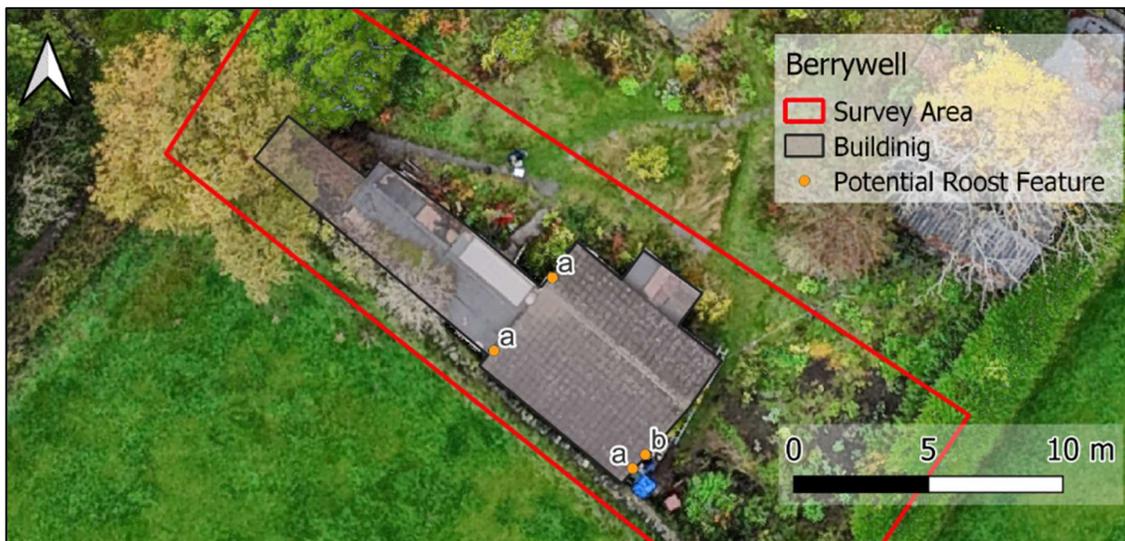
Below: location of the suitable roost features present

Suitable roost locations include missing verge mortar, and loose cladding panels. Any material forming a crevice must be removed carefully by hand. Suitable crevices/features should be searched by the ecologist prior to removal. All material over a crevice/void should be lifted in such a way as to avoid crushing any bats underneath. If bats or droppings are found, then all works in the surrounding area should cease and the ecologist contacted.

All tiles at the verge should be removed under the supervision of the ecologist. Additional supervision may be required depending on the initial findings. Other areas must be signed off in advance by the ecologist before works proceed unsupervised.

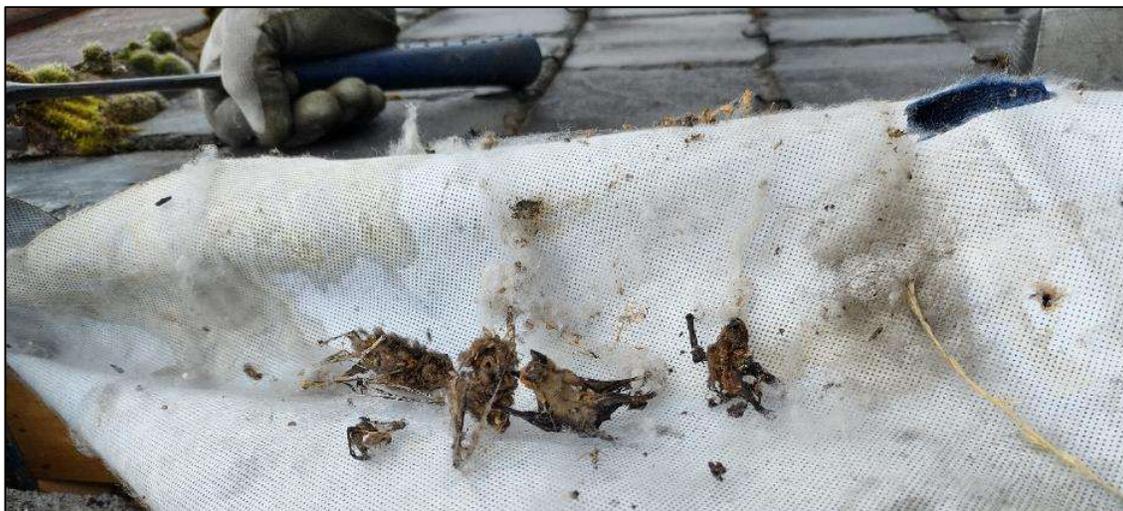
Plate A3.1. Four dead pipistrelles tangled in breathable roofing membrane

One example we have encountered comprised a pipistrelle roost which formed in a building extension constructed in 2009. Over the course of just 13 years the roofing felt degraded to the extent that it trapped and killed more than 10 bats. Fortunately, the problem in this roost was identified and remedial work was undertaken to replace the roofing membrane in 2022.

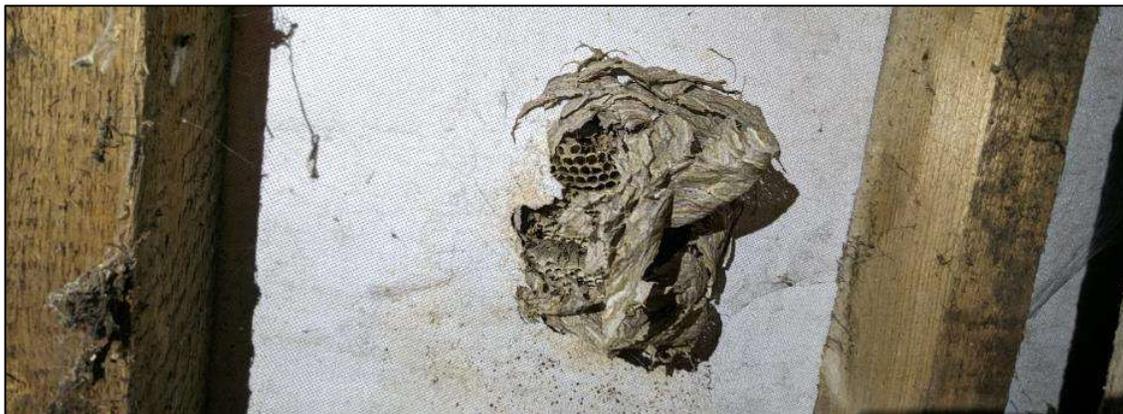
Plate A3.2. Damage to a breathable roofing membrane adjacent to a wasp nest

In recent years a fairly substantial proportion of the lofts we have surveyed which had existing breathable felt, were found to have been damaged by wasps (Plate A3.2). The wasps appear to have chewed holes in the felt and formed nests. This doesn't appear to be a problem associated with traditional bitumen coated roofing felt. Any holes within roofing felt are likely to significantly reduce its functionality as a secondary weather barrier. Where bats or birds come into contact with breathable roofing membranes, they can also damage it causing it to leak, they can also significantly reduce the breathability of the felt in that location.
