**Whitcher Wildlife Ltd.  
Wildlife Consultants.**

**CROW EDGE.  
BAT SURVEY.**

**Ref No:- 100939**

**Date: 30<sup>th</sup> September 2010.**

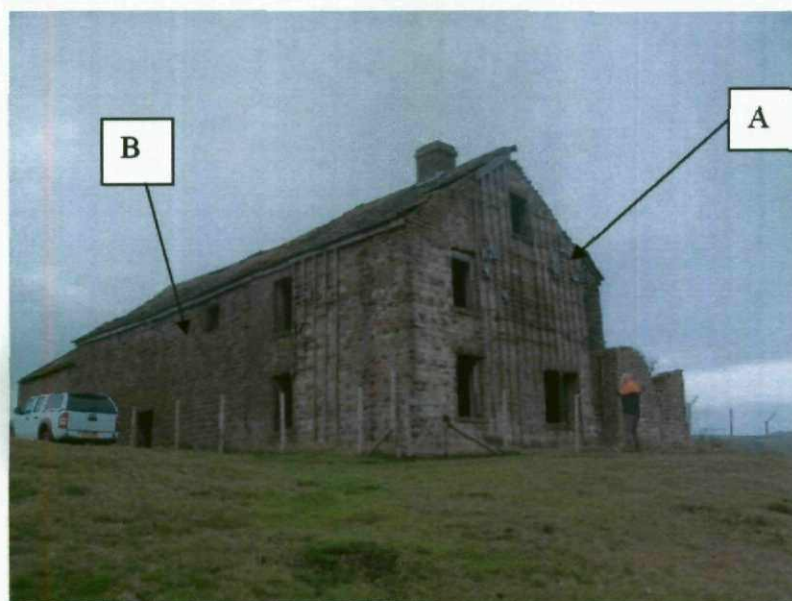
3.3.1.1. Building A is the old farm house on the southern end of the site.

3.3.1.2. The building is constructed with close fitting coursed stone external walls with random stone on the inside and a rubble fill. The external walls are in remarkably good condition for the state of the building although there are a number of open joints where the pointing is missing. The building appears to have been tile clad at some point in time but all that remains are the timber lathes that fixed the cladding to the stone walls. All windows and doors are missing and open.

3.3.1.3. The roof of the building is supported on a king post timber frame. The roof covering is stone slates with no lining and is in a poor state of repair with numerous missing and displaced slates.

3.3.1.4. Internally the middle floor has rotted and is mostly missing and the entire building is very wet as a result of being open to the elements.

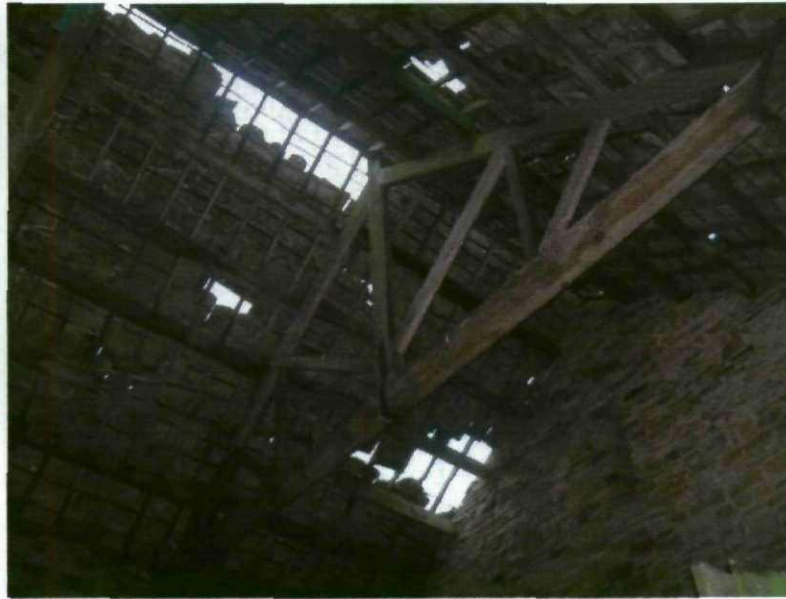
3.3.2.3. The roof of the building is supported on a king post timber frame. The roof covering is stone slates with no lining and is in a poor state of repair with numerous missing and displaced slates and with the majority of the ridge tiles loose or missing, as shown in the photograph below.

3.2.2.4. The inside walls of the building are in a fairly good state of repair although the building is very wet as it is so exposed to the weather.

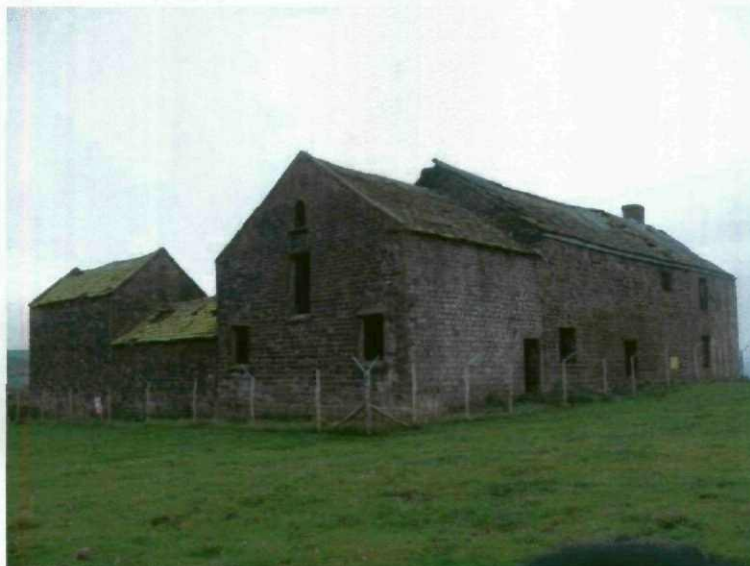
3.3.3.1. This appears to have been a two storey store built onto the northern end of the barn.

3.3.3.2. The construction of the building is the same as above with solid coursed stone walls and a pitched slate roof, as shown below.

3.3.3.4. The walls are generally in a good state of repair although there were a number of openings where the pointing is missing.

3.3.3.5. There are large holes in the roof where there are missing or slipped slates although most of the ridge tiles remain in place.

3.3.3.6. Internally the building is very wet and the middle floor has rotted and it was unsafe to access the upper floor.

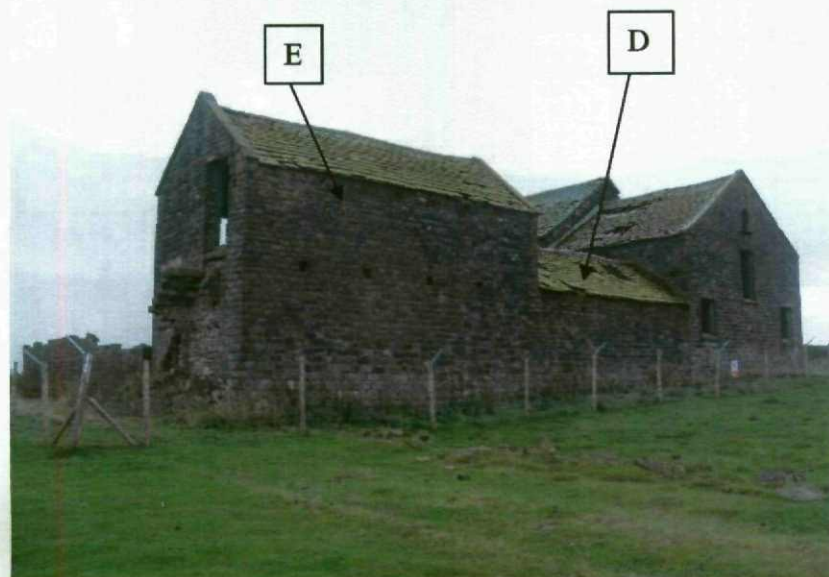
3.3.4.2. The construction is similar to the other buildings with solid stone walls and a pitched, stone slate roof. The front of the building is open to provide access for farm machinery.

3.3.4.4. The roof is in a poor state of repair with missing and displaced roof slates.
