**THURNSCOE HALL**  
**Boundary Wall and Fence**

**Heritage Statement**

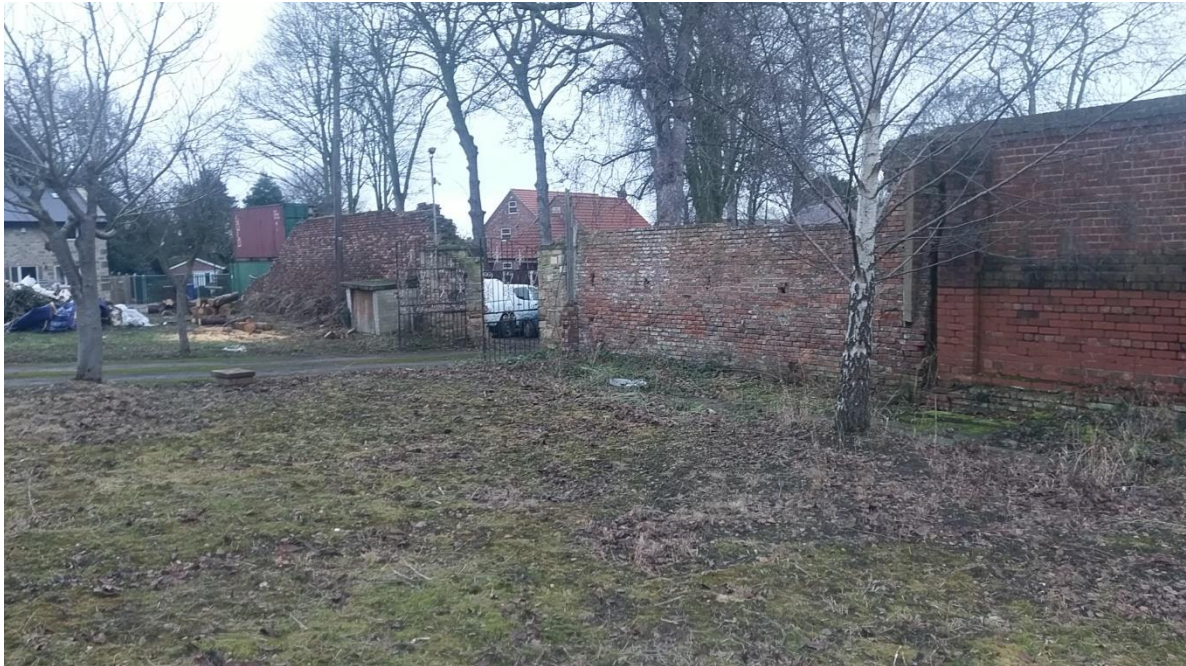
*Fig 8 –North boundary – clay brick; stone gateposts; engineering brickwork*

The north boundary wall combines a mix of different walling from different ages. The south side is predominantly faced in brick, the north façade is in sandstone which has either rotted away or is in poor and unstable condition. The north west elevation is very high, c3m, and has no returns or buttressing. At the north west corner the wall has been removed by the adjacent owner. The brickwork is badly weathered, with large numbers of severely spalled bricks. All cappings/copings have been removed.

The North boundary wall would be demolished and re-built in brick with piers along the line of the existing boundary. This will maintain a consistent appearance along the existing boundary. The gates would be replaced with vertical boarded timber gates at the existing location. Small, low voltage LED up/down lights on a proximity sensor and timeswitch would be provided to the piers on either side of the gateway. This will enhance the approach to the Hall, which is currently not in keeping with the principal entrance to the hall. The gateway will be maintained on the line of the former rear access gateway to the hall.

This would be the only portion of demolition in the scheme. The existing boundary wall along the north elevation is in an unsafe and unstable condition and would require re-building if it is not to be replaced.

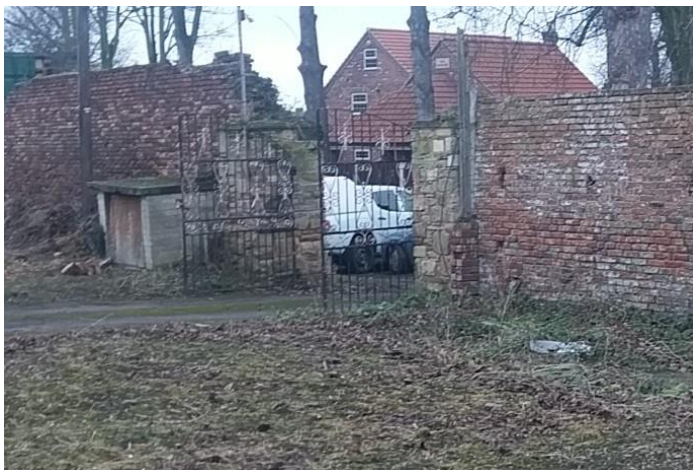
*Fig 9 – Gates and Gateposts*

The gate and gateposts are in random stone with ribbon pointing and may date from the conversion into a residential care home. The gates are in wrought iron, arch headed and simple round sections. The location of the gates is maintained from the rear access from the hall towards the high street shown on the 1892 ordnance survey map. The primary entrance to the hall would have been from the south, and along the west boundary. This is shown on the 1854 and 1892 maps, but has now been developed. To the west side of the gatepost is a small slab enclosure for the gas meter

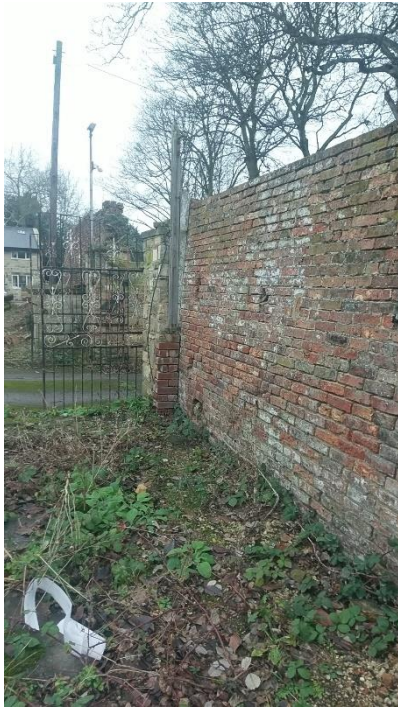
*Fig 10 – NorthE boundary – brick*

The north west boundary wall is a mix of different brick walls, with a mid 20<sup>th</sup> century lean-to shed at the north east corner. The western brickwork is in a very poor condition, with large numbers of badly spalled bricks and no pointing. The central section is in engineering bricks and dates to the middle of the 20<sup>th</sup> Century. Although buttressed the wall has a significant lean to the north and is in danger of collapse. Behind the lean to shed the wall is in brick, with an outer facing of stone which has been robbed.

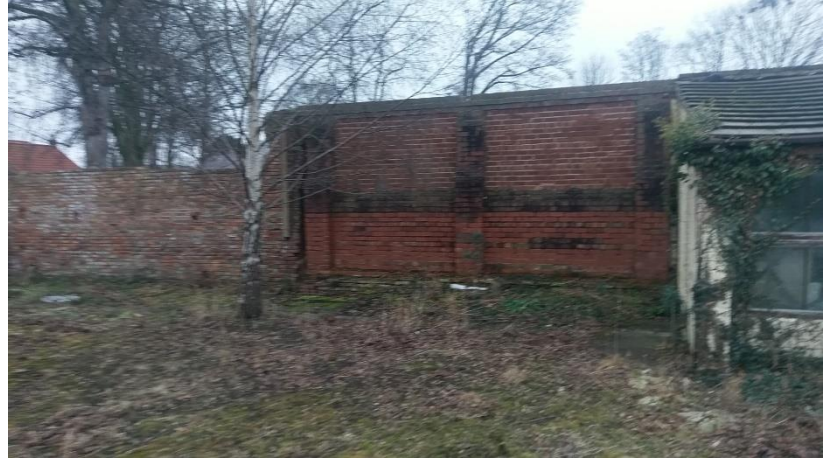
*Fig 11 – NE boundary – engineering brick*

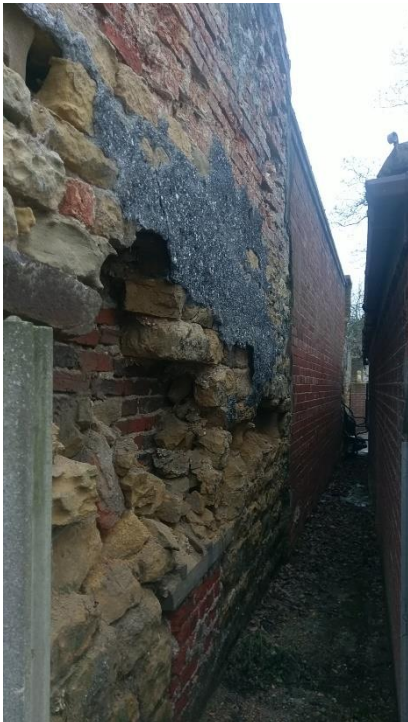
*Fig 12 – NE boundary – brick and stone.*

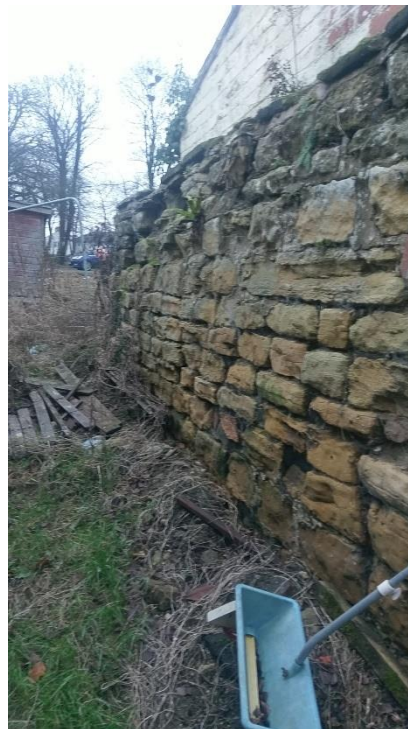
*Fig 13 – NE return – stone outer facing*

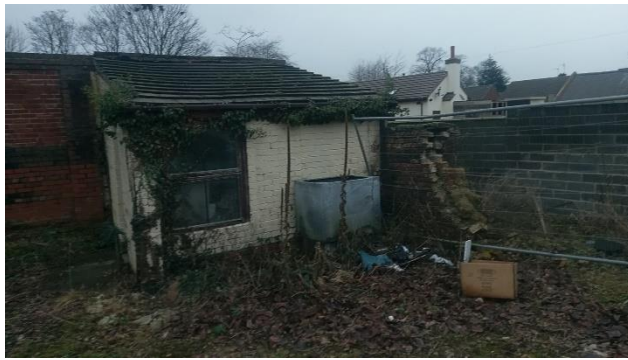
*Fig 14 – NE lean to shed.*

The shed is a simple half brick wall with a reclaimed window and marley modern slate roof. It uses boundary to the north and west. The eastern boundary to the north has been demolished and is only identifiable by the outside face of neighbouring walls and outbuildings.

The brick walls will be continued along the east and west boundaries, north of the house. This will re-affirm the former boundaries of the immediate grounds for the hall. The existing lean to garden shed at the north east corner will be demolished.
