ARBORICULTURAL REPORT **& Impact Assessment** **to BS 5837:2012 at:**

***Former Hoyland Methodist Church,
Duke Street,
Hoyland,
Barnsley
S74 9QR***

Prepared for:
White Agus Partnership

Reference: *AWA5286*

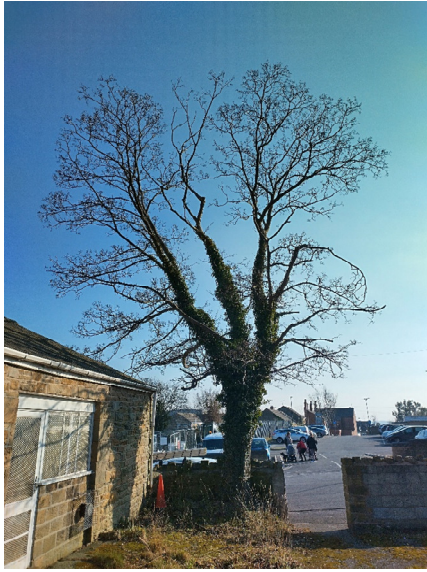
Photo 1: T1 from north west

- 3.2.3 Full details of the surveyed trees are provided in the attached tree data schedule at Appendix 4. General comments are provided below:
- 3.2.4 Norway Maple T1 is in poor condition with significant dieback, deadwood and snapouts in its crown. The tree is situated on a raised mound surrounded by hardstanding, with a retaining wall to the south east, south and south west. The retaining wall is cracked, likely due to the tree and the surrounding hardstanding is lifted and cracked, also likely due to the tree. The removal of T1 is recommended regardless of development at the site. T1 is protected by a Tree Preservation Order, and as such, the permission of the local planning authority is required to remove the tree (unless the removal is approved by planning permission).

- 4.2.5 The wall to the north of Ash T6 is in a state of disrepair, likely partly due to the tree.
- 4.2.6 Norway Maple T1 and Ash T7 are also recommended for removal regardless of development at the site. T1 is protected by a Tree Preservation Order, and as such, the permission of the local planning authority is required to remove the tree (unless the removal is approved by planning permission).

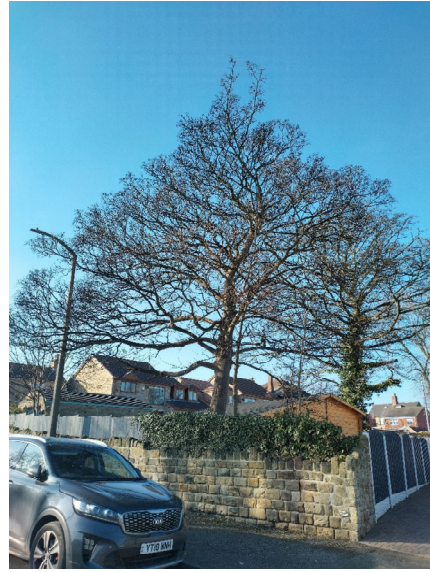
Photo 2: T2 from south east

- 3.2.5 Sycamores T2, T3 and T5 and Ash T4 are large early mature to mature trees in good condition which provide significant amenity value to the site and the surrounding area. T2, T3 and T5 have good future prospects, while Ash T4 may have more limited future prospects due to the fungal disease Ash Dieback. T3, T4 and T5 are situated within site boundaries, while T2 is adjacent and inaccessible and so was only given a cursory inspection with measurements estimated and condition values indicative only.

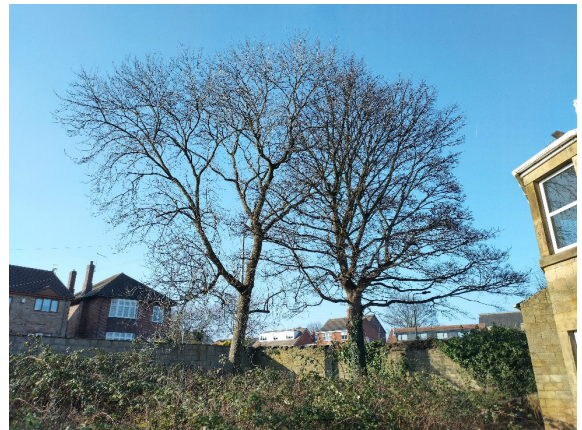
Photo 4: T4 and T5 from south east

- 4.3.5 While the proposed development is able to be constructed with little negative impact on the retained trees at the site, retained Ash T4 and retained Sycamore T5 would dominate the garden of one of the proposed new residential properties and the eastern crown of T5 would be close to coming into contact with the proposed new residential property, and this may lead to pressure from the future residents of the residential property to prune or remove the trees.

- 3.2.9 Ivy covering trees T1, T3, T5 and T6 prevented detailed inspections of the trees being undertaken. It is recommended to sever the Ivy on trees T3 and T5 at the base and at 1.5 regardless of development at the site, so that detailed inspections of the trees can be undertaken in future.
- 3.2.10 Access to trees T10 and T11 was limited due to dense undergrowth.
- 3.2.11 The tree Root Protection Area (RPA) for each tree has been plotted as a polygon centred on the base of the stem. Due to the presence of roads, structures, topography (and past tree management) the RPA is likely to be a simplified representation of the tree roots actual morphology and disposition. However, detailed modifications to the shape of the RPA would largely be based on conjecture and so have been avoided.

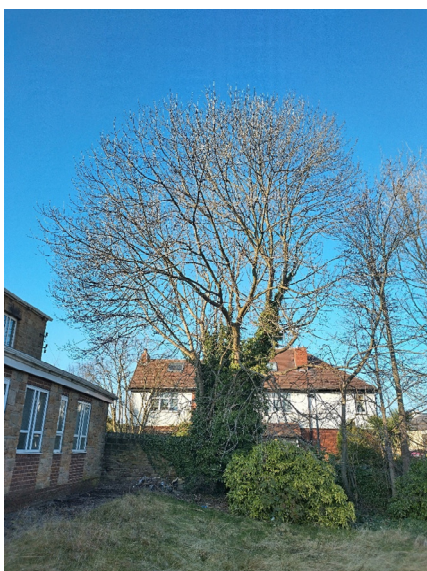
Photo 5: T6 from south east

- 3.2.6 T6 to T13 form a linear group of trees situated at the north eastern corner of the site, bordering the site's northern boundary. The trees are all of low individual value and Ash T6, T7, T9, T11, T12 and T13 likely have limited future prospects due to Ash Dieback, however collectively the trees provide screening between the site and the neighbouring residential properties to the north. The wall to the north of T6 is in a state of disrepair, likely partly due to the tree.

- 4.2.2 The trees which require removal to facilitate the development are T6 and T8 to T13.
- 4.2.3 The trees requiring removal are situated at the north eastern corner of the site, bordering the site's northern boundary. Collectively the trees provide screening between the site and the neighbouring residential properties to the north, but individually the trees are of low value.

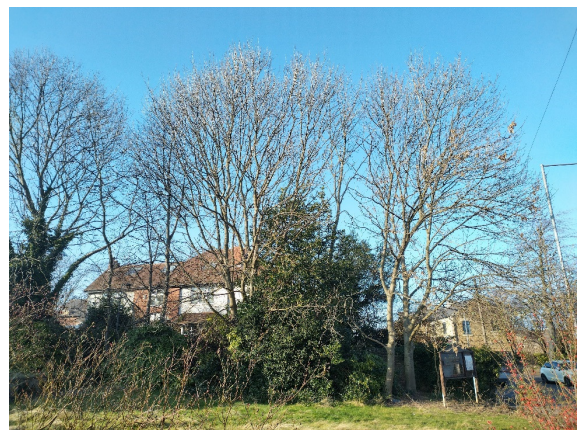
Photo 6: T7 to T13 from south east

- 4.2.4 Ash T6, T9, T11, T12 and T13 which require removal to facilitate the development likely have limited future prospects regardless of the development due to the fungal disease Ash Dieback.

- 3.2.7 T7 has Ash Dieback symptoms and is recommended for removal regardless of development at the site.
- 3.2.8 Cherry T14 is adjacent and inaccessible and so was only given a cursory inspection with measurements estimated and condition values indicative only. There is a retaining wall to the north, north east and north west of the tree, between the tree and the site.

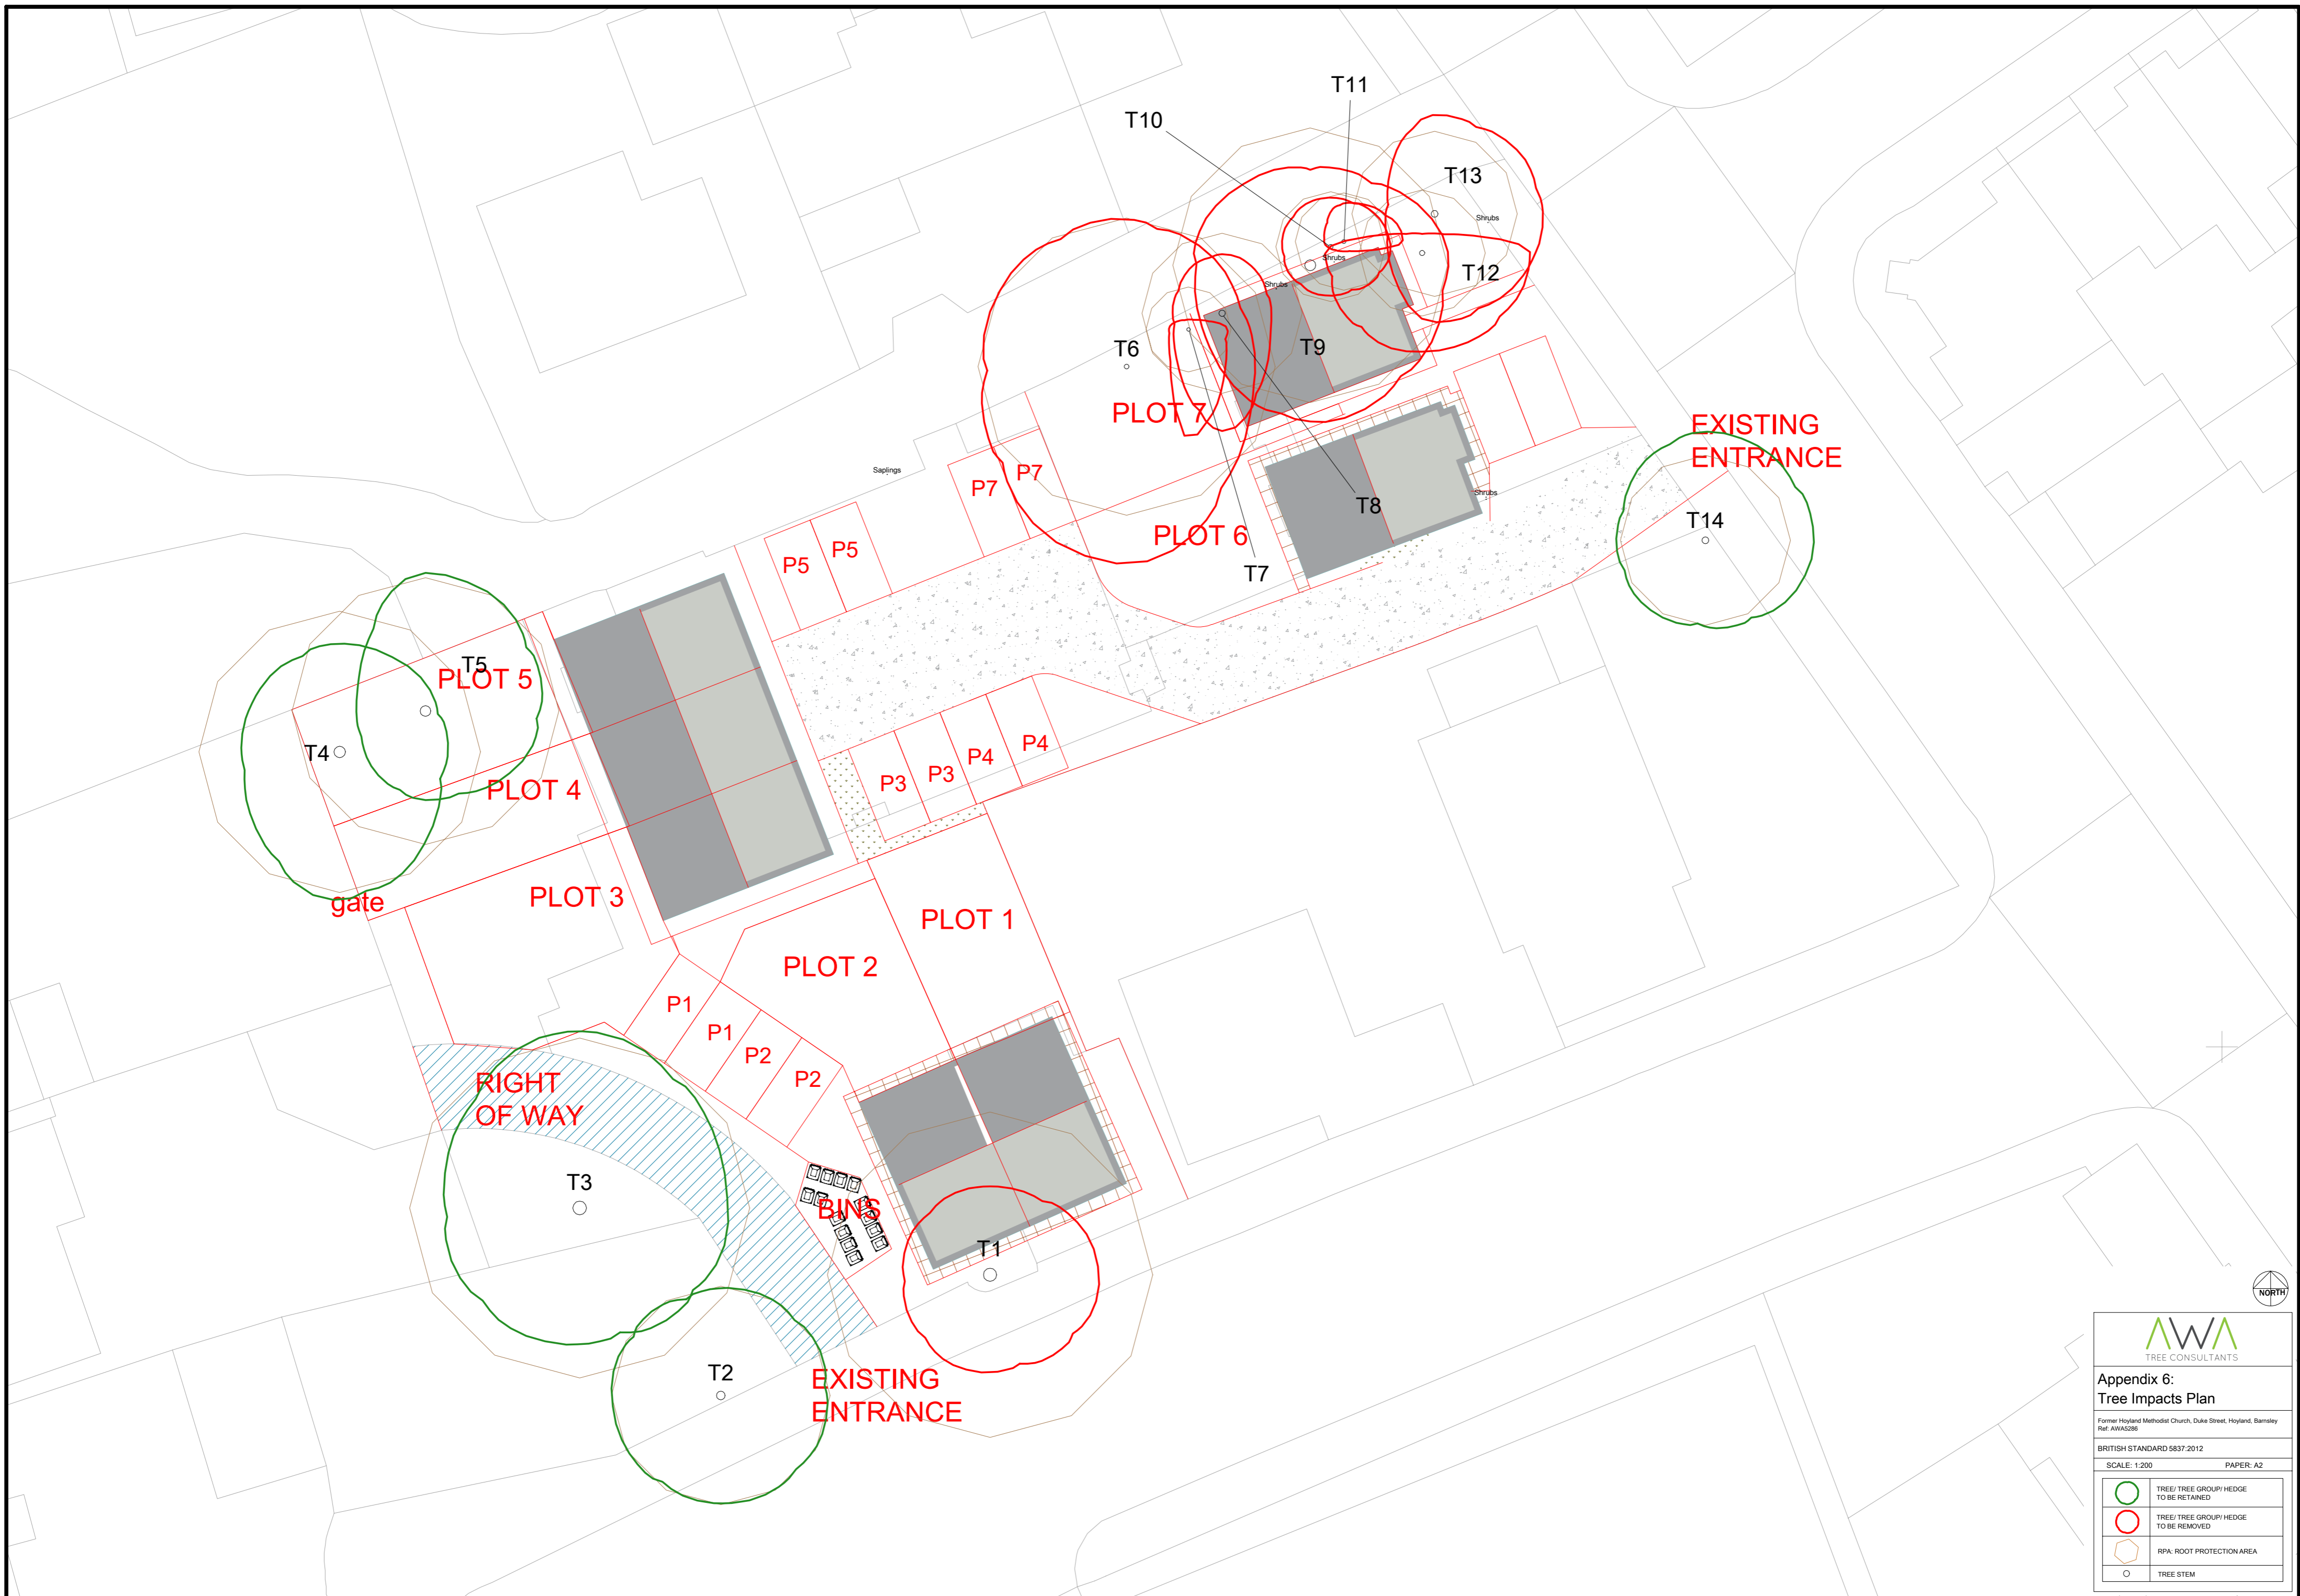
Appendix 6:
Tree Impacts Plan

- 4.2.1 From assessing the new development proposals, 7 trees will require removal to facilitate the development as they are situated in the footprint of the development or their retention and protection throughout the development is not suitable.

- 4.5.1 The retained trees will require protection by fencing in accordance with BS 5837: 2012, during the development phase. If required, an associated Arboricultural Method Statement, detailing protective fencing specifications and construction methods close to the retained trees can be provided.
