| <b>Site Inspection reference</b> | SI-5129-01 | <b>Date of inspection</b> | 22.01.2021 |

**Task description** Climbed endoscope inspection of all potential roost features within three mature ash trees on the southern boundary of the Mount Vernon Road Site.

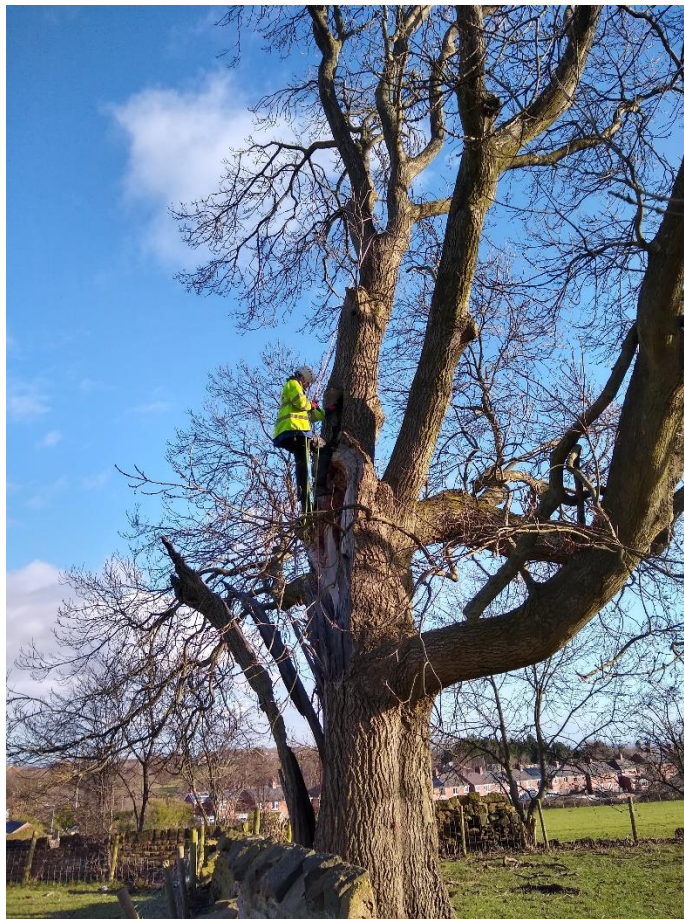
**Photograph 1**

This tree also includes a significant branch scar on its northern elevation. This feature extends from approximately 2m – 4m up the trunk. A small rot hole at the top of the scar extends c.1m into a cavity within the trunk. This feature was found to be suitable for use by roosting bats, but no current or historic evidence of occupation was noted. The minor tear wound associated with the branch scar was found to offer minimal suitability for use by roosting bats.

Roped access  
inspection of  
features in  
eastern tree

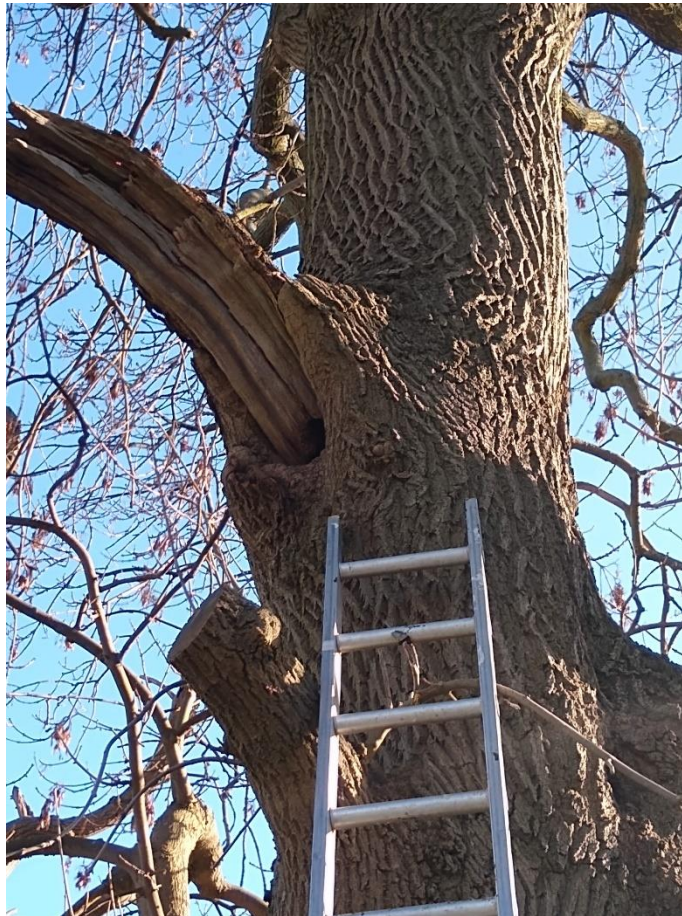
**Photograph 3**

This tree includes a significant rotten branch extending from the crown on the northern elevation, cavities within this feature were found to include significant build ups of detritus resulting from the rotting wood.

This feature links to the cavity associated with a smaller rot hole below, this cavity was found to hold standing water and was deemed unsuitable for use by roosting bats.

Branch scar in  
middle tree
