## **TREE SURVEY**

PROPOSED PROPOED DEVELOPMENT AT

AUTUMN HOUSE CARE HOME, WORSBROUGH

February 2017

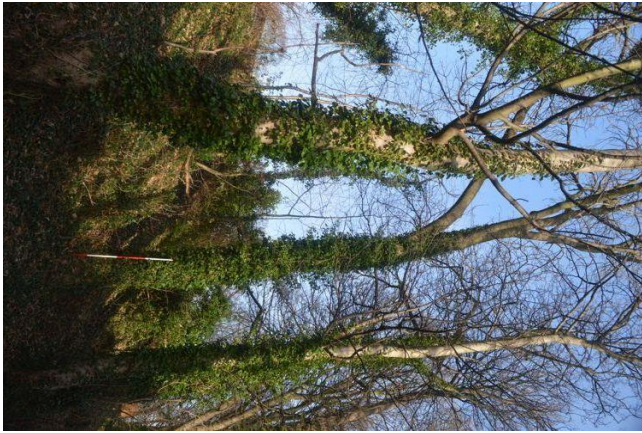
Tree ref. T1 Common Ash (to be retained, cut Ivy) - *part of a tree group*

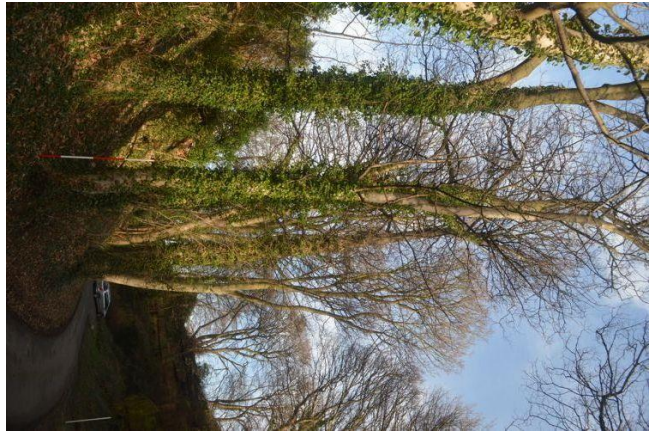
Tree ref. T2 Sycamore (to be retained, periodic review) - *part of a tree group*

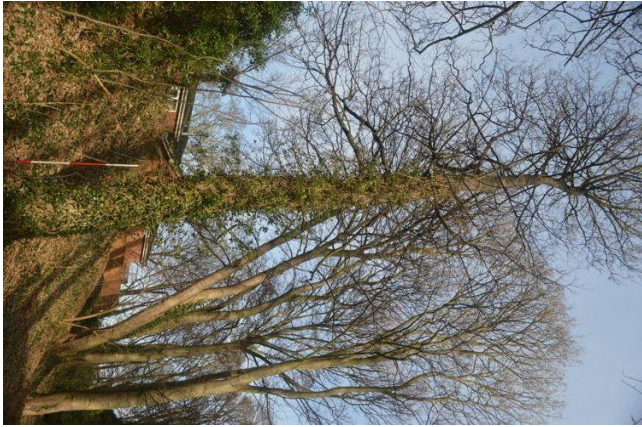
Tree ref. T6 Bird Sycamore (to be retained, cut Ivy) - *part of a tree group*

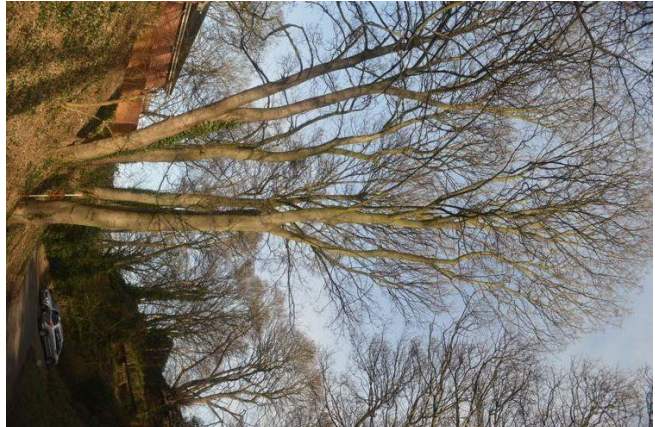
| Ref | Species | Height (m) | Stem Ø (mm) | Branch Spread (m) | Height Crown Clearance (m) | Life Stage | PC | Structural Condition<br>General Observations | Preliminary Management Recommendations | ERC (Yrs) | Grade |
|---|---|---|---|---|---|---|---|---|---|---|---|
| T7 | Sycamore<br>( <i>Acer pseudoplatanus</i> ) | 16-18 | 748 | N 2<br>E 7<br>S 10<br>W 4<br>SW 12 | 10m | Mature | Good | Growing part of woodland group. Tall form typical of shady situation.<br><br>Main stem divides at 2m, forms a shallow bowl / hollow. No obvious problems. Distorted shape crown. Small north side stem storm damage in crown due to movement. | To Be Removed Due to Construction. | 40+ | B2 |

Tree ref. T7 Sycamore (to be removed)

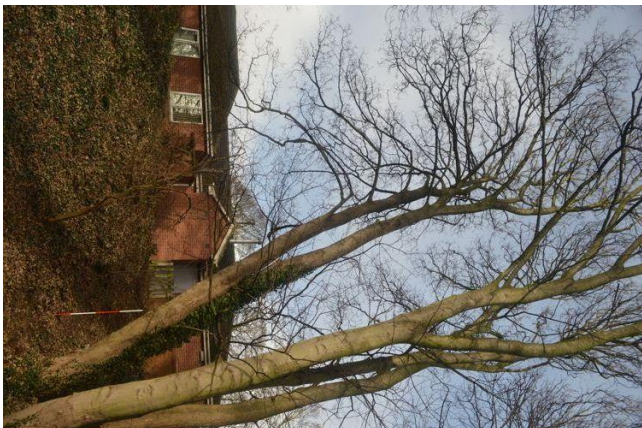
Several of the larger trees have defects that are likely to fail at some point in the near future (whole or in part) but these are often away from the building and in less frequently accessed areas and unlikely to be a problem. Most notably this includes Tree T8 located to the east side of the existing building (proposed for removal).

| Ref | Species | Height (m) | Stem Ø (mm) | Branch Spread (m) | Height Crown Clearance (m) | Life Stage | PC | Structural Condition<br>General Observations | Preliminary Management Recommendations | ERC (Yrs) | Grade |
|---|---|---|---|---|---|---|---|---|---|---|---|
| T8 | Sycamore<br>( <i>Acer pseudoplatanus</i> ) | 16-18 | 827 | 11m dia. -<br>Leans to -<br>SW -<br>- | 6m | Mature | Poor | Growing part of woodland group. Tall, distorted crown, heavily leaning to SW. Main stem divides near base, 2 stems rubbing together. Poor weak union between stems, stress cracks and rot visible. Heavy loading over edge of building. | To Be Removed Due to Construction. | <10 | C2 |

Trees ref. T8 Sycamore (to be removed)

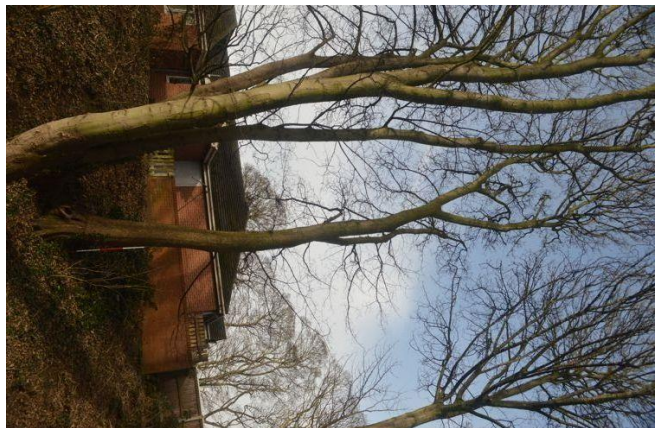
Tree ref. T9 Sycamore (to be removed)

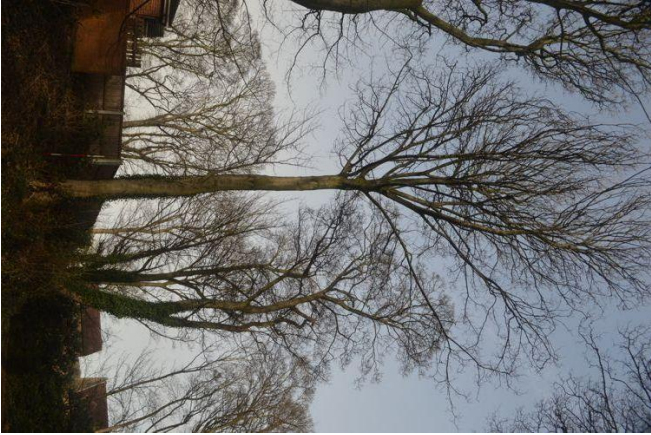
Tree ref. T10 Sycamore (to be removed)

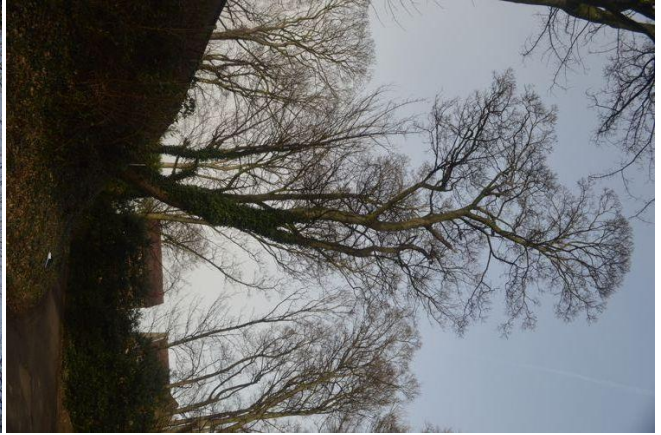
| Ref | Species | Height (m) | Stem Ø (mm) | Branch Spread (m) | Height Crown Clearance (m) | Life Stage | PC | Structural Condition<br>General Observations | Preliminary Management Recommendations | ERC (Yrs) | Grade |
|---|---|---|---|---|---|---|---|---|---|---|---|
| T11 | Sycamore<br>( <i>Acer pseudoplatanus</i> ) | 16-18 | 732 | N 6<br>E 7<br>S 4<br>W 4 | 10m | Mature | Poor | Located on embankment. Stem root base exposed on east side. Main stem bent. Several spiral stress cracks in lower main stem, possible wind twisting. Some storm damage in crown. Main stem divides 8-10mH and NE lateral has visible cavity mid-way up. Ivy growth. | To Be Removed Due to Construction. | 40+ | C2 |

Tree ref. T11 Sycamore (to be removed)

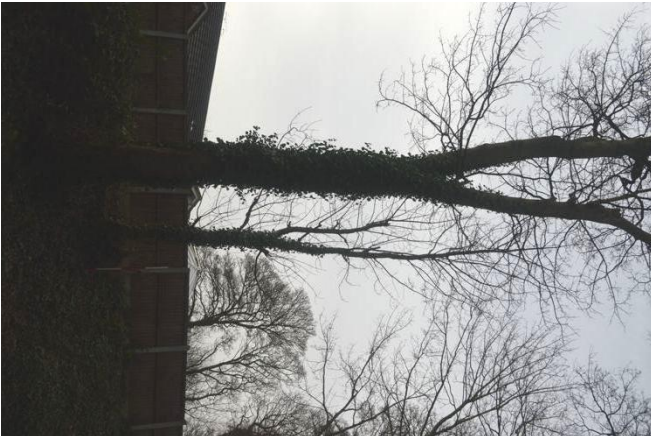
Tree ref. T12 Sycamore (to be removed)

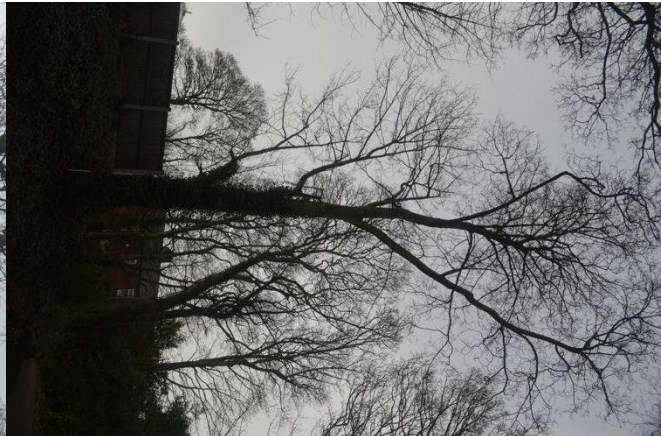
Tree ref. T13 Sycamore (to be removed)

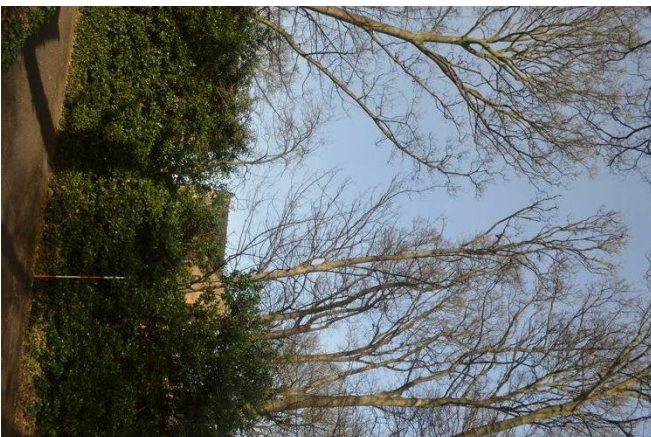
Tree ref. T15 Sycamore (to be removed)

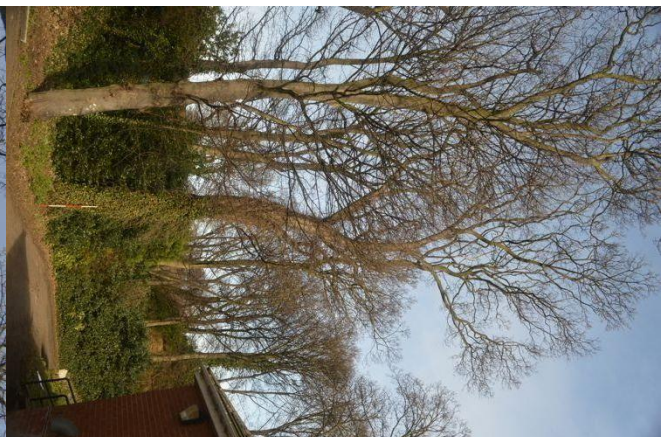
Tree ref. T21 Sycamore (to be retained, remove deadwood, cut Ivy)

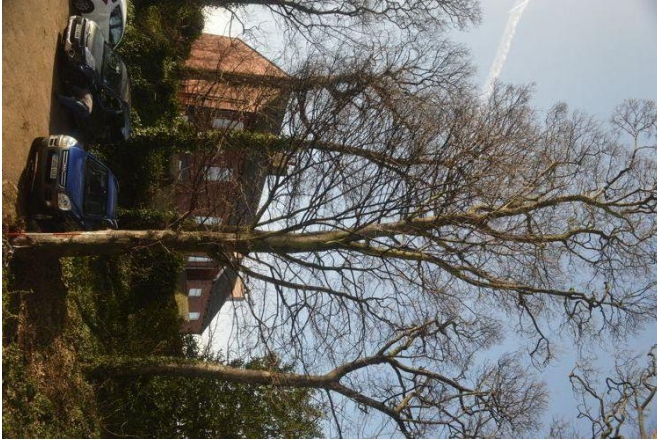
| Ref | Species | Height (m) | Stem Ø (mm) | Branch Spread (m) | Height Crown Clearance (m) | Life Stage | PC | Structural Condition<br>General Observations | Preliminary Management Recommendations | ERC (Yrs) | Grade |
|---|---|---|---|---|---|---|---|---|---|---|---|
| T25 | Sycamore<br>( <i>Acer pseudoplatanus</i> ) | 14-16 | 541 | N 4<br>E 4<br>S 4<br>W 4 | 4m | Mature | Good | Located close to edge of track / parking area. Some lower side branched removed to 3m over track and parking. Generally good, some minor storm damage in crown, not a problem. Vulnerable to car damage. | None. | 40+ | B2 |

Tree ref. T25 Sycamore (to be retained, protect from vehicles)

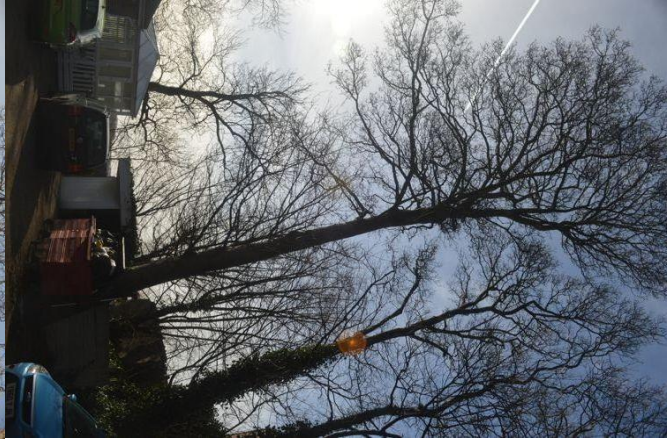
Tree ref. T31 Sycamore (to be retained, protect from vehicles)

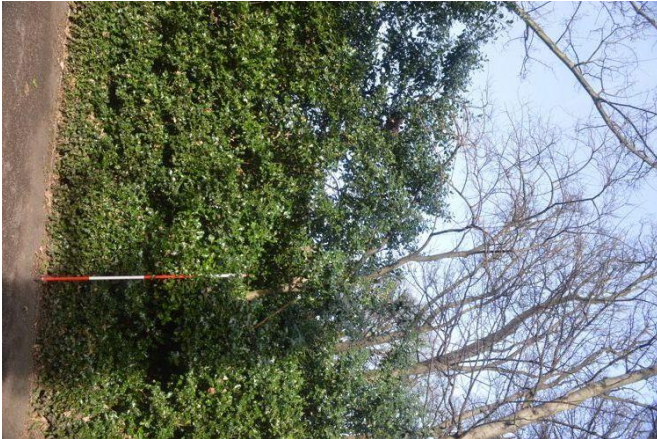
Holly hedgerow to the northern side of the site, access road boundary.
