# ARBORICULTURAL REPORT & Impact Assessment to BS 5837:2012 at:

*Land off Lee Lane,  
Royston,  
Mapplewell,  
Barnsley  
S71 4RT*

Report Date: *January 2026*

Reference: *AWA7126*

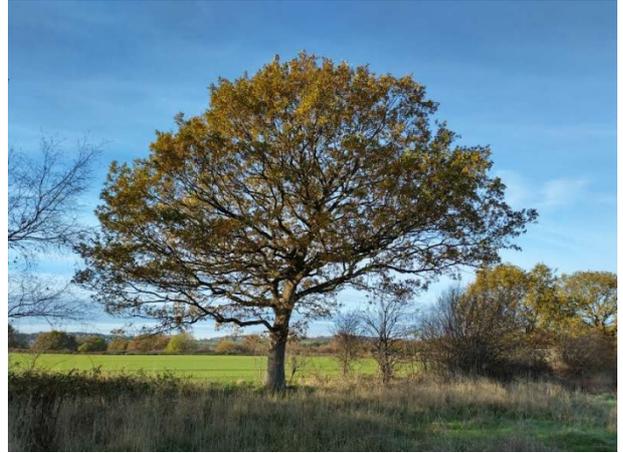
Photo 2: T19 from east

- 3.2.4 The A-category trees comprise T19, T31, T40, T61, T74, T75, T104, T105, T108, T114, T115, T119, T163 and T169, all Oaks. T19 and T31 are early-mature boundary Oaks with basal cavities and minor decay but good vitality; T40 is a large mature boundary Oak; and T61 is an early-mature boundary Oak with large historic pruning wounds but strong reaction growth. Within the main site, T74 and T75 are mature Oaks in the central area of site, these trees have stem cavities and epicormic growth but remain high value trees. Along the western boundaries, T104, T105, T111, T114, T115 and T119 were largely inaccessible but appear in good overall condition. T108 is an early-mature Oak that has had a historically partially collapsed but has adapted to its new form. T163 and T169 are mature boundary Oaks with Ivy, minor structural defects and are prominent along the roadside.

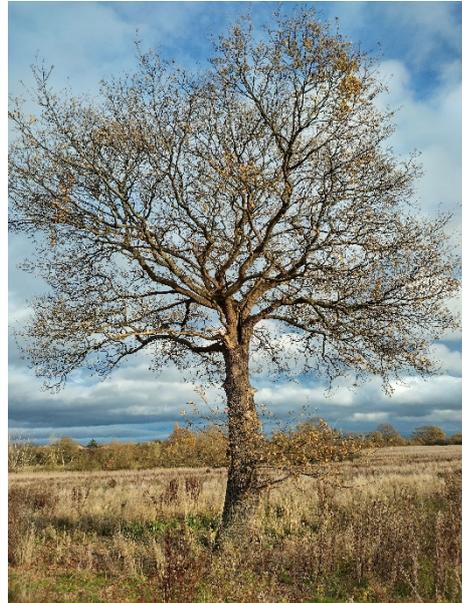
Photo 4: T73 from west

good overall condition. T73 is a B-category Oak within the main site area, with bark damage and minor decay that remains a notable internal constraint. Sessile Oaks T91, T92, T93 and T103, and Field Maples T85 and T98, are semi-mature or early-mature boundary trees.

T73	Oak	<i>Quercus robur</i>	Early-mature	12	1	680	No	4	7	6.5	5	6	Damage to buttress roots	Single stemmed, Vertical, Moderate cavity, Moderate decay, Stubs	Minor deadwood	In field. Bark damage and minor decay to southern buttress exposing heartwood and causing hollowing to southern stem. Bark dysfunction to east at 2m. Hollowing to western stem with moderate decay from 2m to 5m. Dead branches around hollow.	Good	Fair	20 to 40 yrs	Low	B	Removal required to facilitate development

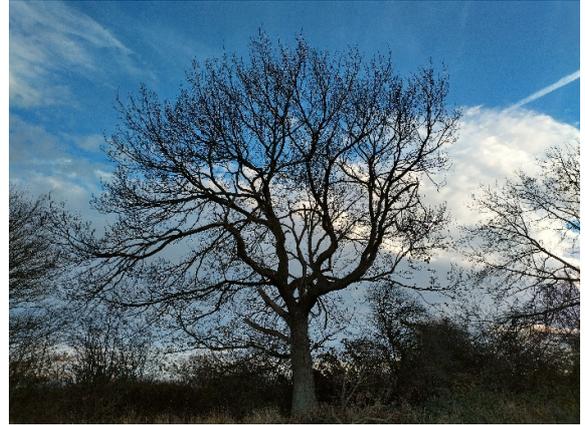
Photo 8: T84 from north

T84	Oak	<i>Quercus robur</i>	Early-mature	15	1	740	No	4	8	8	8.5	7.5	Limited access around base	Single stemmed, Vertical, Stubs, Minor decay	Minor deadwood, Snapped /hanging branches, Moderate deadwood, Major deadwood	On boundary ownership unclear. Several large snapouts for 3m branch junction leaving hung up branches and stubs up to 300mm approx. diameter. Hung-up branches likely to fail into shrubby group to south.	Fair	Fair	20 to 40 yrs	Low	B	Removal required to facilitate development

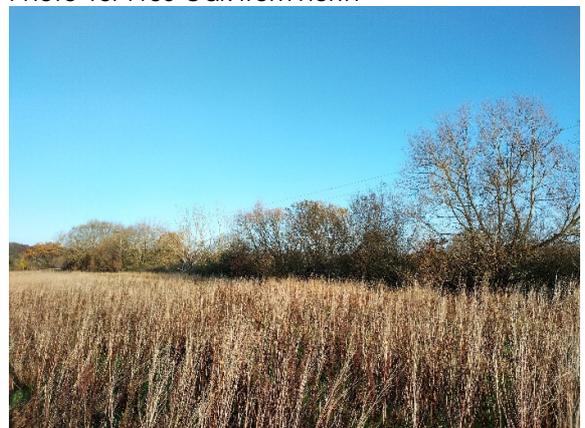
Photo 12: T124- T140 from south

- 3.2.7 In the north-eastern part of the site, Willows T127, T128, T129, T130, T132, T133, T135, T136 and T137 stand in and around a flooded boundary drainage ditch. Several of these Willows have experienced collapses, stem submergence and large snap-outs, but as a species are well suited to adapting to such conditions and they continue to provide enclosure and screening along the ditch line.
