**Arboricultural Survey & Impact Assessment  
269 Sackup Lane Darton**

Report Reference: AIA-1934-1  
27 June 2025  
Amended 12 March 2026

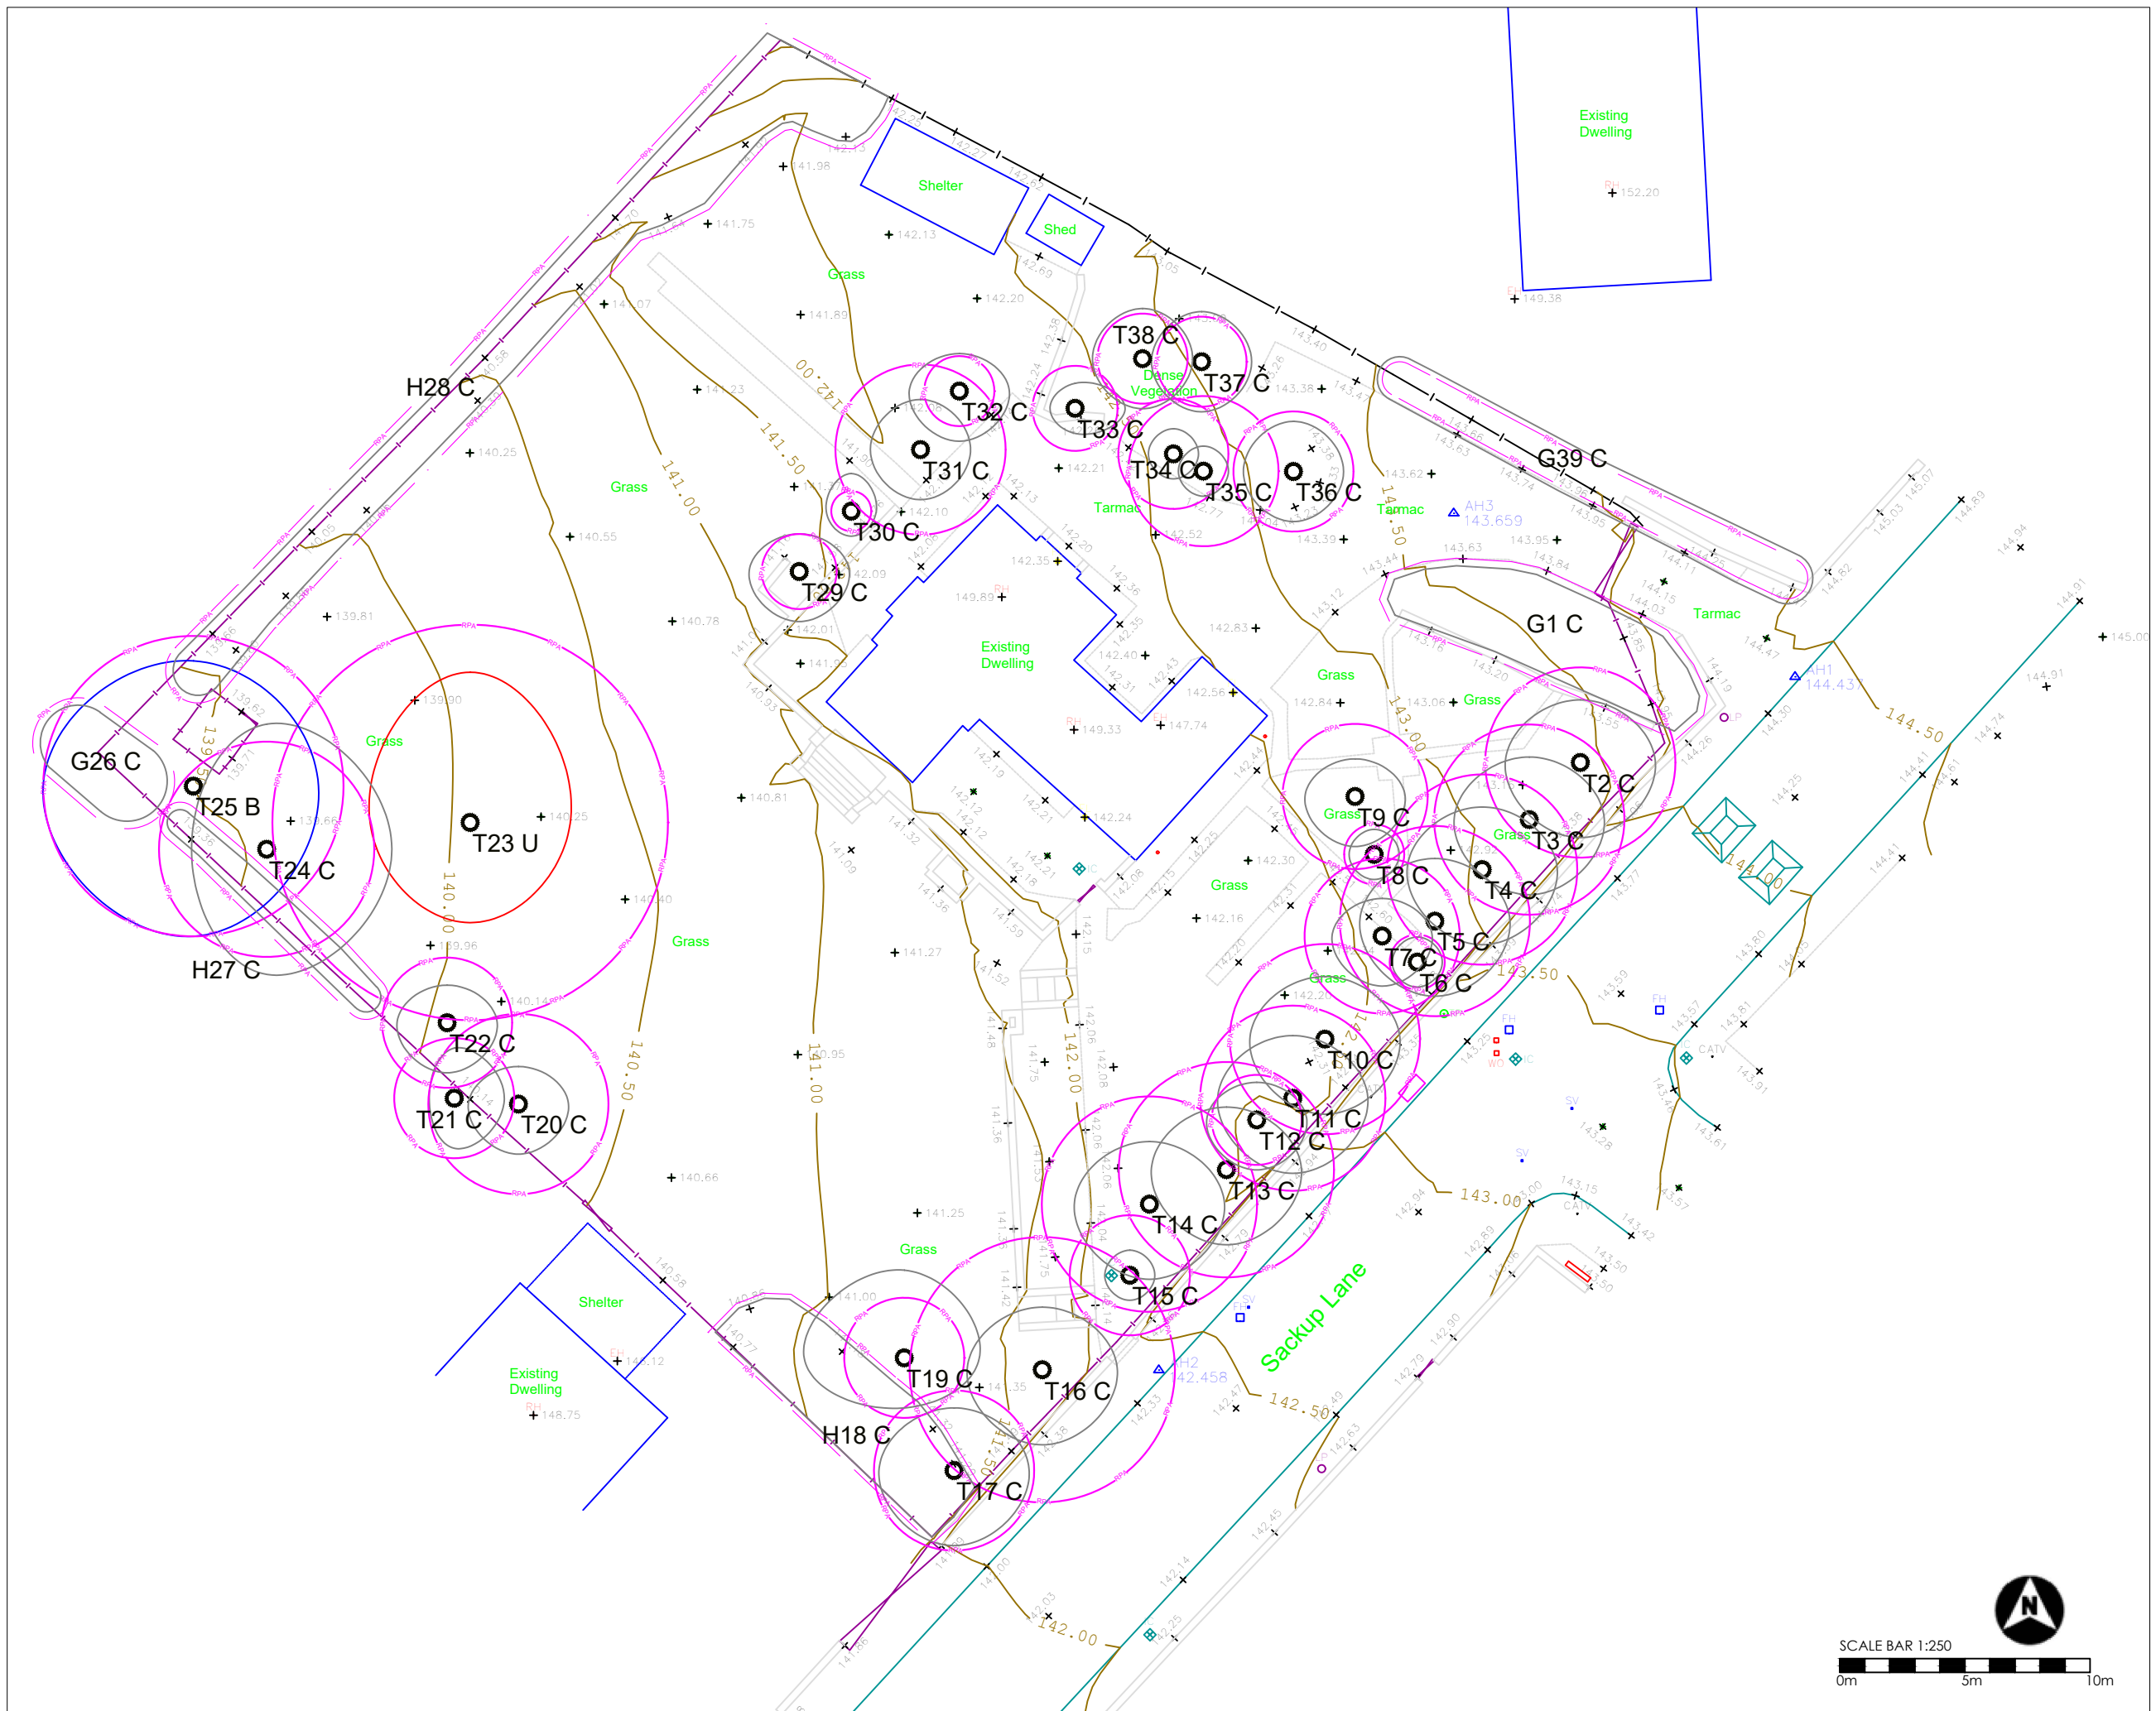
Drawing Title: <b>Tree Constraints Plan</b>	
Site Address: 269 Sackup Lane Darton	
Client: Mr F Collumbine	
Date: 11/02/2026	Job Ref: TCC-1934-1
Scale: 1:250 at A3	Revision: 2

3.1.3 The TIP at appendix 5 identifies a requirement to construct the proposed access over the RPA's of retained trees T2, T4, T5, T7, T10, T11, T14, T15 and T17. This issue is discussed in further detail at Section 3.3 of the report.

- 3.3.2 As recommended in BS5837 we have plotted the RPAs (in magenta) onto the TCP (appendix 4) and TIP (appendix 5). The proposed driveways will to a greater or lesser extent require new surfacing within the RPA's of T2, T4, T5, T7, T10, T11, T14, T15 and T17. Therefore, in order to retain these items whilst limiting potential harmful construction impacts, driveways will need to withstand the weight of construction machinery and vehicles without causing compaction to the underlying soils.

- 3.3.3 Taking account of paragraphs 3.3.2, where drives impact on RPA's these will be constructed utilising a "no dig" cellular confinement system. An example of this type of construction is shown in figures 1 and 2 below. If adopted this approach should not cause any demonstrable harm to tree health and longevity and can be detailed within an Arboricultural Method Statement to ensure retained trees are not compromised by approved development.

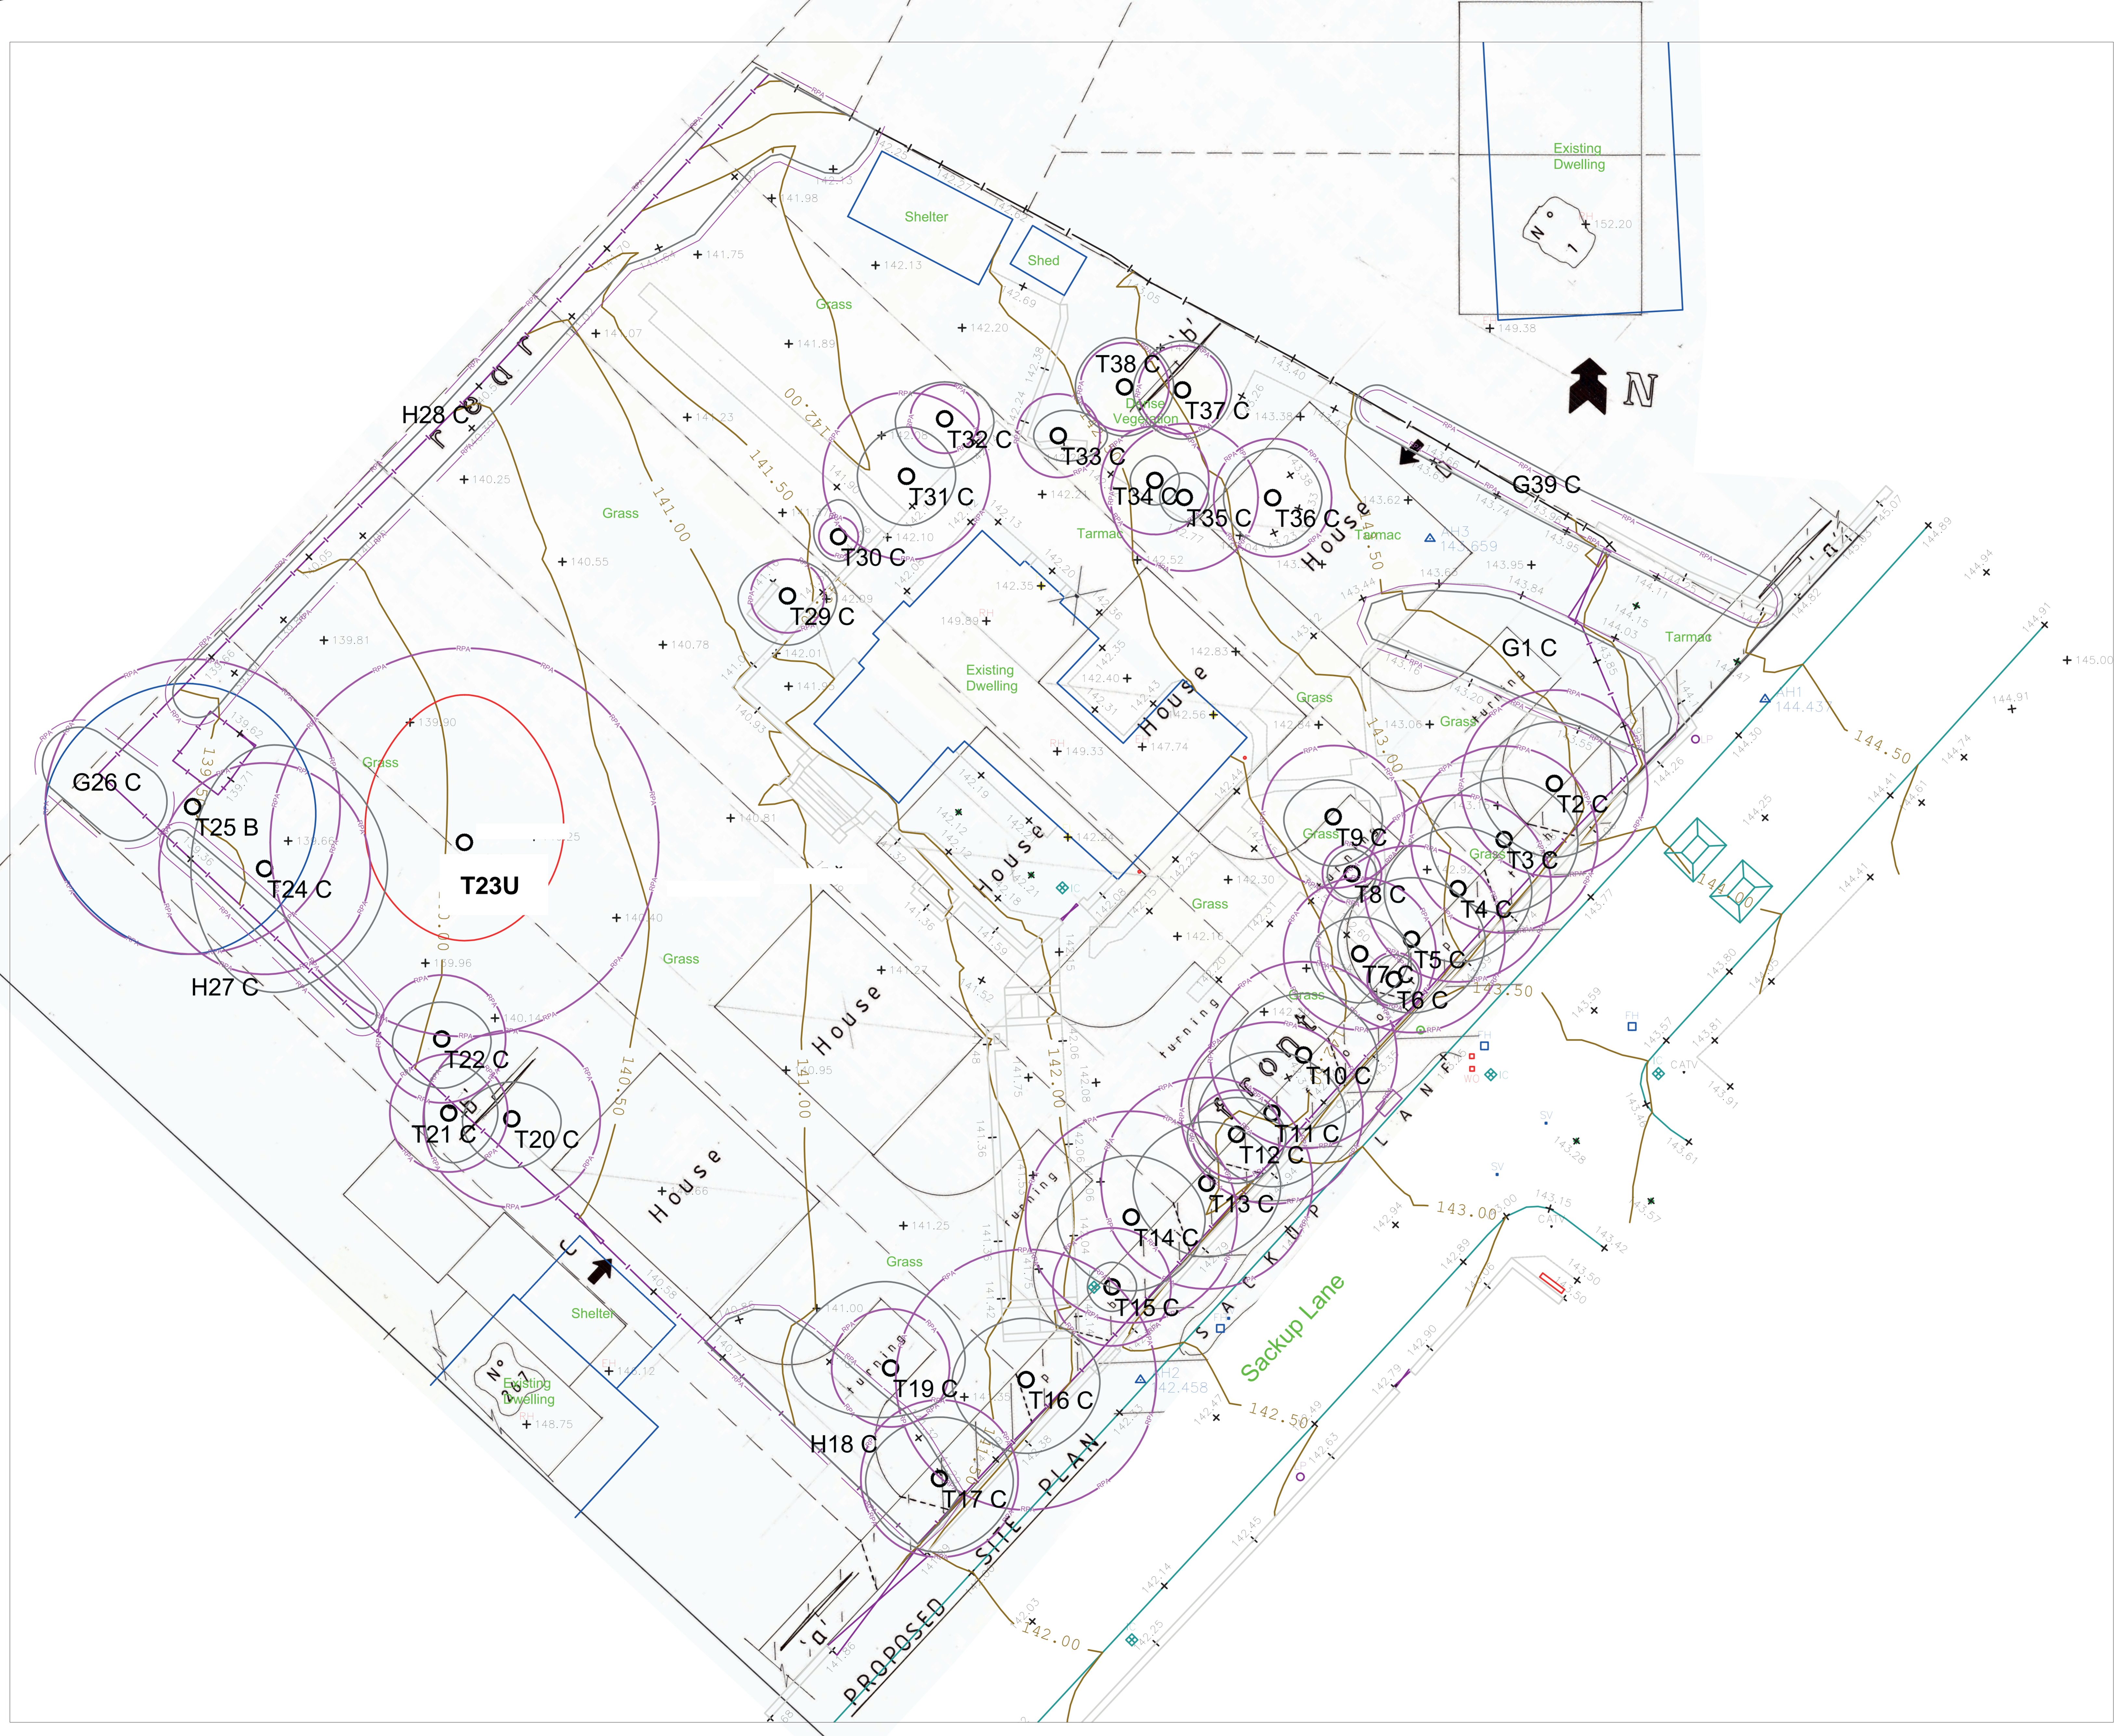
**Appendix 5**  
**Tree Impact Plan**

3.2.1 As highlighted below in Table 2 the footprint of the proposed development will require the removal of several low-quality category "C" trees. Of these theoretically G1 (part), T20, T34, T37 and T38 could be retained, though retention would markedly impact on the use and enjoyment of new properties. Taking account of the low quality of tree involved and opportunities for more favourable planting these items are recommended for removal.

3.2.2 Additionally, 1No. seriously defective category "U" Willow T23 and 1No. Laburnum T6 are recommended for removal on arboricultural management grounds alone, irrespective of proposed development.
