# BS 5837: 2012 Arboricultural Survey & Impact Assessment

Site Address:	103 High Street, Penistone, S36 6BR	Client:	John Mahoney
Report Ref:	HSP01-24	Report Date & Revision:	12th March 2024 1
Author:	Laurence Smith BSc (Hons) Arb, M Arbor A	Signed:	<i>Laurence Smith</i>

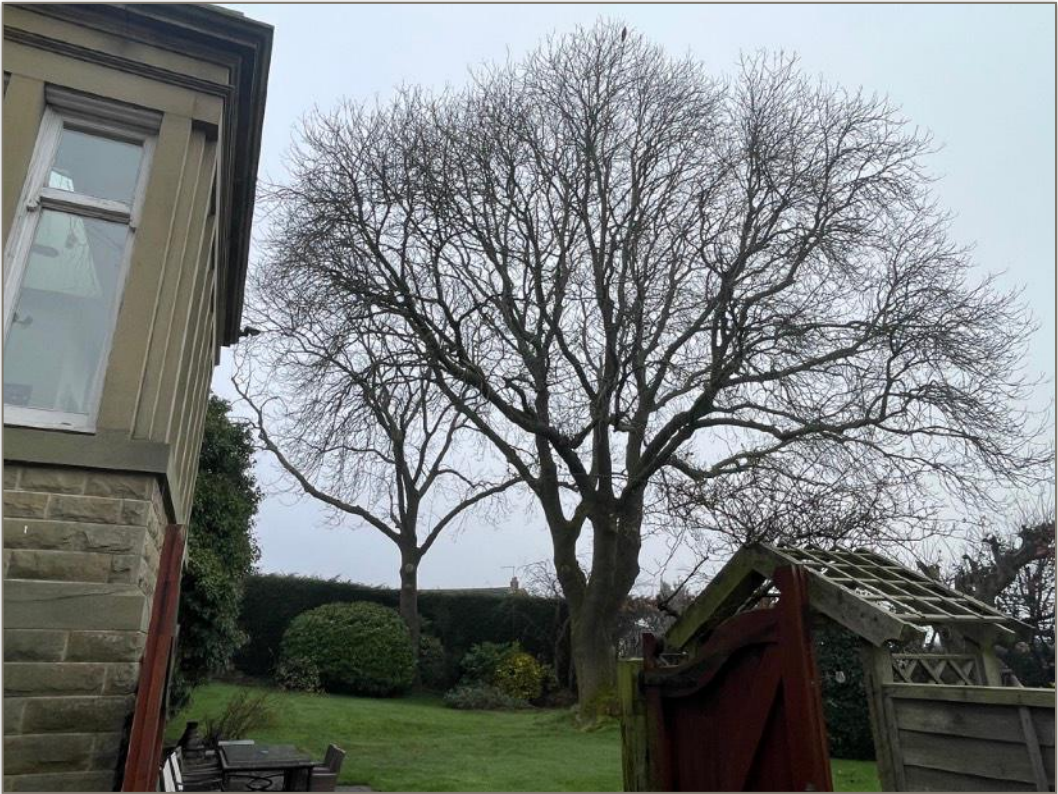
ID	Age Class	Species	Height (m)	Stem Diameter (mm)	Branch Spread (m) N E S W	First Main Branch Height (m) / Direction	Canopy Height (m)	Vitality	General Observations	Preliminary Management Recommendations	Estimated Remaining Contribution	Category Grading	Root Protection Area Radius (m)	Fig ref:
T1	Mature	Ash <i>Fraxinus excelsior</i>	20	720	5, 10, 4.5, 9.5	6 W	5.5	Fair	Occluded pruning wounds to 6m where the canopy develops two long lateral limbs growing east and west. Minor reduction in vigour although not considered significant to health at this point.	None	20>	B2	8.6	Fig 1.
T2	Over Mature	Ash <i>Fraxinus excelsior</i>	22	1210	8.5, 11, 11.5, 13	6.5 S	5	Normal	Large surface roots visible under the grass. Swelling around the base on the southern aspect assumed to be as a result of ongoing epicormic development. Moderate occluded pruning wounds to around 6m before the canopy expands out laterally. Branches have sporadic epicormic along the length of the limbs. Minor deadwood but generally good condition for its age.	None	40>	A2	14.5	Fig 1.

**Figure 1.** T1 (background) and T2 (foreground).

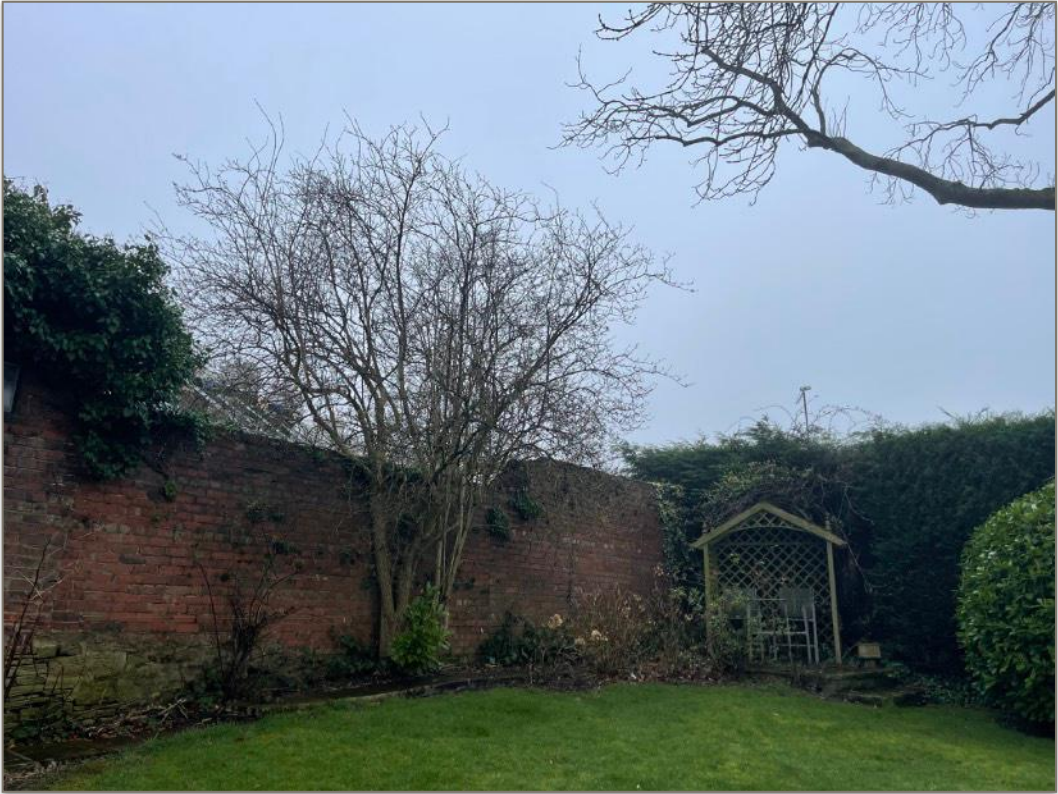
**Figure 2.** T3 located against the boundary wall with H5 to the right of the image.

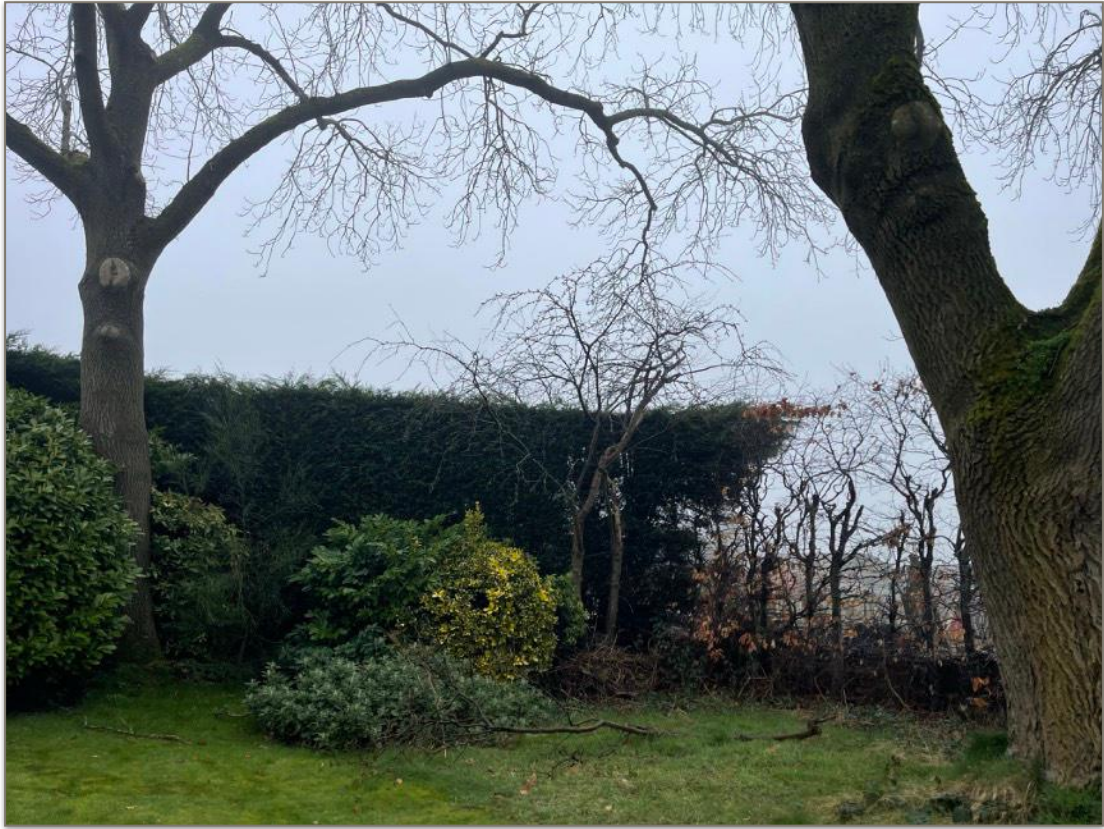
**Figure 3.** T4 located under T1 and T2 with H5 behind.

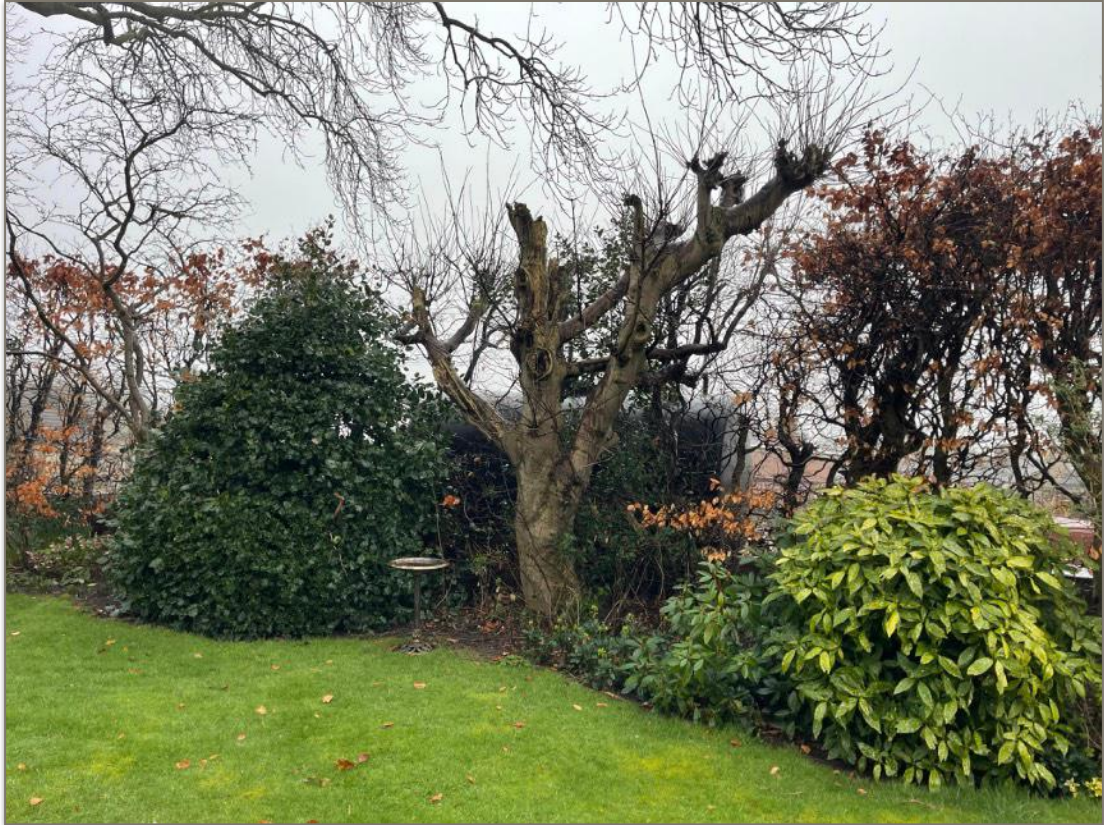
**Figure 4.** T6 located slightly proud of the boundary feature H5.

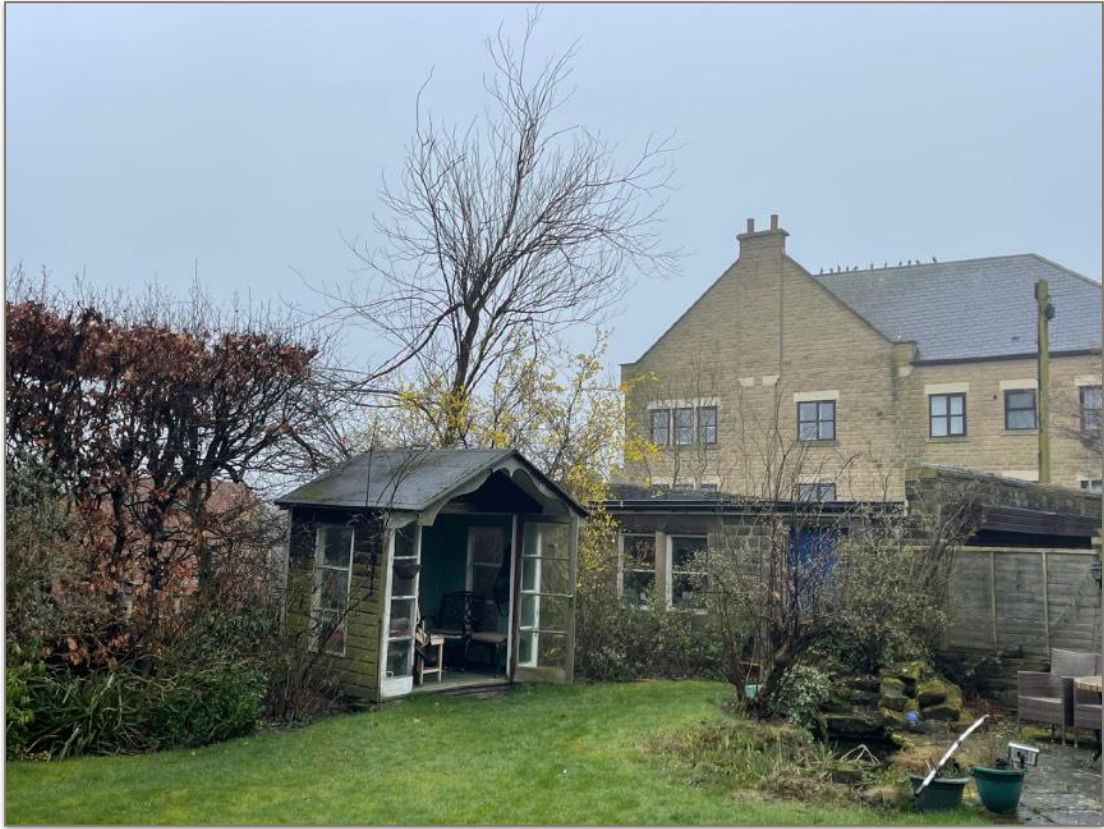
ID	Age Class	Species	Height (m)	Stem Diameter (mm)	Branch Spread (m) N E S W	First Main Branch Height (m) / Direction	Canopy Height (m)	Vitality	General Observations	Preliminary Management Recommendations	Estimated Remaining Contribution	Category Grading	Root Protection Area Radius (m)	Fig ref:
T7	Semi Mature	Willow Sp. <i>Salix</i>	6	200*	2, 2.5, 2, 2	N/A	2	Normal	No access to the base of the tree with vision obscured. The diameter is estimated based on canopy visible. The tree makes up part of the boundary feature although it is not clear if the stem is located within the site boundary.	None	10>	C2	2.4	Fig 5.

**Figure 5.** T7 located behind existing structures and vegetation.
