# ARBORICULTURAL METHOD STATEMENT

***Red House Farm,  
Cross Hill,  
Brierley,  
Barnsley,  
South Yorkshire  
S72 9LE***

Date: *March 2022*

Reference: AWA4243

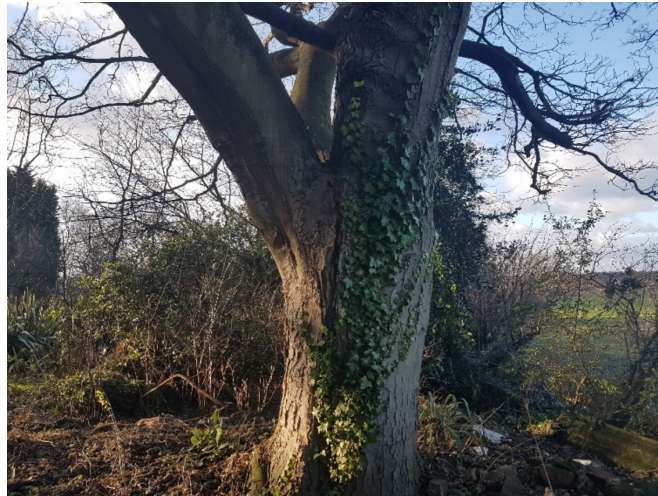
- 3.1.8 A large low southern limb of Sycamore T67 overhangs a proposed new residential property. There is a significant poor included bark union at the base of the overhanging limb and it is foreseeable that the poor union will be a point of failure in future. The overhanging limb therefore requires pruning works to facilitate the proposed development. The most appropriate pruning works to facilitate the proposed development would be to remove the entire limb, with the final pruning cut made to close to the base of the limb, above the poor union. While these pruning works would leave a large final pruning wound, the tree should readily tolerate the works and there are limited suitable points higher up the limb at which to prune to, which would reduce the pressure on the poor union while also providing adequate clearance from the proposed new residential property.

3.1.9 The significant poor included bark union at the base of the low southern limb of Sycamore T67 is detailed in the image below:

3.1.10 The required pruning works to Sycamore T67 are detailed in the image below:
