**ARBORICULTURAL IMPACT ASSESSMENT  
to BS 5837:2012**

**96 Church Hill  
Royston  
Barnsley  
South Yorkshire  
S71 4NG**

22096/ChC

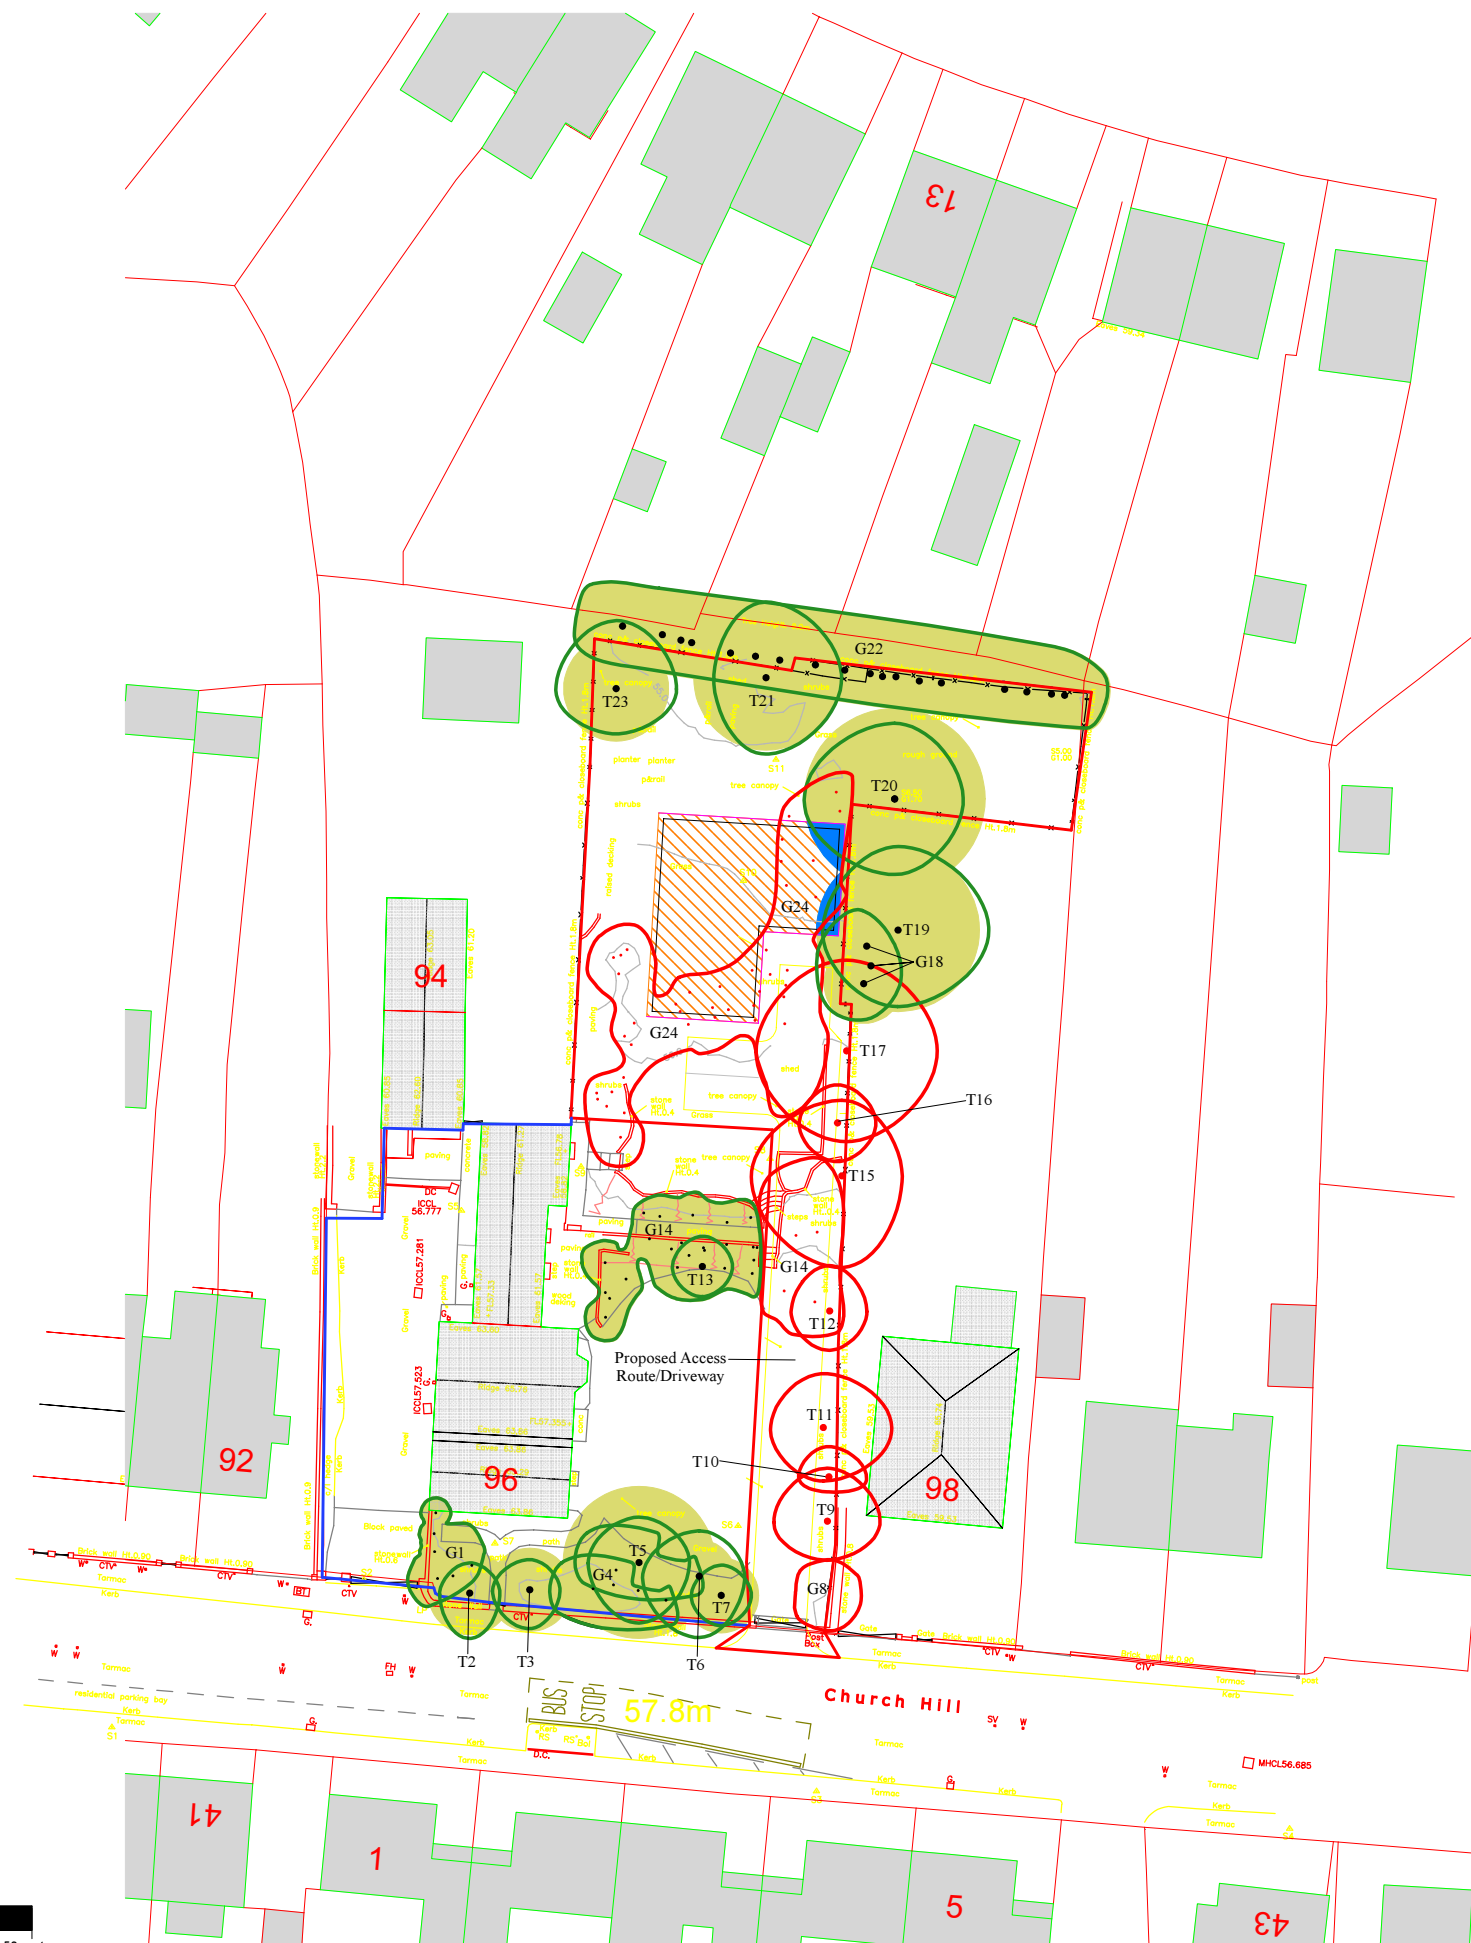
| <b>Appendix 6: Arboricultural Implications Plan .....</b> | <b>17</b> |

- 3.5.4.1 The footprint of proposed dwelling incurs the RPA of **T19** and **T20**. In this case, because of the minimal nature of the incursion, and as these trees are situated on third party owned land, it is considered appropriate to undertake root pruning. This will allow for the construction of the building, without causing ‘ripping’ damage to the roots, a problem commonly associated with mechanical excavation, whilst also preventing the need for specialist foundation designs.
- 3.5.4.2 Advice should always be sought from a suitably qualified Structural Engineer. The water demand of trees can be an important consideration when determining the appropriate foundation design. Due of this, water demands for the trees identified on this site are included in **Appendix 1**, in accordance with current **NHBC Standards**, for use by the appointed structural expert.

| | ROOT PROTECTION AREA<br>ENCROACHED BY THE<br>PROPOSED DWELLING;<br>ROOT PRUNING UNDER<br>ARBORICULTURAL<br>SUPERVISION REQUIRED<br>(T19 & T20) |
