PEAR TREE FARM

BRIERLEY, BARNSELY

Preliminary Bat Roost Assessment

August 2016

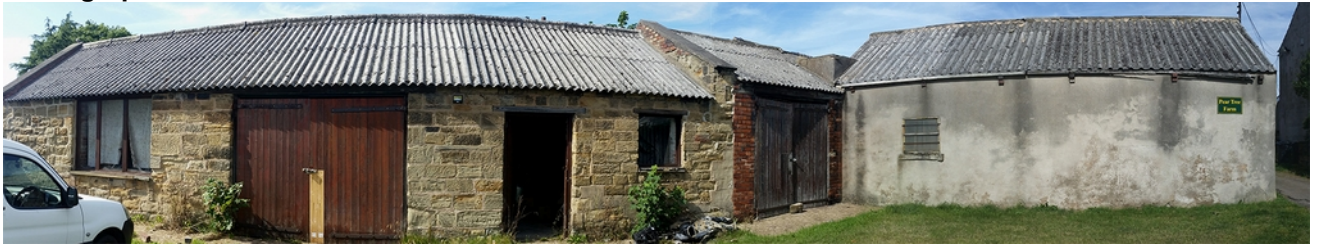
Photograph 1

This is a single storey stone and brick built barn and is split into 3 sections by solid internal walls. The windows and doors are well sealed on A1 and A2. The door to A3 is loosely fitted. The stone, brickwork and pointing are generally in a good condition.

All have a corrugated cement sheet roof featuring a continuous vent along the length of the ridge and potential access points beneath the sheeting. One broken roof sheet was found on the north side of A1 allowing bats to potentially access the interior of the barn.

Due to there being potential access points into the barn and some suitable roosting locations this building is considered to have **low** suitability for roosting bats.

Building A1, A2, A3 and A4, south elevation

Therefore a single survey visit is required during the period May-August. The survey should comprise one dusk emergence or one dawn re-entry survey. (See tables 7.1 and 7.3 within Appendix A for further information.)

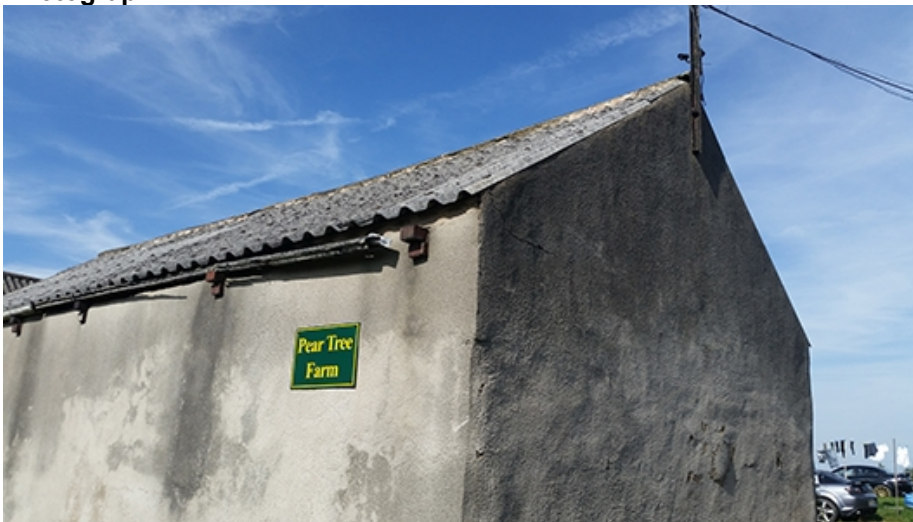
Photograph 2

This is a single storey stone a brick built barn covered in cement render. The doors are window openings are tightly fitted.

The roof is a corrugated cement sheet roof and the ridge is well pointed. There are potential access points beneath the sheeting however no direct evidence of bats was found.

This building is considered to have **low** suitability for roosting bats.

Building A4, south-east gable end

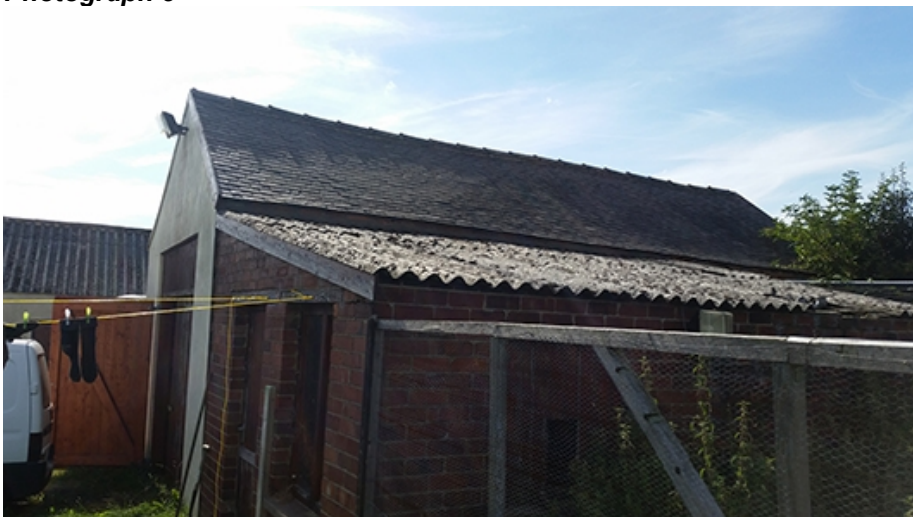
Photograph 3

This is a single storey brick wall and corrugated cement sheet roof canopy currently being used as a chicken coop. There are significant openings and the roof is in a deteriorating state of repair.

The exposed and draughty nature of these canopies does not provide the right micro climate preferred by roosting bats. Therefore the canopy is considered to have **negligible** suitability for roosting bats.

Building A8 – Chicken Coop

Buildings A5 and A8 are considered to be of **negligible** roost suitability for bats and do not require further surveying prior to construction commencing.

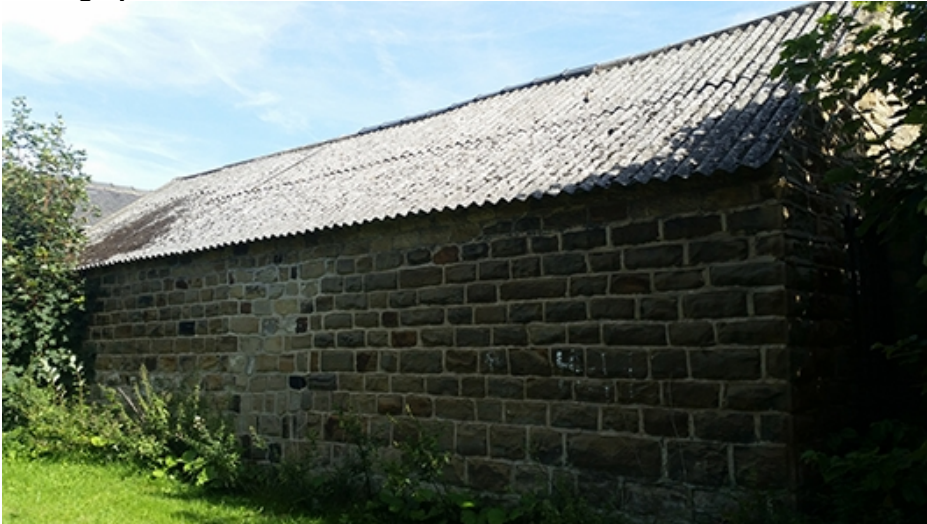
Photograph 4

This building is a single storey stone built barn. The windows and doors are well sealed, except for an open window into what used to building A5. The stone, brickwork and pointing are generally in a good condition.

The roof is a corrugated cement sheet roof and the ridge is well pointed. There are potential access points beneath the sheeting however no direct evidence of bats was found.

Due to there being potential access points into the barn and some suitable roosting locations this building is considered to have **low** suitability for roosting bats.

Building A6, north elevation

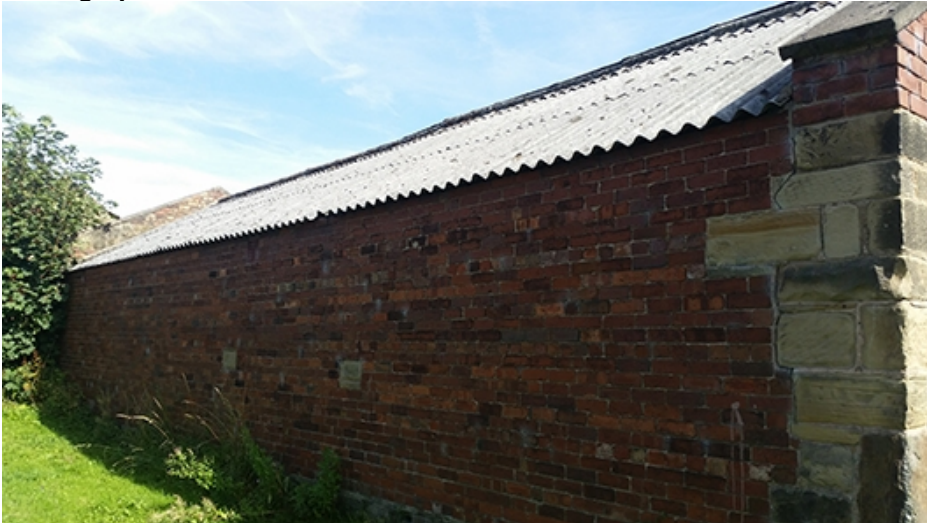
Photograph 5

Building A1 and A2 north elevation

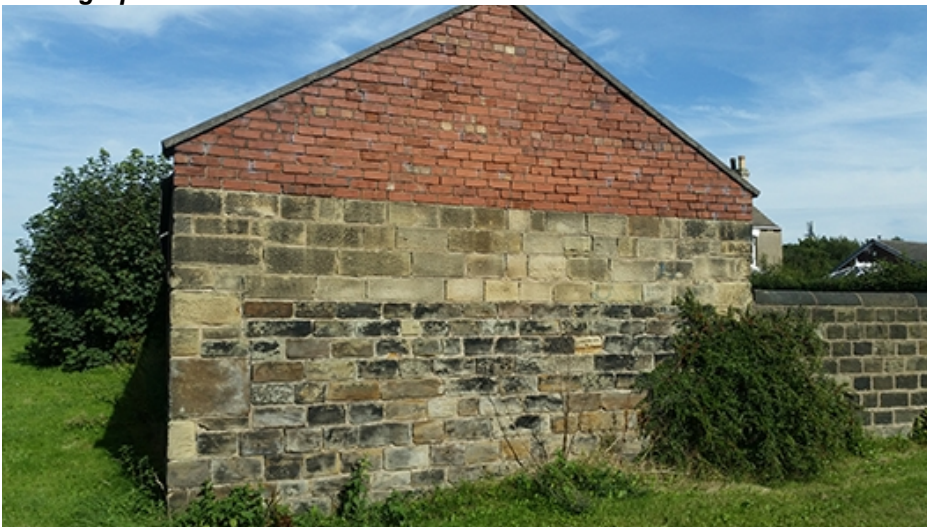
Photograph 6

Both the South-west elevation of A1 and the wall between A2 and A3 rise up above roof level with a gable parapet. Both have significant damp throughout.

Building A1, north-west parapet gable

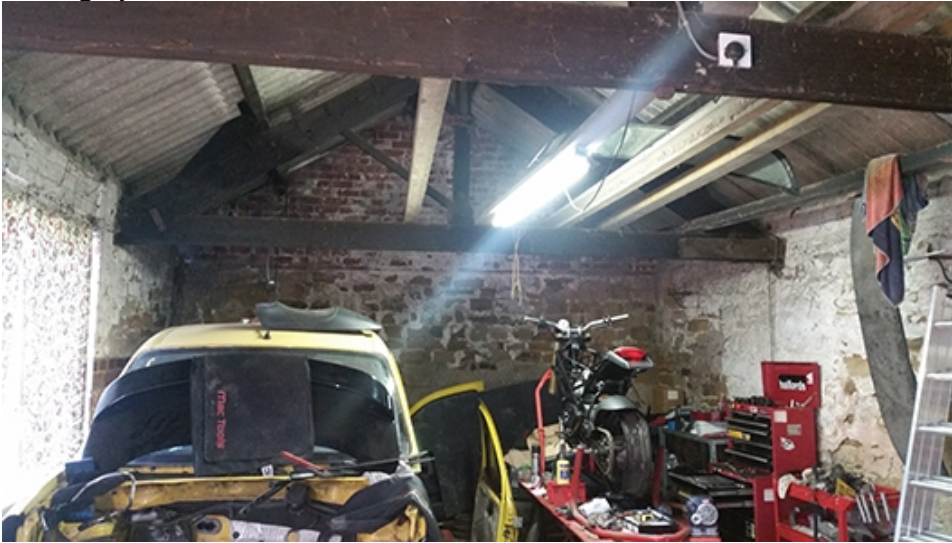
Photograph 7

The internal inspection found there was not a separate roof void, no insulation or lining and a timber roof structure.

On closer inspection very few suitable roosting locations were found and no direct evidence such as droppings, feeding remains, stains or scratching was seen. No squeaking or chattering was recorded.

Building A1, internal

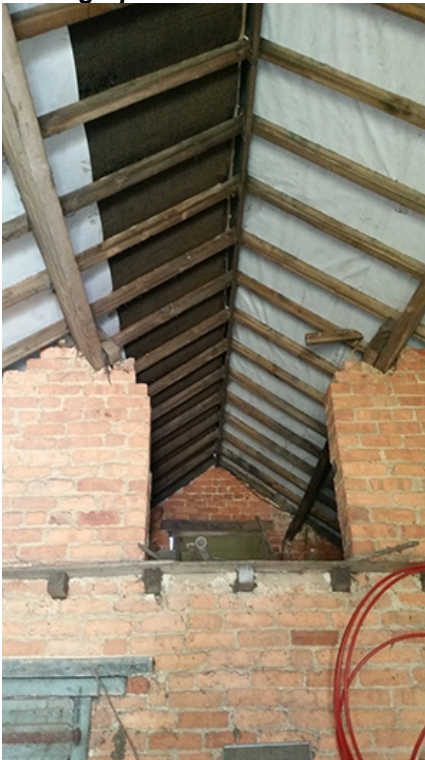
Photograph 7

The internal inspection of this building was slightly hindered by the instability of the first floor however the internal brickwork and woodwork was all inspected with binoculars for direct evidence of bats, however none was found.

Swallow (*Hirundo rustica*) nesting ledge was identified within the building, but was unoccupied at the time of survey.

The internal inspection found there was a felt lining to the roof.

Due to there being potential access points into the barn and some suitable roosting locations including behind fascia board this building is considered to have **low** suitability for roosting bats.

Building A7, internal
