**ARBORICULTURAL IMPACT ASSESSMENT  
to BS 5837:2012  
at  
Land at Green Road  
Dodworth  
Barnsley  
South Yorkshire  
S75 3RR**

**Client:**  
Newett Homes

**JCA Ref:**  
18317-C/AJB

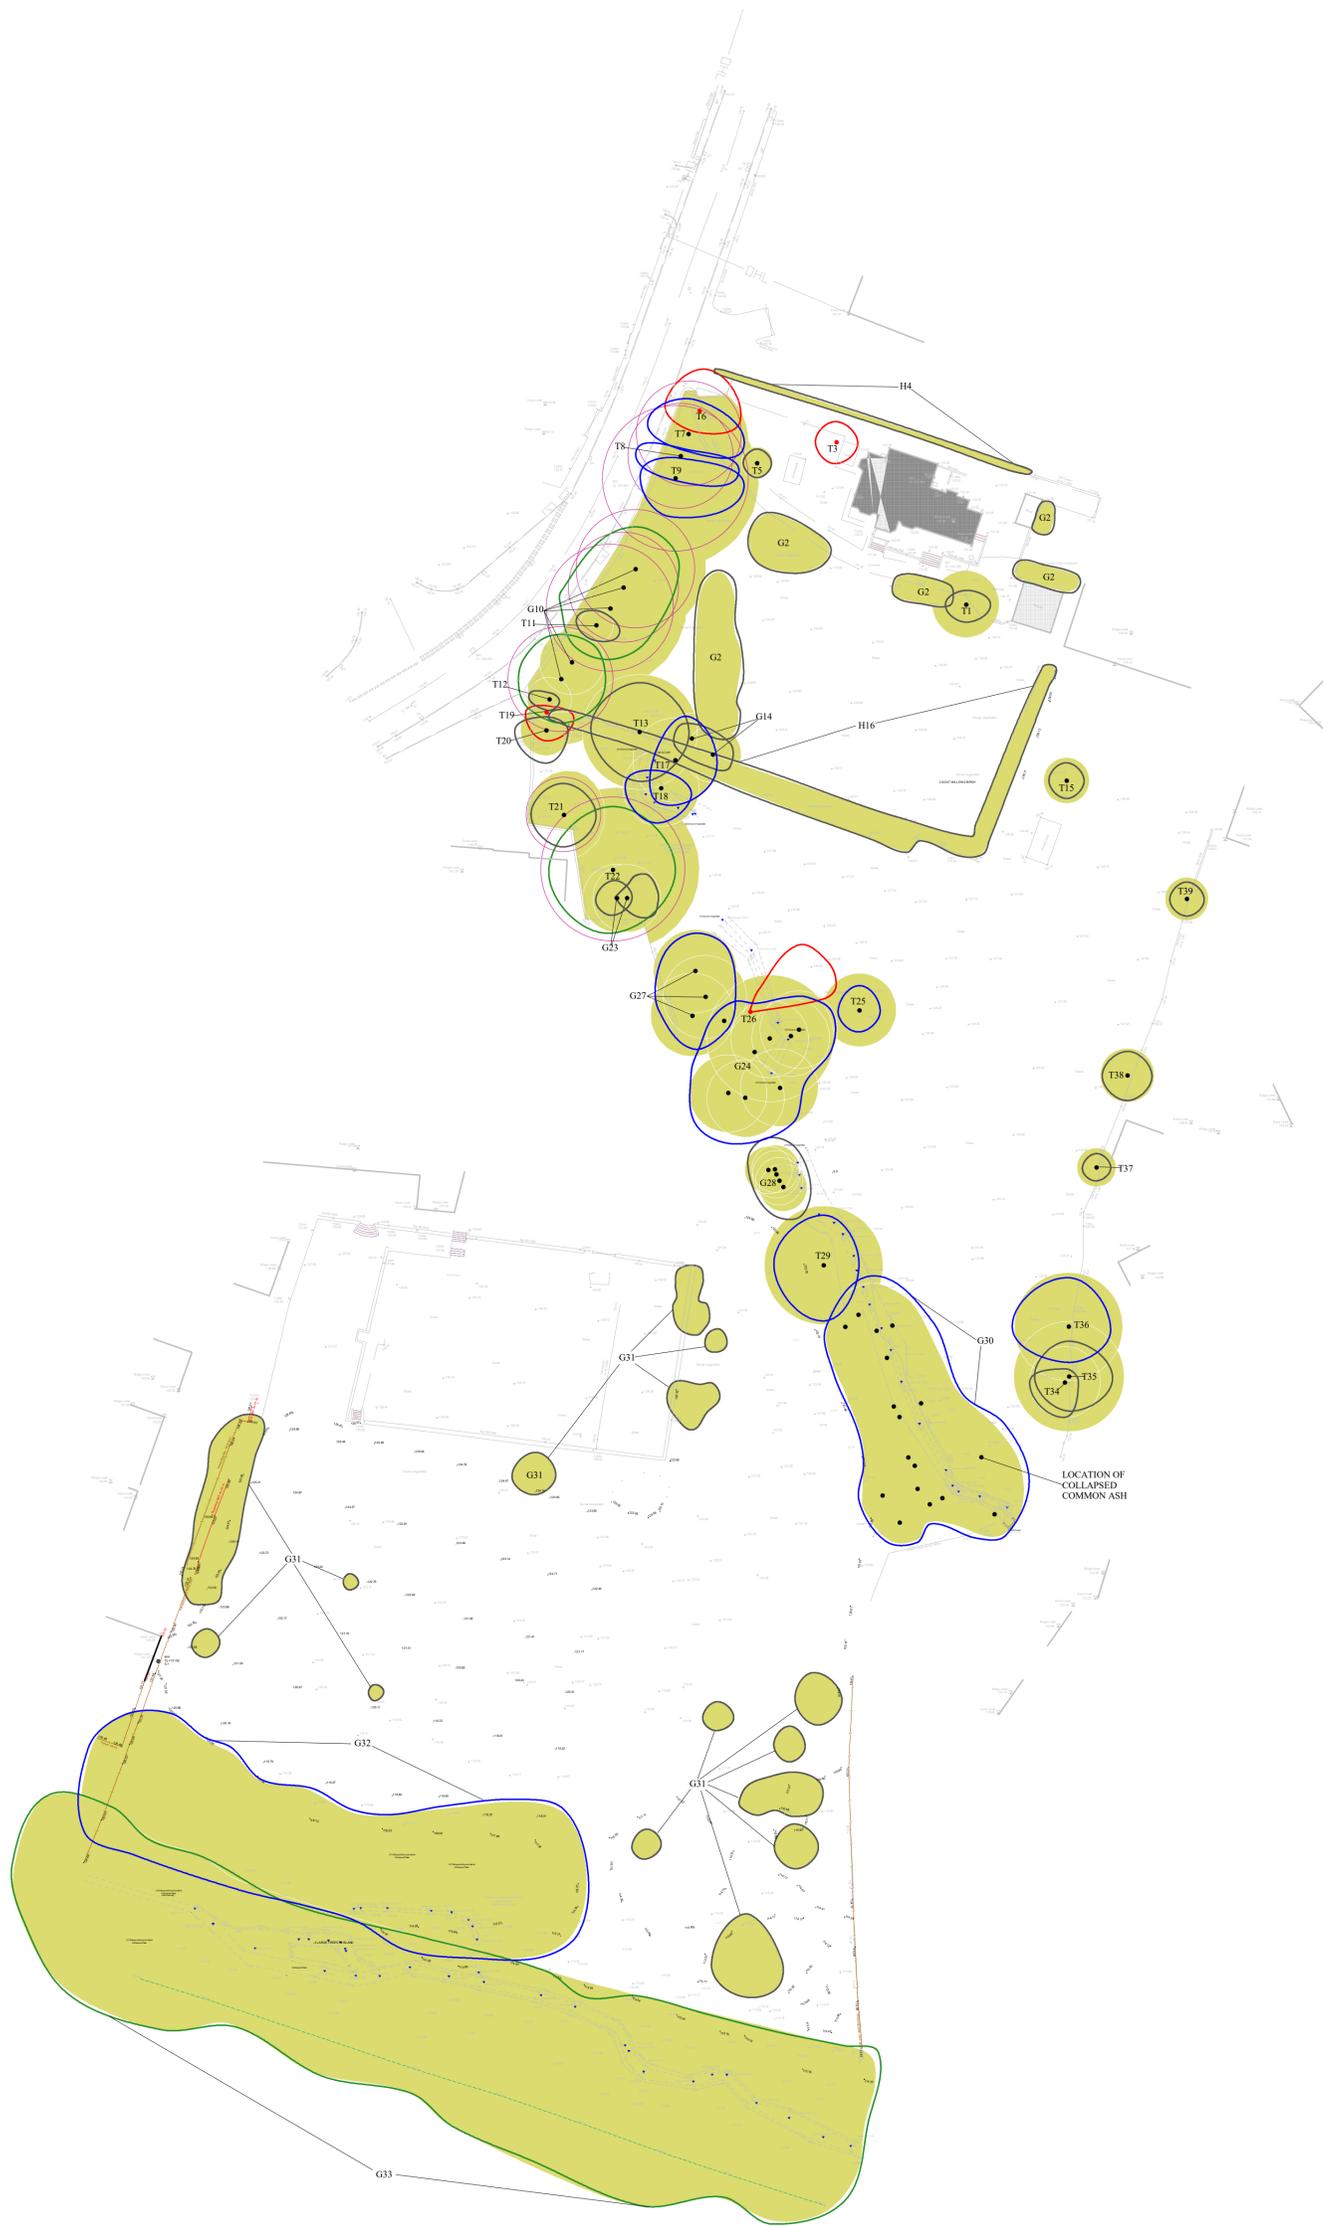
**Appendix 6:  
Tree Constraints Plan**

- 4.7 The protection of retained trees can be achieved by the creation of a Construction Exclusion Zone based on the Root Protection Area of a tree. The Root Protection Area of each tree or group is marked on the Tree Constraints Plan at **Appendix 5**.

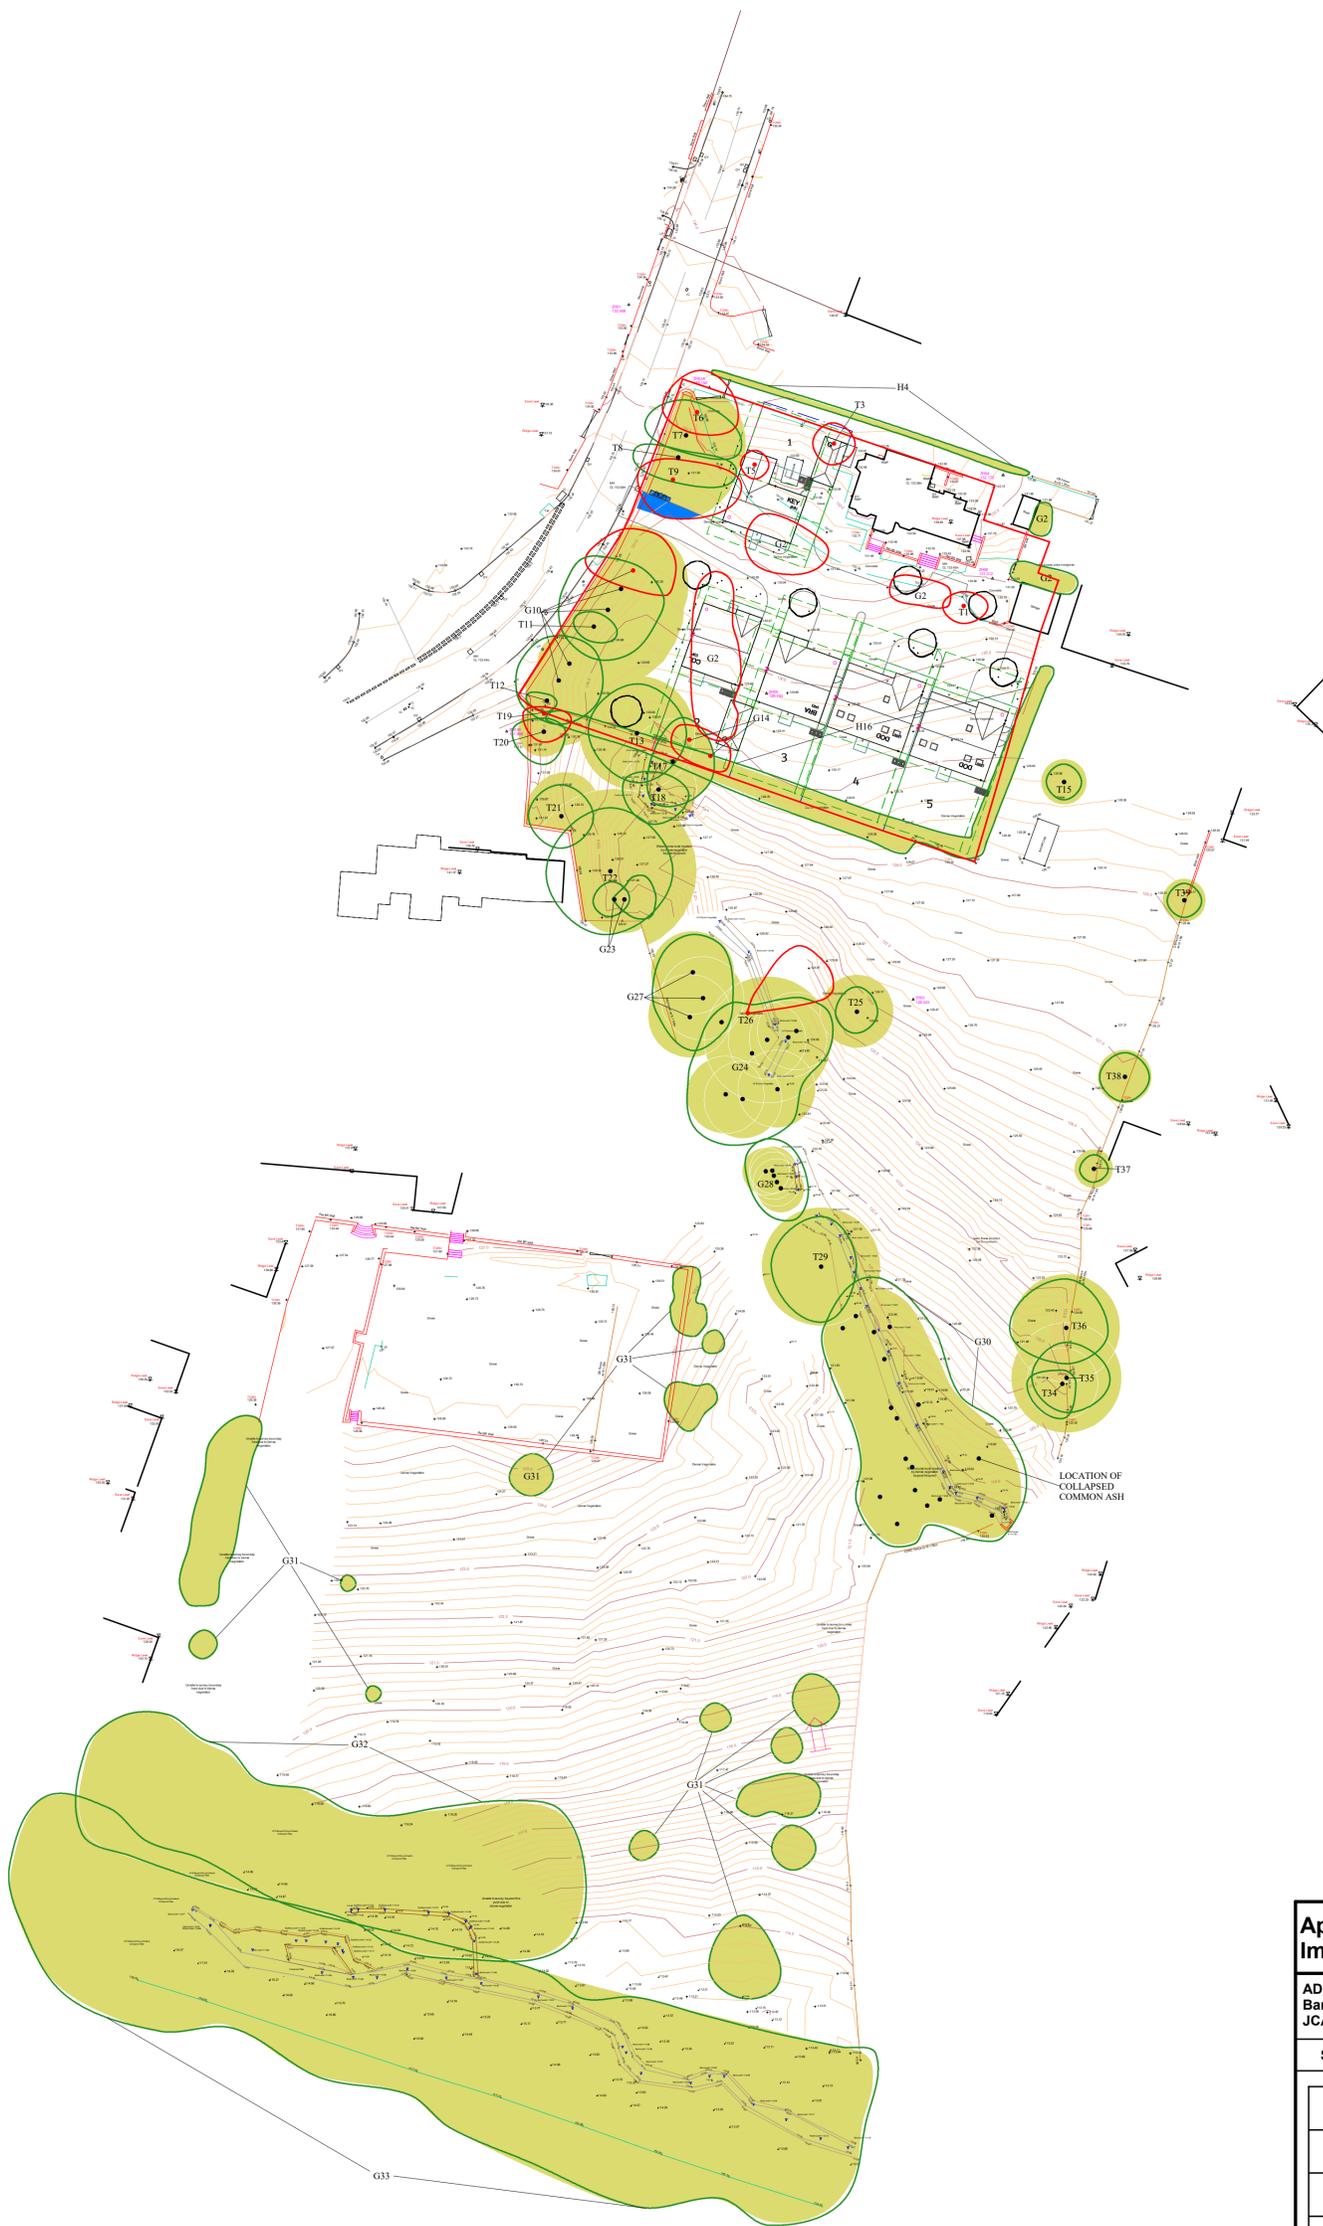
**Appendix 6: Arboricultural Implications Plan**

- 3.2.1 In order to facilitate the proposed development, it will be necessary to remove **T1**, three sections of **G2** (as shown in red on the plan at **Appendix 6**), **T5**, **T9**, one tree within **G10** (as shown in red on the plan at **Appendix 6**) and **G14**. Of these, the tree within **G10** falls into retention category 'A', **T9** falls into retention category 'B' and **T1**, **G2**, **T5** and **T14** fall into retention category 'C'.
- 3.2.2 Whilst the development will require the removal of some trees within the site, it should be noted that a planting scheme is included within the proposals. This will act to part mitigate tree losses, improve the visual benefits of the site and the surrounding area, and will improve the localised tree stock.

- 3.3.1 Where the footprint of the proposed access driveway passes within the RPA of **T8** (as shown in blue shade on the plan at **Appendix 6**), root pruning will be required, under the supervision of an appointed arboriculturist. Root pruning will accommodate the proposed access driveway whilst preventing any 'ripping' damage, a problem commonly associated with mechanical excavations.

3.5.3.1 Proposed hard surfacing is located within the RPA of **T8**, as shown in blue shade on the plan at **Appendix 6**. Due to the nature of the incursion, it is not considered necessary to install specialised surfaces. Instead, root pruning will be undertaken under the supervision of an appointed arboriculturist to prevent ‘ripping’ damage, which is commonly associated with mechanical excavation.

- 3.6.1 Part of the proposed development will encroach into the RPAs of **T8**, resulting in possible root loss. It would therefore be prudent to apply appropriate mycorrhizae fungi to the soils around these trees after the construction phase is complete. Certain mycorrhiza fungi form a symbiotic relationship with tree roots.
- 3.6.2 A tree root associated with such mycorrhiza will take up nutrients more effectively and this will therefore help the tree to produce new roots more effectively, so benefitting their recovery.
