# **29 Hermit Lane, Higham, S75 1PL**

## **Preliminary Roost Appraisal**

Final Report

10 May 2026

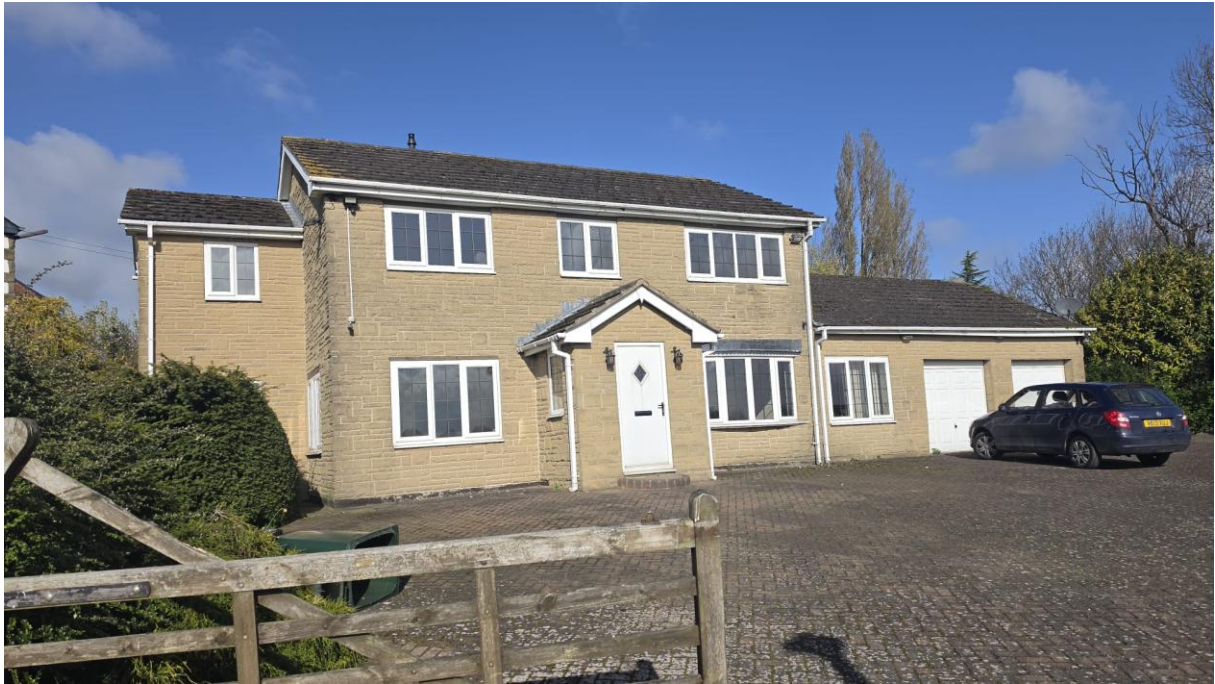
- 3.5 The following was noted:
  - The building is a two storey residential property, constructed from brick.
  - The roof is pitched and constructed from clay roof tiles and clay ridge tiles.
  - The window and door frames are constructed from PVC.
  - The soffits are constructed from PVC and are in good condition, with no visible gaps.

Photograph 1: Front of main building.

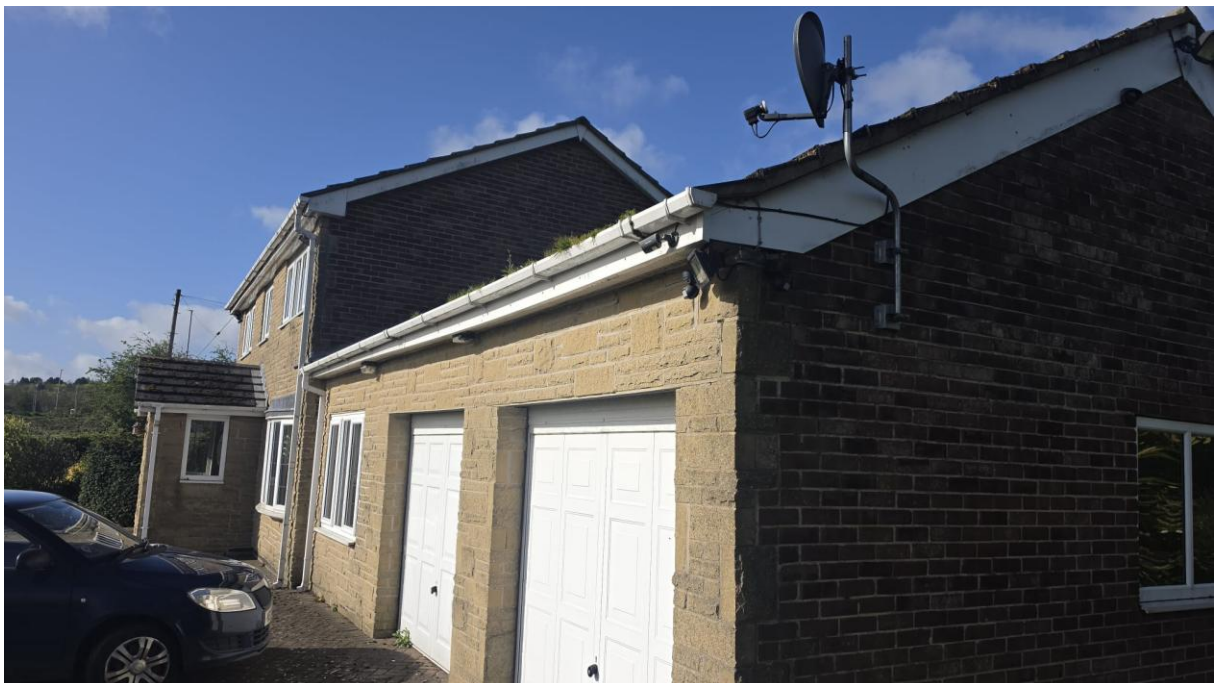
Photograph 2: Main building

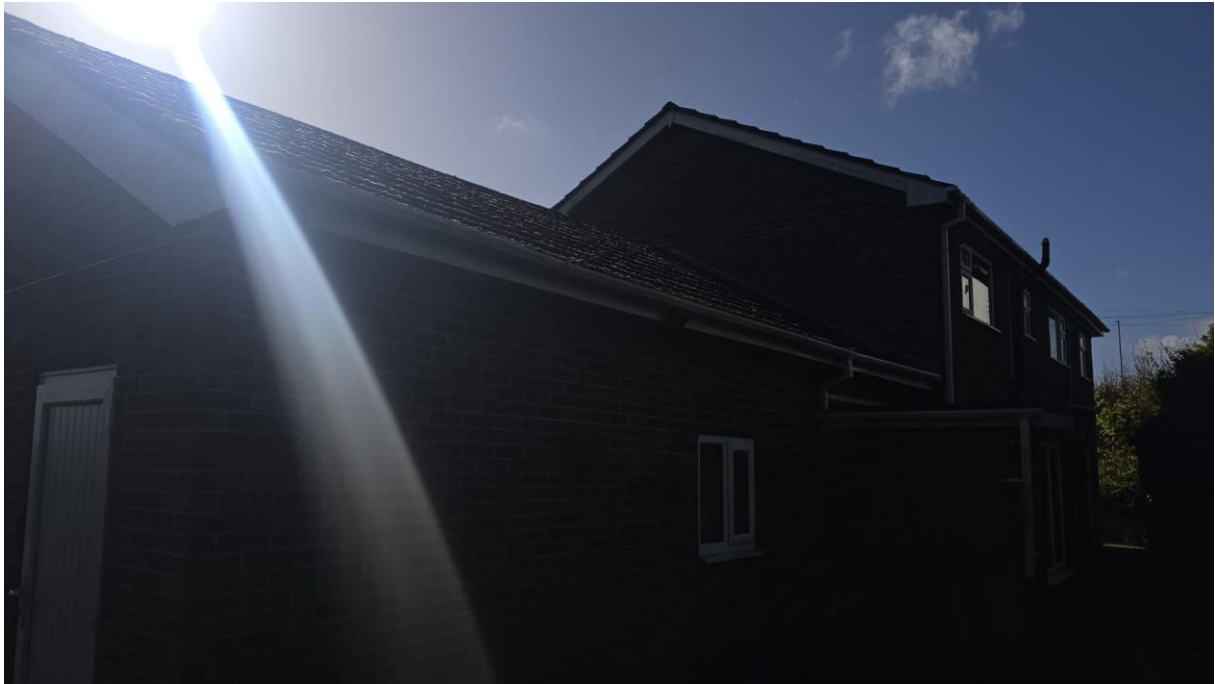
Photograph 3: Rear of building.

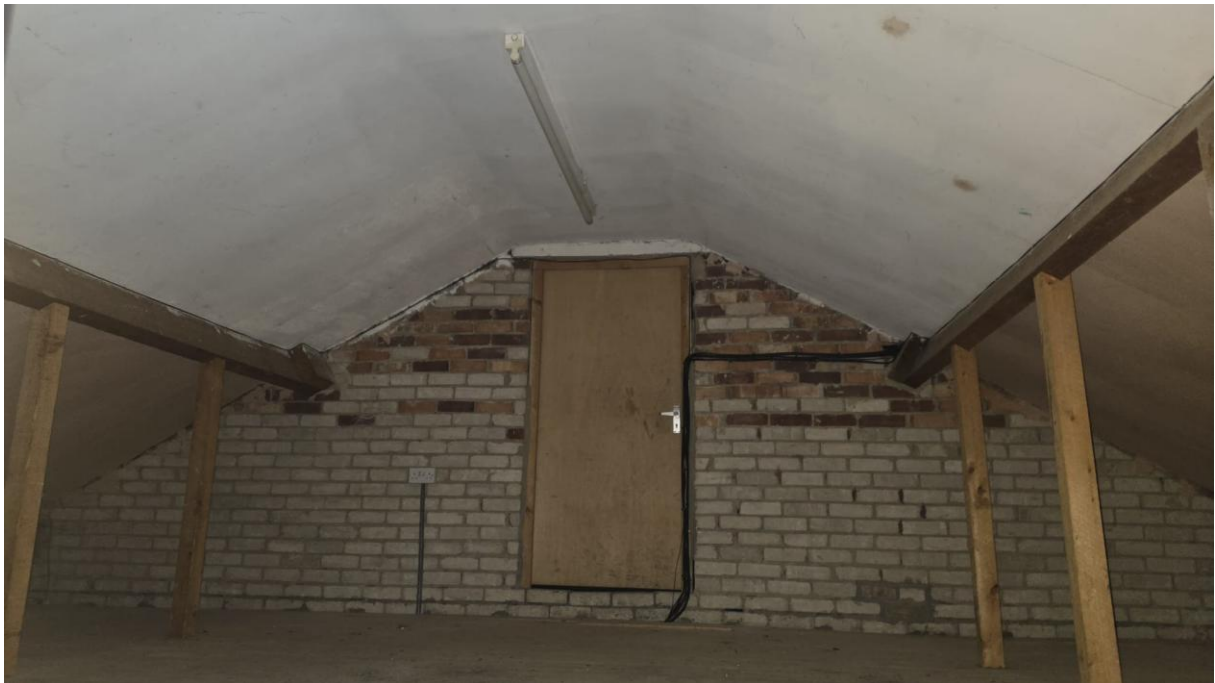
Photograph 4: Inside garage roof void

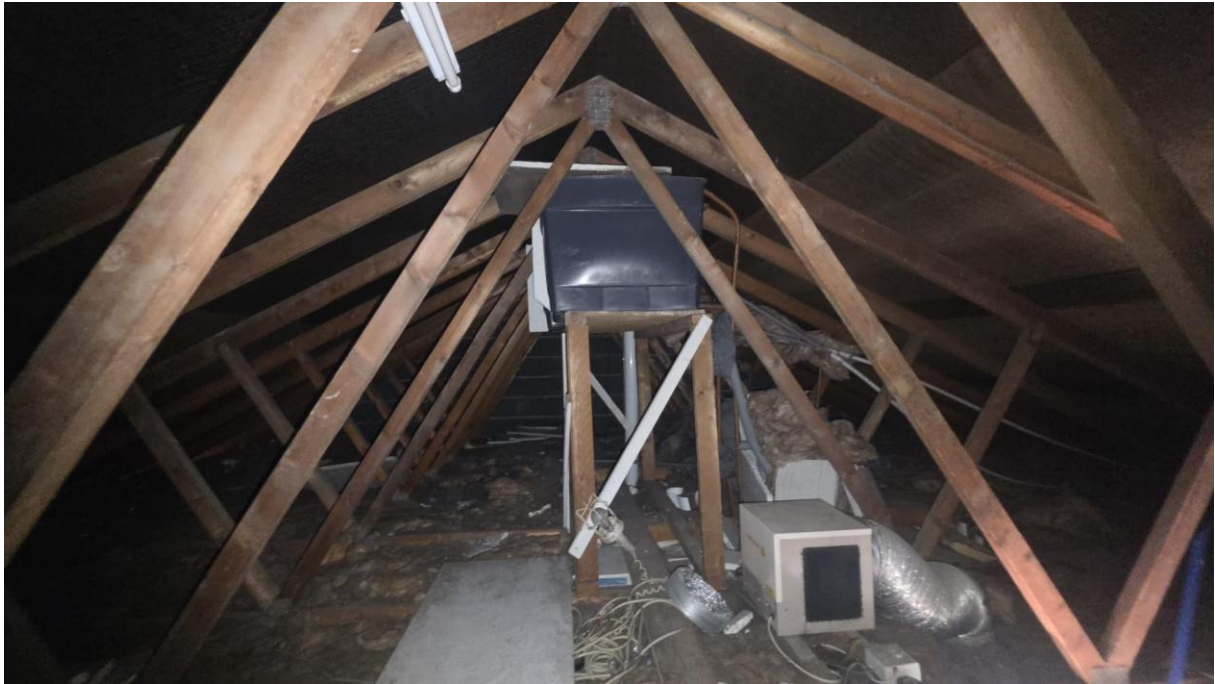
- 3.6 The following was noted:
  - The ridge beam and rafters are constructed from wood.
  - There is a bitumen felt liner present, in reasonable condition.
  - There is fibreglass insulation present, in poor condition. There are some areas of partial boarding.
  - There is a sealed water tank present.
  - No bats or droppings were recorded in the void.
- 3.7 The building is considered to hold negligible potential to support roosting bats due to a lack of suitable access points, or roosting opportunities but is suitable for nesting birds.

Photograph 5: Inside main roof void

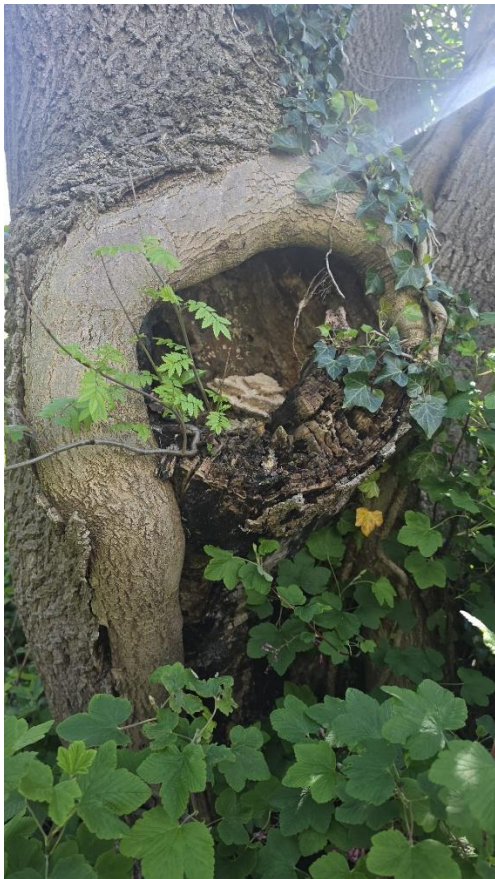
- 3.8 There is a tree within the grounds of the property which has a large tear out which has rotted and provides a feature suitable for roosting bats.

- 3.9 The tree is due to be retained as part of the proposed development therefore lighting mitigation around the tree is required.

Photograph 6: Tree with BRP

- All building contractors are explicitly forbidden from handling bats or interfering with bats in any way.
- 4.3 The tree with roosting potential for bats is due to be retained as part of the proposed development. If this is subject to change then further surveys will be required.

- 4.4 All lighting installed as part of the development will be in line with Guidance Note 08/23 Bats and Artificial Lighting at night. The following will be required:

- LED lighting will be used and light levels will be kept as low as possible. Metal halide, fluorescent sources will not be used.
  - Lighting will be directed to where it is required, and away from any identified roost access points.

- Only luminaires with no light output above 90 degrees and/or an upward light ratio of 0% and with good optical control will be used, luminaires will always be mounted on the horizontal, i.e. no upward tilt.

- Any external security lighting will be set on motion-sensors and short (1 min) timers.
  - Internal lighting within the new rooms will be recessed where installed in proximity to windows to reduce glare and light spill.

- Light sources will emit minimal ultra-violet light, peak higher than 550nm and be of a warm white spectrum (ideally <2700 Kelvin).
  - The use of bollard or low-level downward directional luminaires is strongly discouraged.
