# **ARBORICULTURAL REPORT & Impact Assessment to BS 5837:2012 at:**

***Bank View,  
Green Moor Road,  
Green Moor,  
Wortley,  
South Yorkshire  
S35 7DQ***

Prepared for:  
***Garry Greetham Associates***

Reference: AWA3976

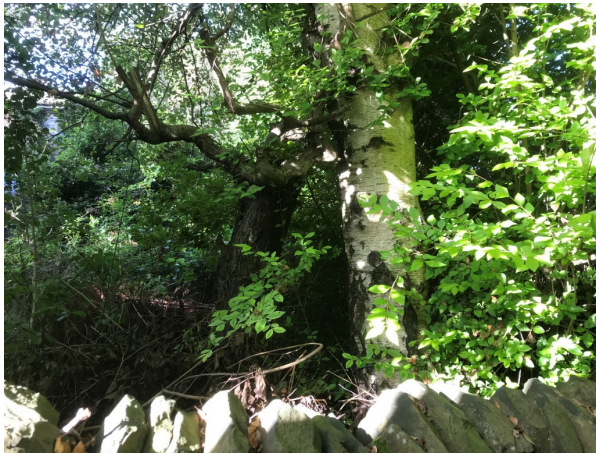
Photo 1: T3 from east

- 3.2.8 T2, T3 and T5 from a row of early mature Birch situated in adjacent land beyond the site's western boundary wall. A public footpath is situated between the trees and the site. The trees were inaccessible and so were only given cursory inspection with measurements estimated and condition values indicative only. T2 and T3 appear in fair condition, but have minor cavities and poor pruning back to the boundary resulting in profuse epicormic growths and wounding on their stems and branches. T5 is in poorer condition, with a moderately sized cavity in the stem at 4 metres. This tree has previously been topped and regrowth from original stem has reduced the tree's crown weight. These trees have limited long term value and prospects, but within the adjacent boundary group, provide useful screening and green infrastructure for the site.

| | Tree Species | | | Measurements | | | | Crown (m) | | | | Tree Condition | | | | | | | | Value | | Management |
|---|---|---|---|---|---|---|---|---|---|---|---|---|---|---|---|---|---|---|---|---|---|---|
| T3 | Birch | <i>Betula pendula</i> | Early-mature | 14 | 1 | 380 | Yes | 5 | 3 | 4.5 | 6 | 4 | Limited access around base | Single stemmed. Slight lean. Epicormic growths. Old pruning wounds. Stubs. Bark damage. Minor cavities | Normal. Minor deadwood. Snapped /hanging branches. Slightly unbalanced | Adjacent Birch. Limited access prevented detailed inspection. Beyond wall boundary. Debris and garden waste stacked around base. | Fair | Fair | 10 to 20 yrs | Moderate | C | No works required |

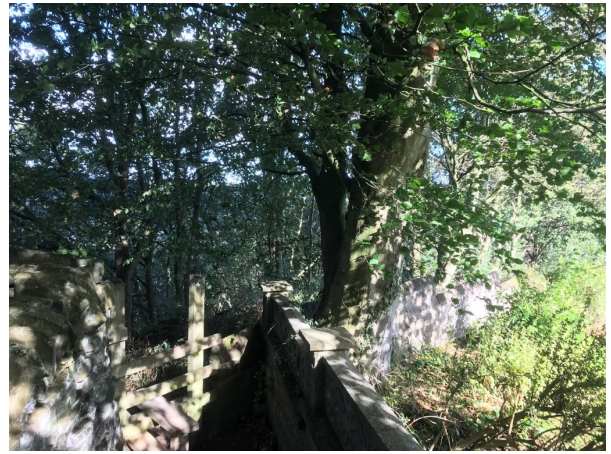
Photo 2: T6 stem from south

- 3.2.4 The site's most significant tree is Beech T6, situated at the corner of boundary walls at the site's western boundary. T6 is a large mature tree in good overall condition. The tree is of multiple stemmed form and is pushing into the retaining wall to the south west.

- 4.2.2 The trees and tree groups that require removal to facilitate the proposed new development are T6, T10, T13, G14, G15 and T16.
- 4.2.3 Beech T6 is of high value retention category 'A'. It may be possible to retain the tree as part of the proposed new development, if the proposed new residential property could be constructed using specialist footings such as mini/micro pile and suspended beam or a cantilevered foundation which will not negatively impact tree roots, and with no significant ground level changes within the tree's RPA.

| Tree ID | Tree Species | | Maturity | Measurements | | | | Crown (m) | | | | | Tree Condition | | | | | | | Value | | Management |
|---|---|---|---|---|---|---|---|---|---|---|---|---|---|---|---|---|---|---|---|---|---|---|
| T6 | Beech | <i>Fagus sylvatica</i> | Mature | 18 | 3 | 580, 590, 310 | No | 5 | 7.5 | 8 | 7 | 7.5 | No visual defects | Twin stemmed at 1m. Vertical. Old pruning wounds. Stubs. Pruning wounds from crown lifting. Bark damage. Tight union. Minor cavities. | Normal. Minor deadwood. Well developed crown | Situated at corner of boundary walls. Pushing into retaining wall to south west. Crown raised towards site. Tight main union but defined reaction wood low on stem. | Good | Fair | >40 yrs | Moderate | A | Removal required to facilitate proposed new development |

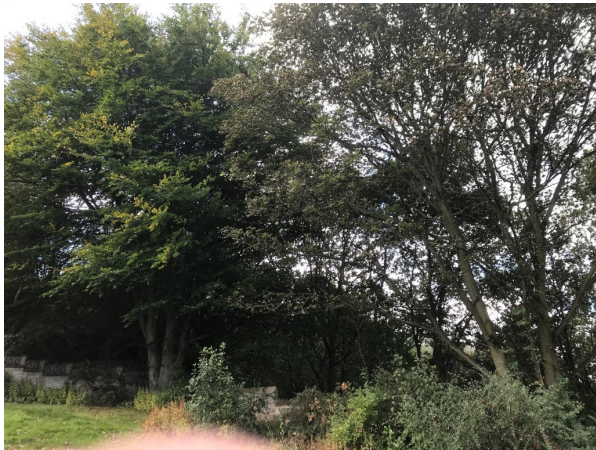
Photo 3: T6 and G18

- 3.2.5 G18 forms an adjacent high value mature woodland group situated in adjacent land beyond the site's north western boundary. The group is

predominantly comprised of Oak with several Sycamore and occasional Birch and Rowan.

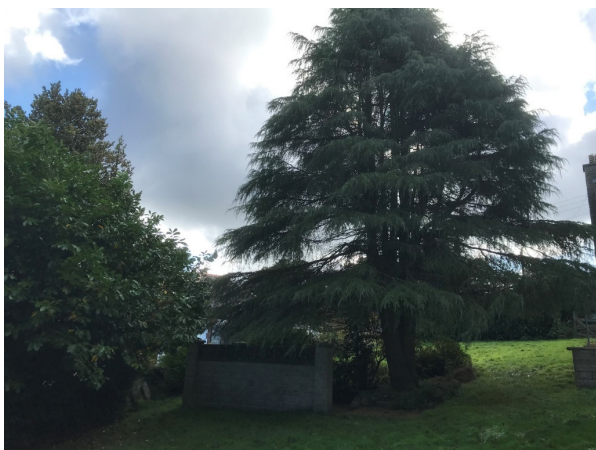
Photo 5: T13 from north west

- 3.2.6 Cedar T13 is a moderate value tree situated to the site's eastern boundary which is in good overall condition with no significant visible defects. While prominent from within the site, the tree is not visible from any easily accessible public vantage points and provides little amenity value outside of site boundaries.

- 4.2.4 Cedar T13 is of moderate value retention category 'B' and while its removal will have some negative impact from within the site, the tree is not prominently visible from any easily accessible public vantage points and provides little amenity value outside of the site boundaries.

| Tree ID | Tree Species | | Maturity | Measurements | | | | Crown (m) | | | | | Tree Condition | | | | | | | Value | | Management |
|---|---|---|---|---|---|---|---|---|---|---|---|---|---|---|---|---|---|---|---|---|---|---|
| T13 | Cedar | <i>Cedrus deodara</i> | Early-mature | 15 | 2 | 450, 450 | No | 4 | 5 | 5 | 5 | 5 | No visual defects | Twin stemmed at 1m. Vertical. Stubs | Normal. Minor deadwood | Main union with good reaction wood. Some bare patches, possibly due to branch loss. Exposed site. Good prospects. | Good | Good | 20 to 40 yrs | Low | B | Removal required to facilitate proposed new development |

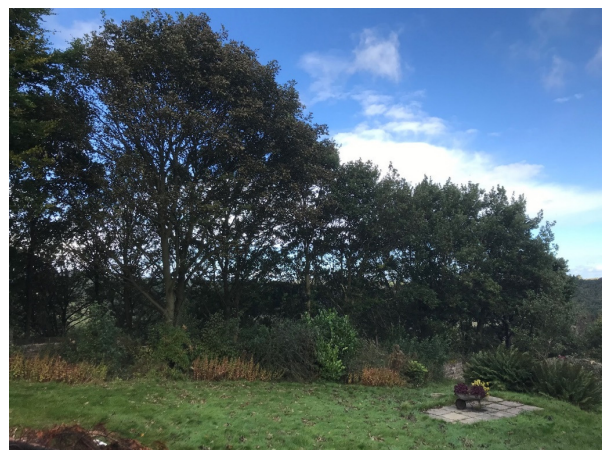
Photo 6: G18 from south

| | Tree Species | | | Measurements | | | | Crown (m) | | | | | Tree Condition | | | | | | | Value | | Management |
|---|---|---|---|---|---|---|---|---|---|---|---|---|---|---|---|---|---|---|---|---|---|---|
| G18 | Oak. Sycamore. Birch. Rowan. | <i>Quercus sp.</i><br><i>Acer sp.</i> <i>Betula sp.</i> <i>Sorbus sp.</i> | Early-mature | 18 | 10 | 300 | Yes | 4 | See plan | | | | Adjacent woodland group of predominantly Oak with occasional larger Sycamore. Some Birch and Rowan. Public access by footpath through wood. | | | | Good | Good | >40 yrs | Moderate | A | No works required |
