Existing Detached Garage

**91 Pye Avenue, Mapplewell,
S75 6AG**

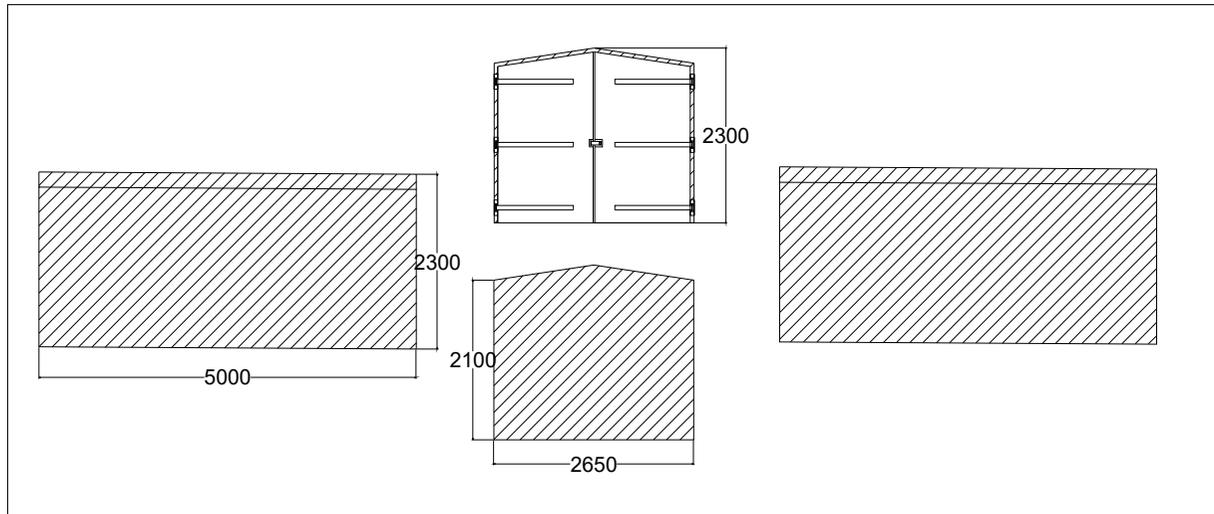
Existing garage utilises a steel frame, steel corrugated panels and timber barn doors.

The Garage is in a state of disrepair with the steel frame twisted, roofing panels broken/missing and timber doors unable to be opened.
