ARBORICULTURAL REPORT

& Impact Assessment
to BS 5837:2012 at:

Hudroyd Farm, Genn Lane, Barnsley S70 6NW

Reference: AWA6073

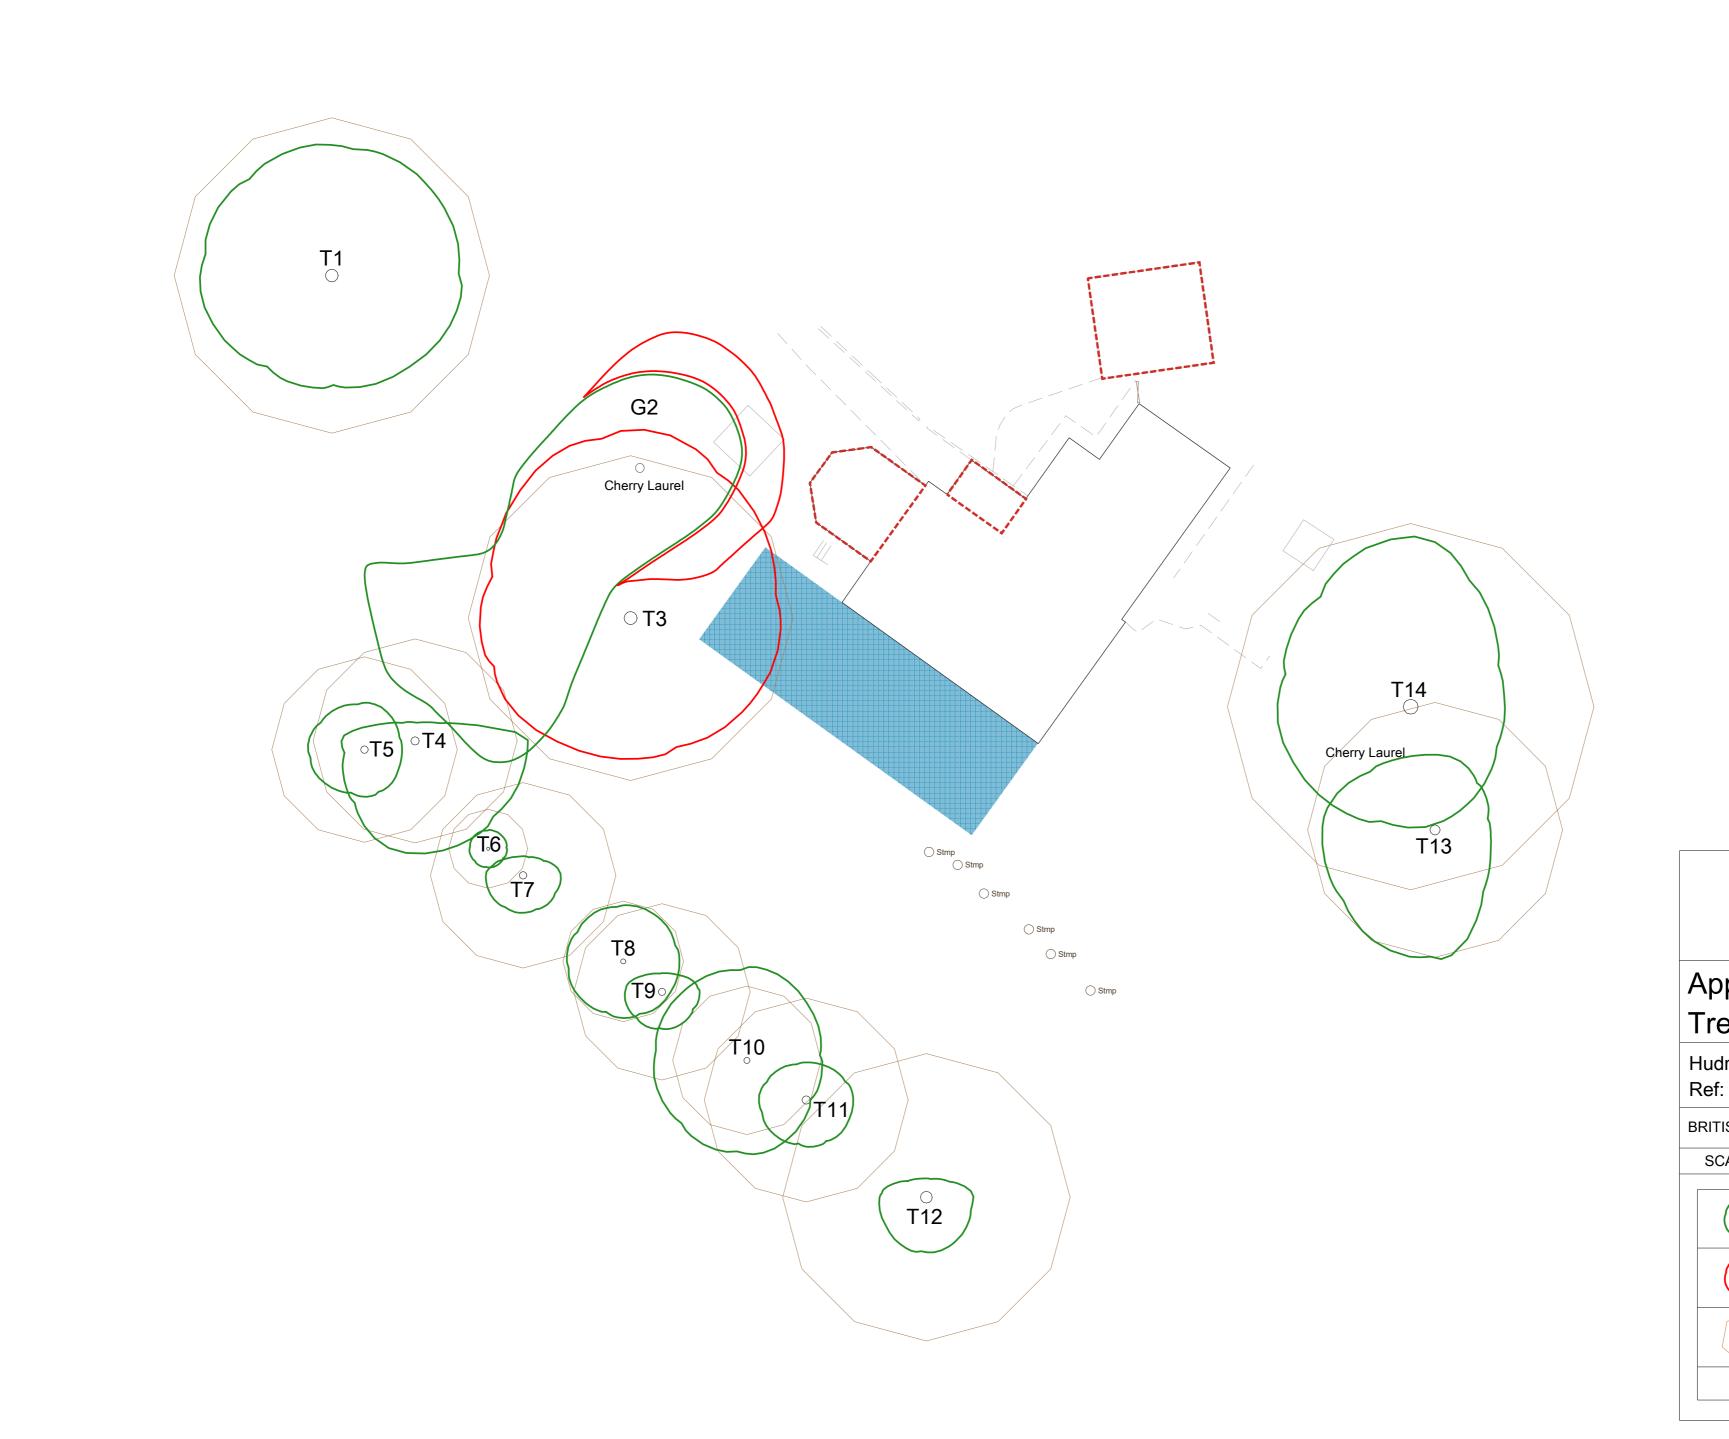
Appendix 6: Tree Impacts Plan

- 4.2.2 The tree that requires removal to facilitate the development is T3.
- 4.2.3 T3 is a mature Ash which has moderate amenity value due to its size and location. However, this tree has poor vitality with a sparse crown and minor deadwood throughout as a result of infection by Chalara Ash Dieback. This disease is usually fatal, either directly or indirectly and the long-term prospects of this tree are likely to be extremely limited, requiring removal within the next 10-20 years regardless of the development.

- 4.2.6 The tree group that requires pruning works to facilitate the development is G2. The work required is a 2m reduction of the northern, eastern and southeastern crown of a Cherry Laurel within this group. This is a species that will easily tolerate hard pruning and as such will not suffer any significant negative impacts from this work.

- 4.2.4 The removal of this tree can be mitigated by the planting of replacement trees in a more suitable location.
- 4.2.5 1 tree group requires pruning works to facilitate the development.
