## **Tree Survey**

| <b>Survey for trees at site:</b> | Westfield House, 47 Victoria Road, Barnsley, S70 2BU |
| <b>Prepared for:</b> | Emerald Construction Ltd. |
| <b>Reference</b> | TreeSurvey <b>0155</b> |

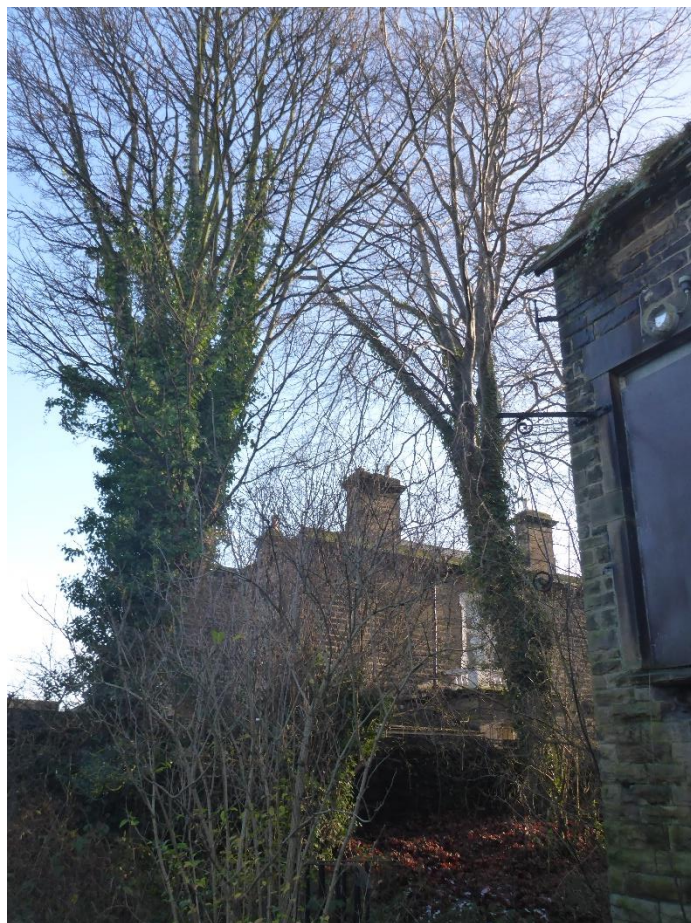
| Ref. | Species | Latin | Age Class | Est. Remain. Cont. | BS | | Tree height (m) | Stem DBH (mm) | No. stems | Crown Spread (m) | | | | Crown clear (m) | Structural condition | RPA radius (m) | RPA area m² | Additional comments | Recommendations |
|---|---|---|---|---|---|---|---|---|---|---|---|---|---|---|---|---|---|---|---|
| T3 | Beech<br>TPO 1 | <i>Fagus sylvatica</i> | Mature | 20-40 | B | 2 | 19.5 | 600 | 1 | 9 | 5.3 | 4.6 | 6.3 | 5.5N | Fair | 7.2m | 162.9 | Some ivy is present on the tree making it difficult to observe the structure. The tree has a large spreading crown which overhangs the boundary into the neighbouring property and overhangs the roof the building on the site. The top of the crown was observed to be leaning slightly towards the boundary, and the tree is situated on slightly raised ground. A large wound that has healed effectively was observed | Sever the ivy to aid future inspections. Crown lift lower branches and crown clean to remove deadwood as part of general maintenance. Crown lifting and pruning away from the roof, may also be necessary to facilitate construction access. Inspect biennially. |

*Photo 2: T2 and T3 (left to right) situated close to the existing building.*

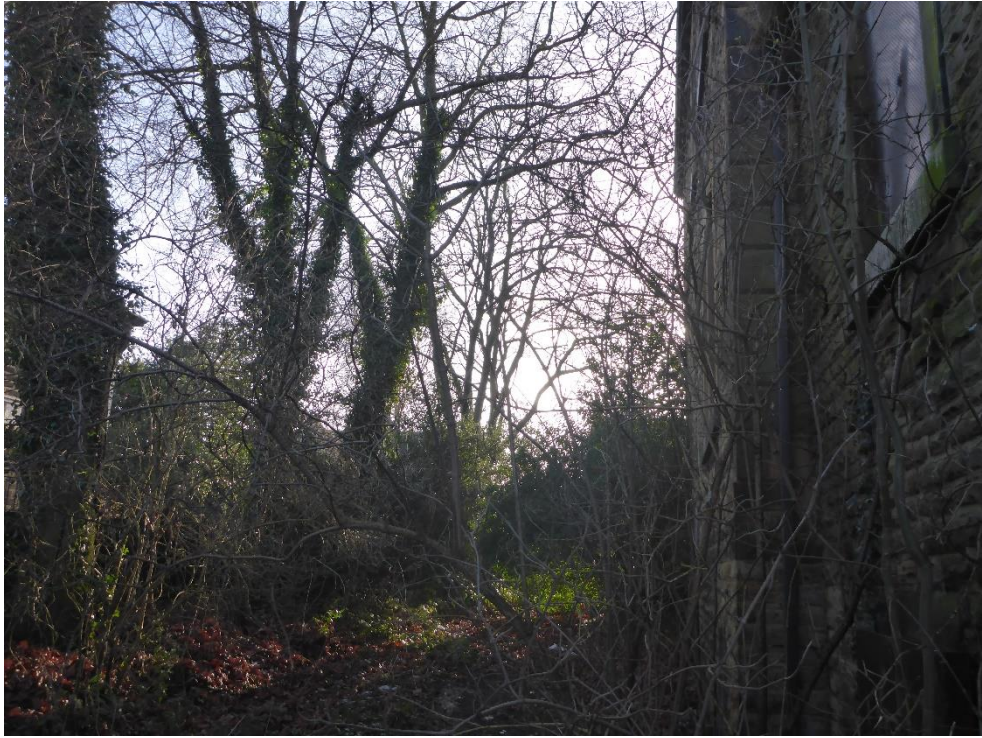
*Photo 3: Trees T3, T4, T5, T6 situated in a line running along the east border, with the existing building to the right.*

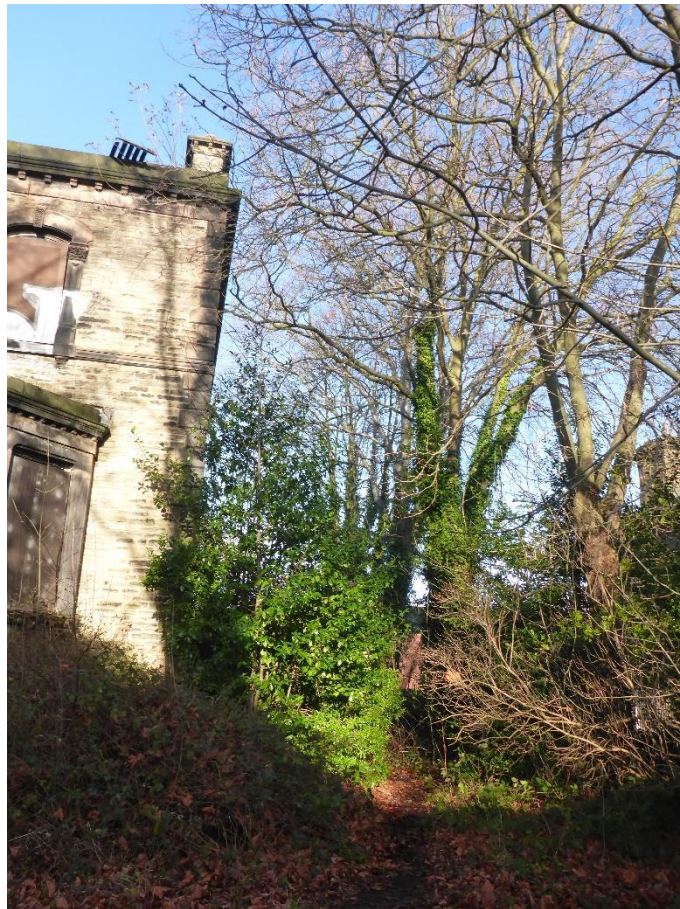
| T6 | London Plane<br><br>TPO 1 | <i>Platanus x hispanica</i> | Early mature | 20-40 | B | 2 | 16.0 | 470 | 1 | 2.5 | 5.8 | 4.5 | 6.0 | 4E | Fair | 5.6m | 99.9 | The tree has reaching branches touching the house and overhanging into the neighbouring property. Some deadwood and broken branches are present. Thick understory shrubs present around the tree making access difficult to inspect. Tree is leaning slightly SW | Clear understory shrubs to aid future inspections. Crown lifting and pruning away from the roof may also be necessary to facilitate construction access. Inspect biennially |

*Photo 4: T5 and T6 on the east boundary situated close to the existing building. The proposed driveway is to run between the existing building and these trees.*

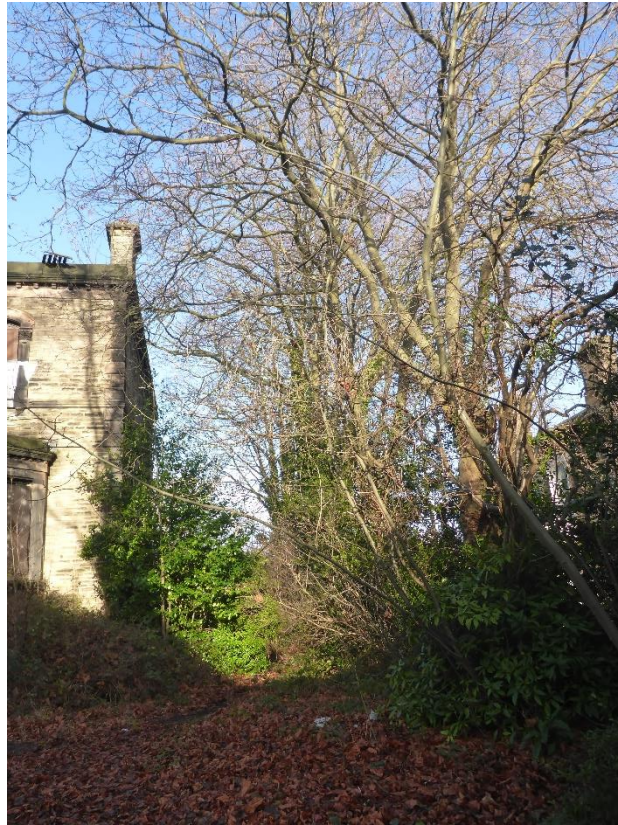
*Photo 5: Trees on east border (right) and existing building. The proposed driveway is to run in between.*

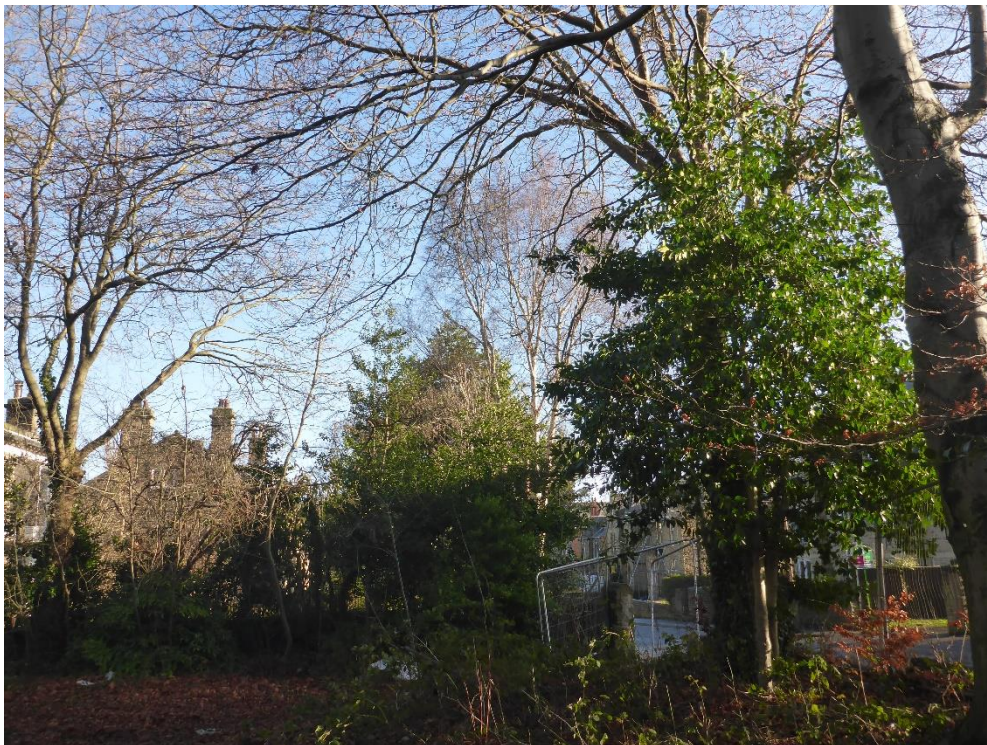
*Photo 6: T8 (situated right of middle) close to current site access from Victoria Road. Branches of T8 overhang access driveway. Understory shrubs also present.*

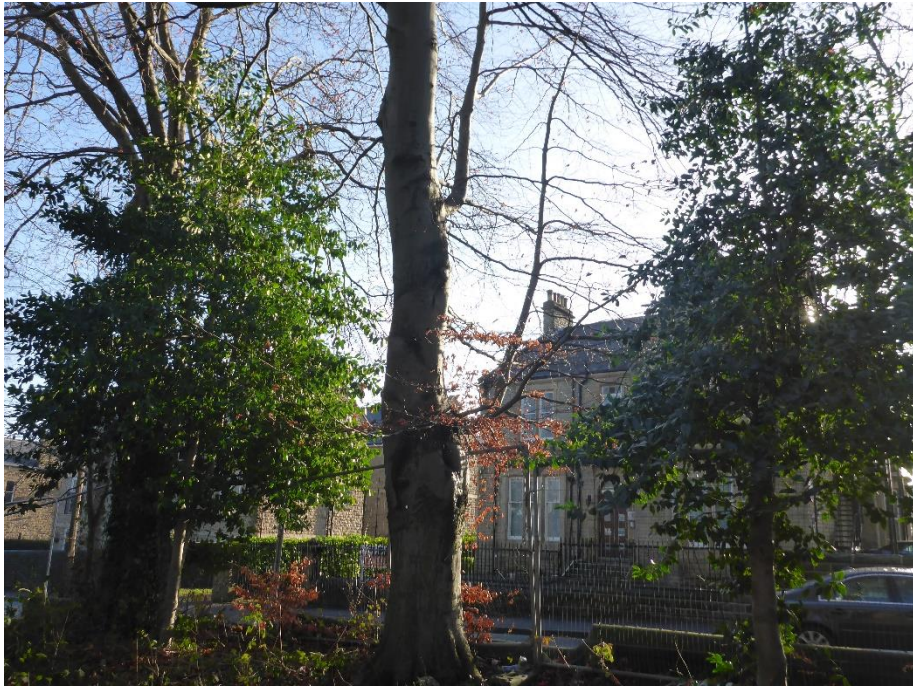
*Photo 6: T9 (centre) situated on south border, bordering Victoria Road.*

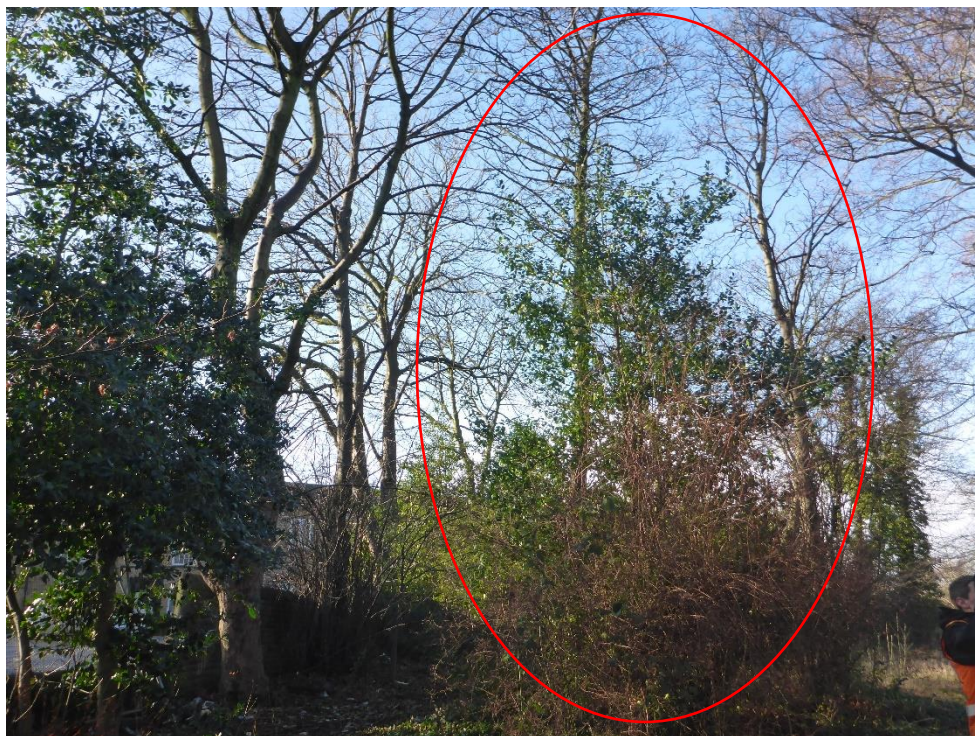
*Photo 7: Trees lining south border (left), and T12, T13, and T31 (centre, circled).*

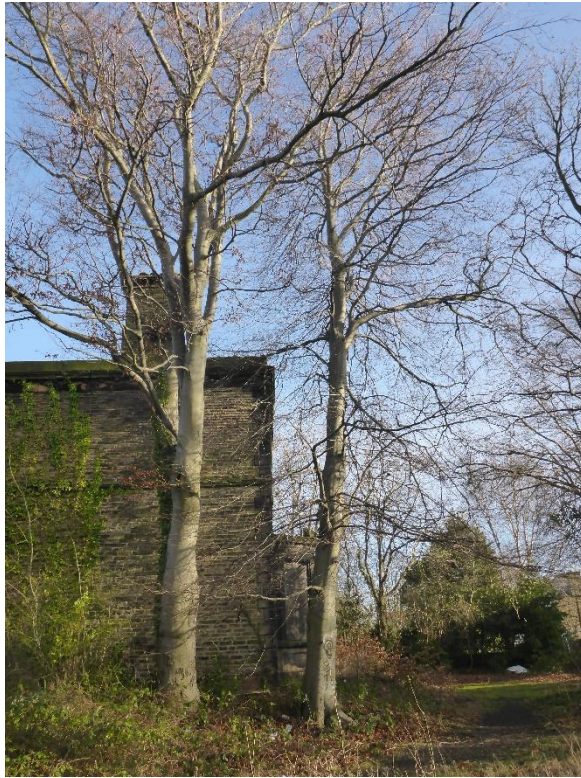
- 3.2.7 Trees T14 and T15 are situated very close to the existing two storey building (approx. 3m). They are both very large and mature. Such mature trees are generally unsuitable to be positioned so close to buildings, as they have large spreading crowns which can cause conflict with structures. Additionally, T15 was observed to have a significant V-shaped union between its two main stems. V-shaped unions have the possibility of failure because the wood in the union is more weakly attached. Therefore it's unlikely that these trees have long term futures because they are in unsuitable positions with regards to the existing building, and T15 has the possibility of failure due to its structure. Removal of these trees would therefore be considered acceptable.

*Photo 8: T14 (right) and T15 (left), situated in very close proximity to the existing building.*

- 6.7 As detailed in the tree condition survey (Appendix 1), trees T14 and T15 are situated in very close proximity to the existing building. These trees are unlikely to be suitable for long term retention in such close proximity to a property, therefore their removal is considered acceptable. T15 in particular was observed to have a significant structural defect, with a V- shaped union which could potentially fail in the future, therefore limiting its overall potential contribution. T28 and T29 are relatively young trees that can be removed if they obstruct the proposed driveway from the west entrance of the site. These trees are too young to currently be of high value.

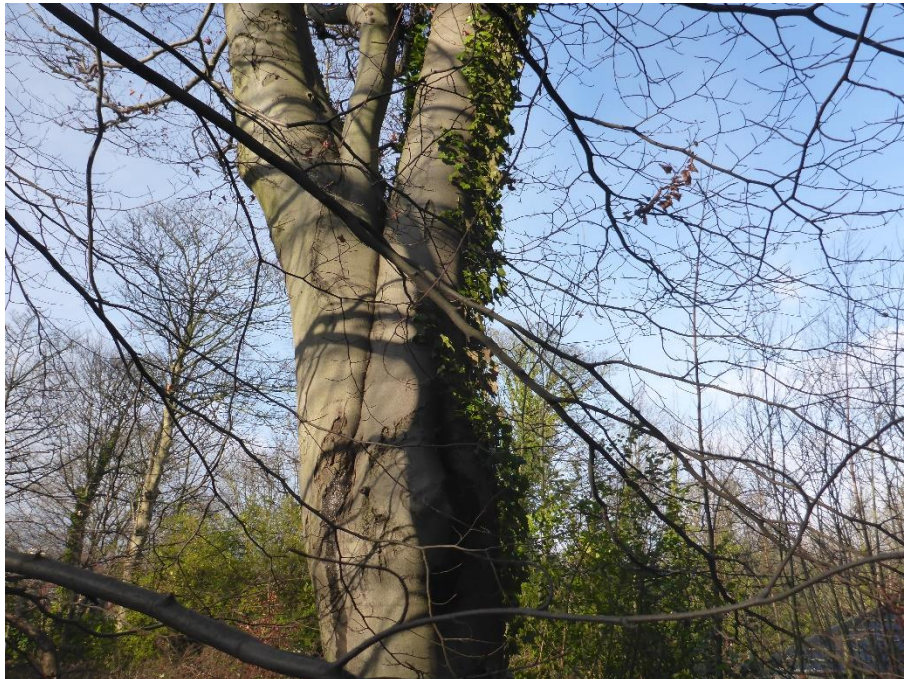
| | | | | | | | | | | | | | | | | | | attached, therefore failure is possible. The tree is situated very close to the property (3.0m) and is leaning towards the property. The tree has a large crown which is spreading over the property. | Therefore it may not have a long term future. Therefore removal would be acceptable. |

*Photo 9: T15 with significant V-shaped union and merged stems.*

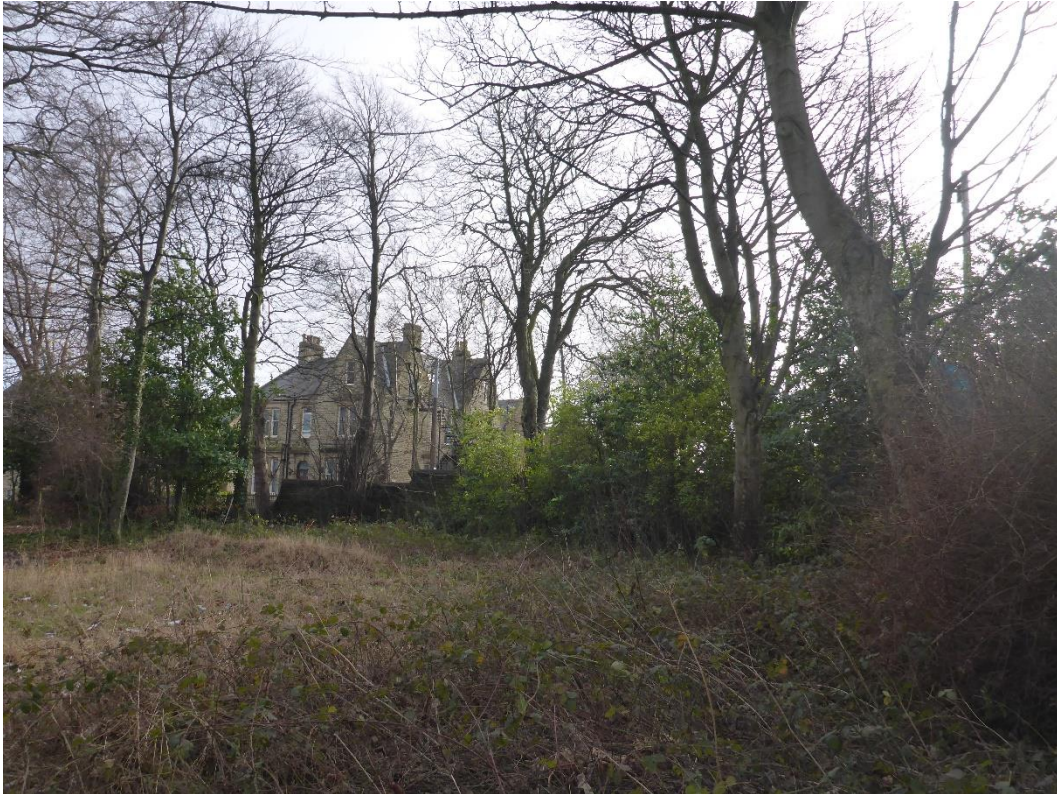
*Photo 10: Trees bordering the south of the site (centre) and trees bordering the SW of the site, bordering Sackville Street (right).*

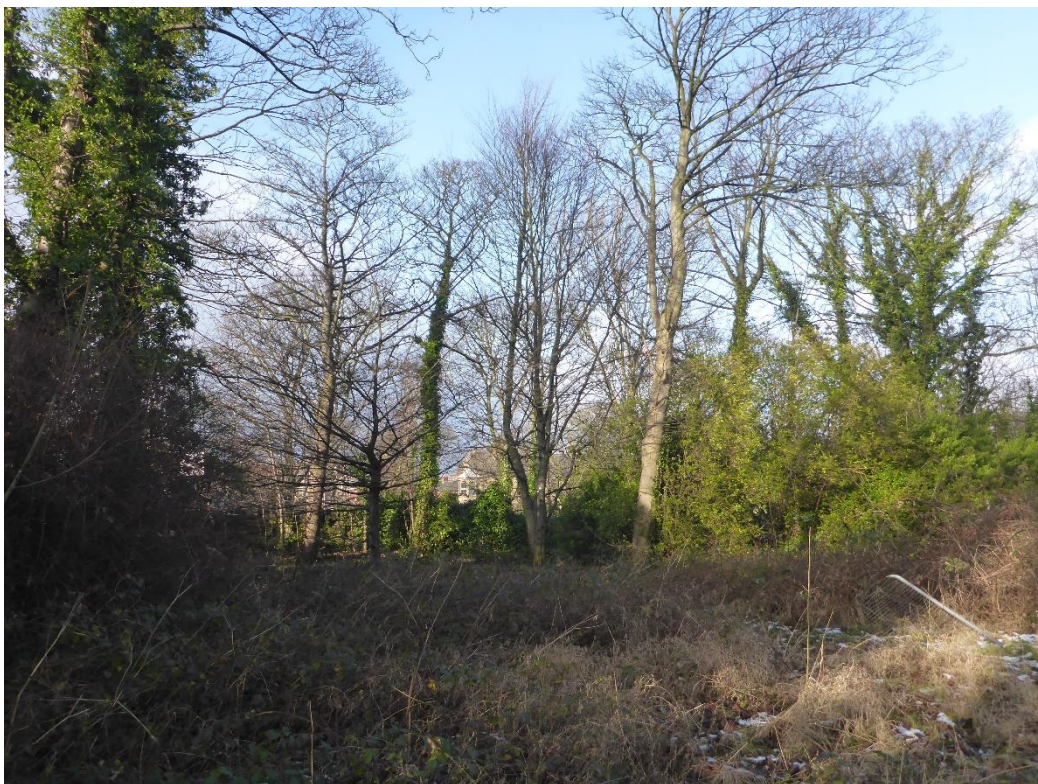
*Photo 11: Trees T22 to T27 along the North West border.*

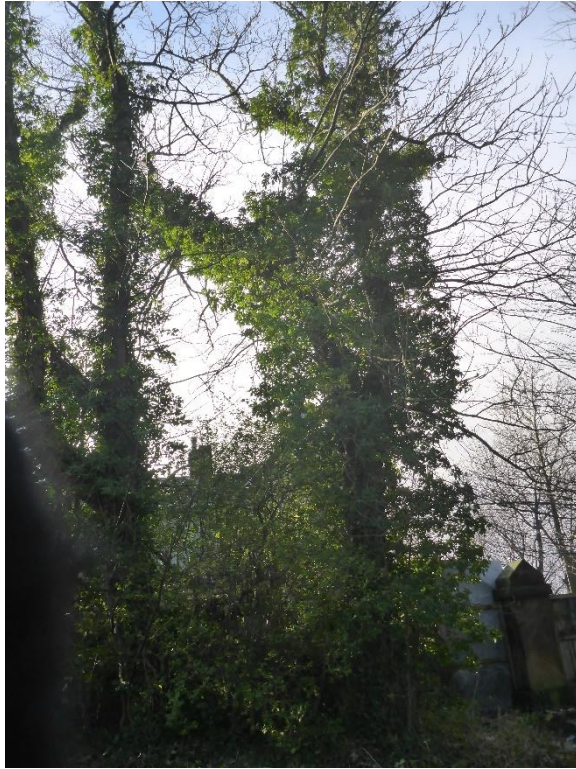
| T21 | Ash<br>TPO 1 | <i>Fraxinus excelsior</i> | Early<br>mature | 10-20 | C | 2 | 17.5 | 460 | 1 | 5.0 | 6.0 | 2.3 | 5.0 | 3W | Poor | 5.5m | 95.7 | The tree is almost entirely covered in ivy, and appears smothered by it. The structure was very difficult to inspect due to the thick ivy. Some deadwood was observed. | Sever ivy and re-inspect. |

*Photo 12: T20 and T21 (left to right), and the new proposed driveway entrance from Sackville Street, right*

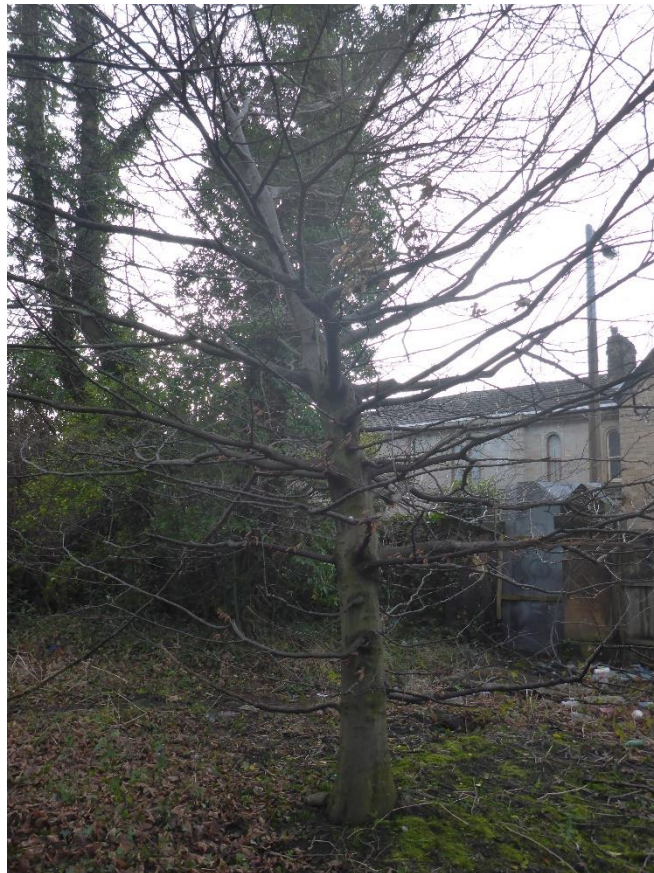
*Photo 13: T29, and new proposed access driveway from Sackville Street, right*

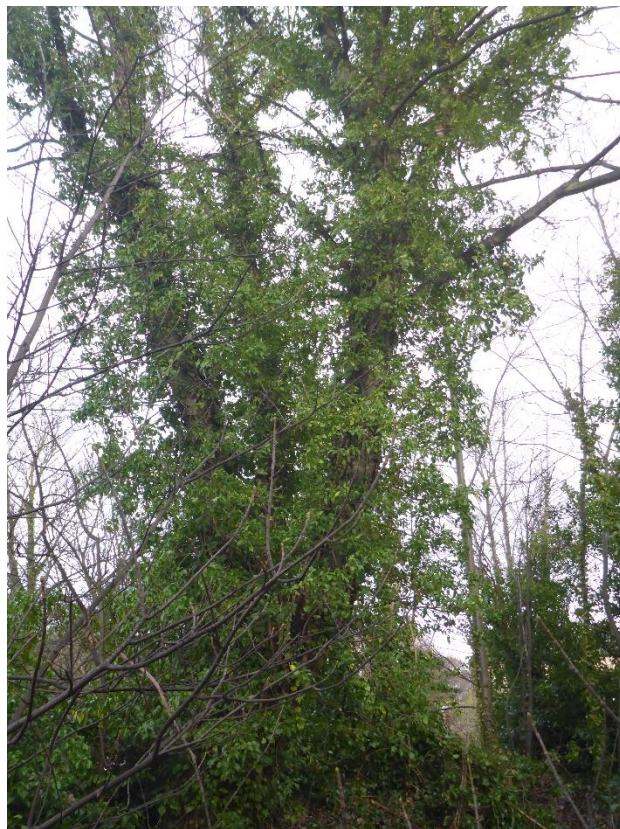
*Photo 15: T26, covered in ivy*

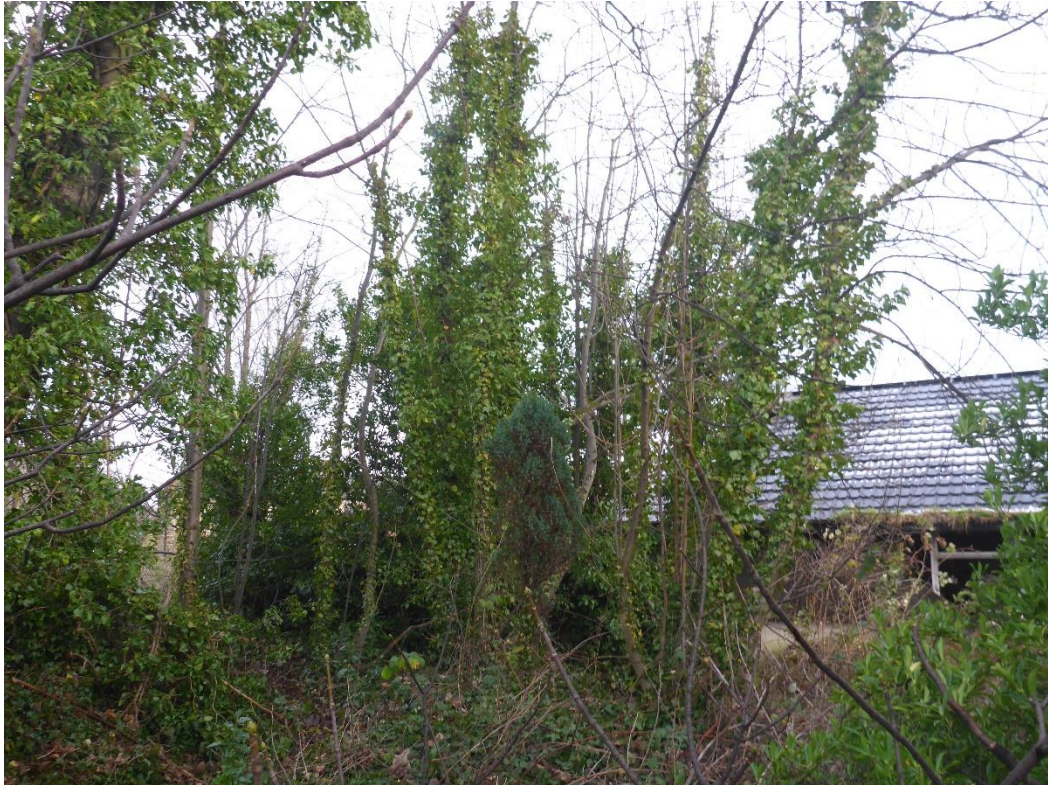
*Photo 16: Clump of understory self-set shrub undergrowth, marked as T30.*

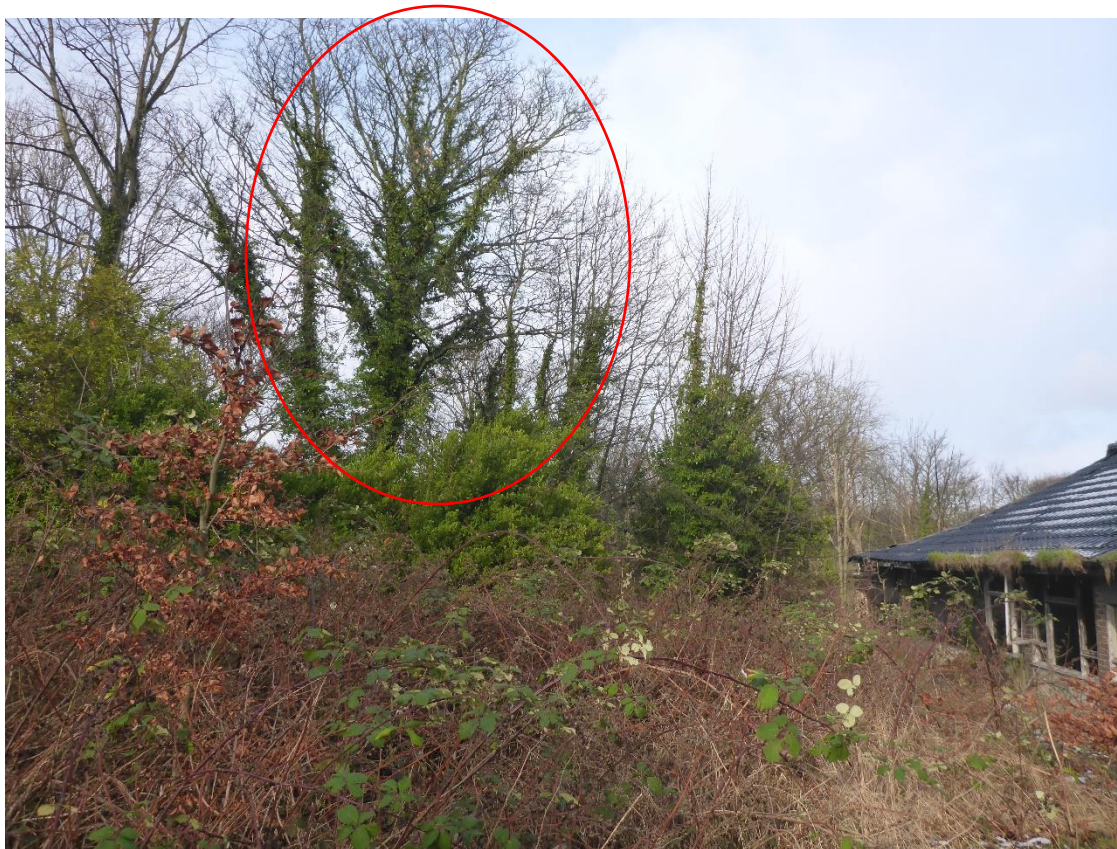
*Photo 17: T26, circled, and understory clump of shrubs and vegetation. Single storey building to right*
