**Arboricultural Implication Assessment  
Equi trek  
Montgomery House  
Sheephouse Wood  
Stocksbridge  
S36 4GS**

Report Reference: AIA1,1275-4

19 June 2020

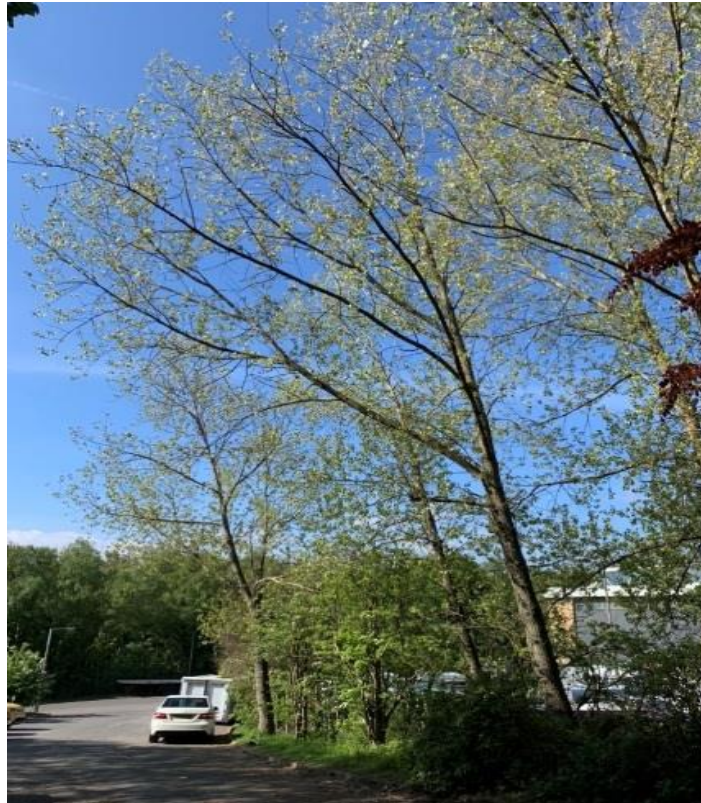
3.2.2. In addition to the development related tree losses 9No. individual trees and 1No. tree group are recommended for removal. These trees are all seriously defective items identified as category 'U' items and should be removed on the basis of good arboricultural management irrespective of the development proposal. The tree numbers concerned include T3604, T3605, T3606, G3607, T3608, T3609, T3610, T3611, T3612 & T2652. It is worth noting the Hybrid Poplars (T3606-T3612) have been identified as category 'U' items due to their physiological condition, short lived nature and limited safe remaining life expectancy. Photograph 3 overleaf provides an example of the poor physiological condition of Hybrid Poplar's T3606 and T3608.

Photograph 3: Displays the sparse appearance of Hybrid Poplar's T3606 and T3608, believed to be infected with *Aplano-bacterium populi* Ridé. *Pseudomonas syringae*.

G3607	11 Hawthorn, <i>Crataegus monogyna</i> & 1 Laburnum, <i>Laburnum anagyroides</i>	3	1	200	See plan.					Early-mature	S=Poor, P=Poor. Poor quality material including several which are either dead or in a state of severe decline.	Remove regardless of development proposal.	<10 yrs	U	2.4
T3608	Hybrid Black Poplar, <i>Populus x canadensis</i>	16	1	240	1	3	4	1	6-s	Semi-mature	S=Fair, P=Poor. Sparse appearance with chlorotic, undersized foliage. Slender form due to suppression from dominant neighbour. Appear to be infected with Aplanobacterium populi Ridé. Pseudomonas syringae or similar bacterial infection. Limited life expectancy.	Remove regardless of development proposal.	<10 yrs	U	2.9
T3609	Hybrid Black Poplar, <i>Populus x canadensis</i>	18	1	400		6	5	3	6-s	Early-mature	S= Fair, P=Poor. Sparse appearance with chlorotic, undersized foliage. Major deadwood present. Appear to be infected with Aplanobacterium populi Ridé. Pseudomonas syringae or similar bacterial infection. Limited life expectancy.	Remove regardless of development proposal.	<10 yrs	U	4.8

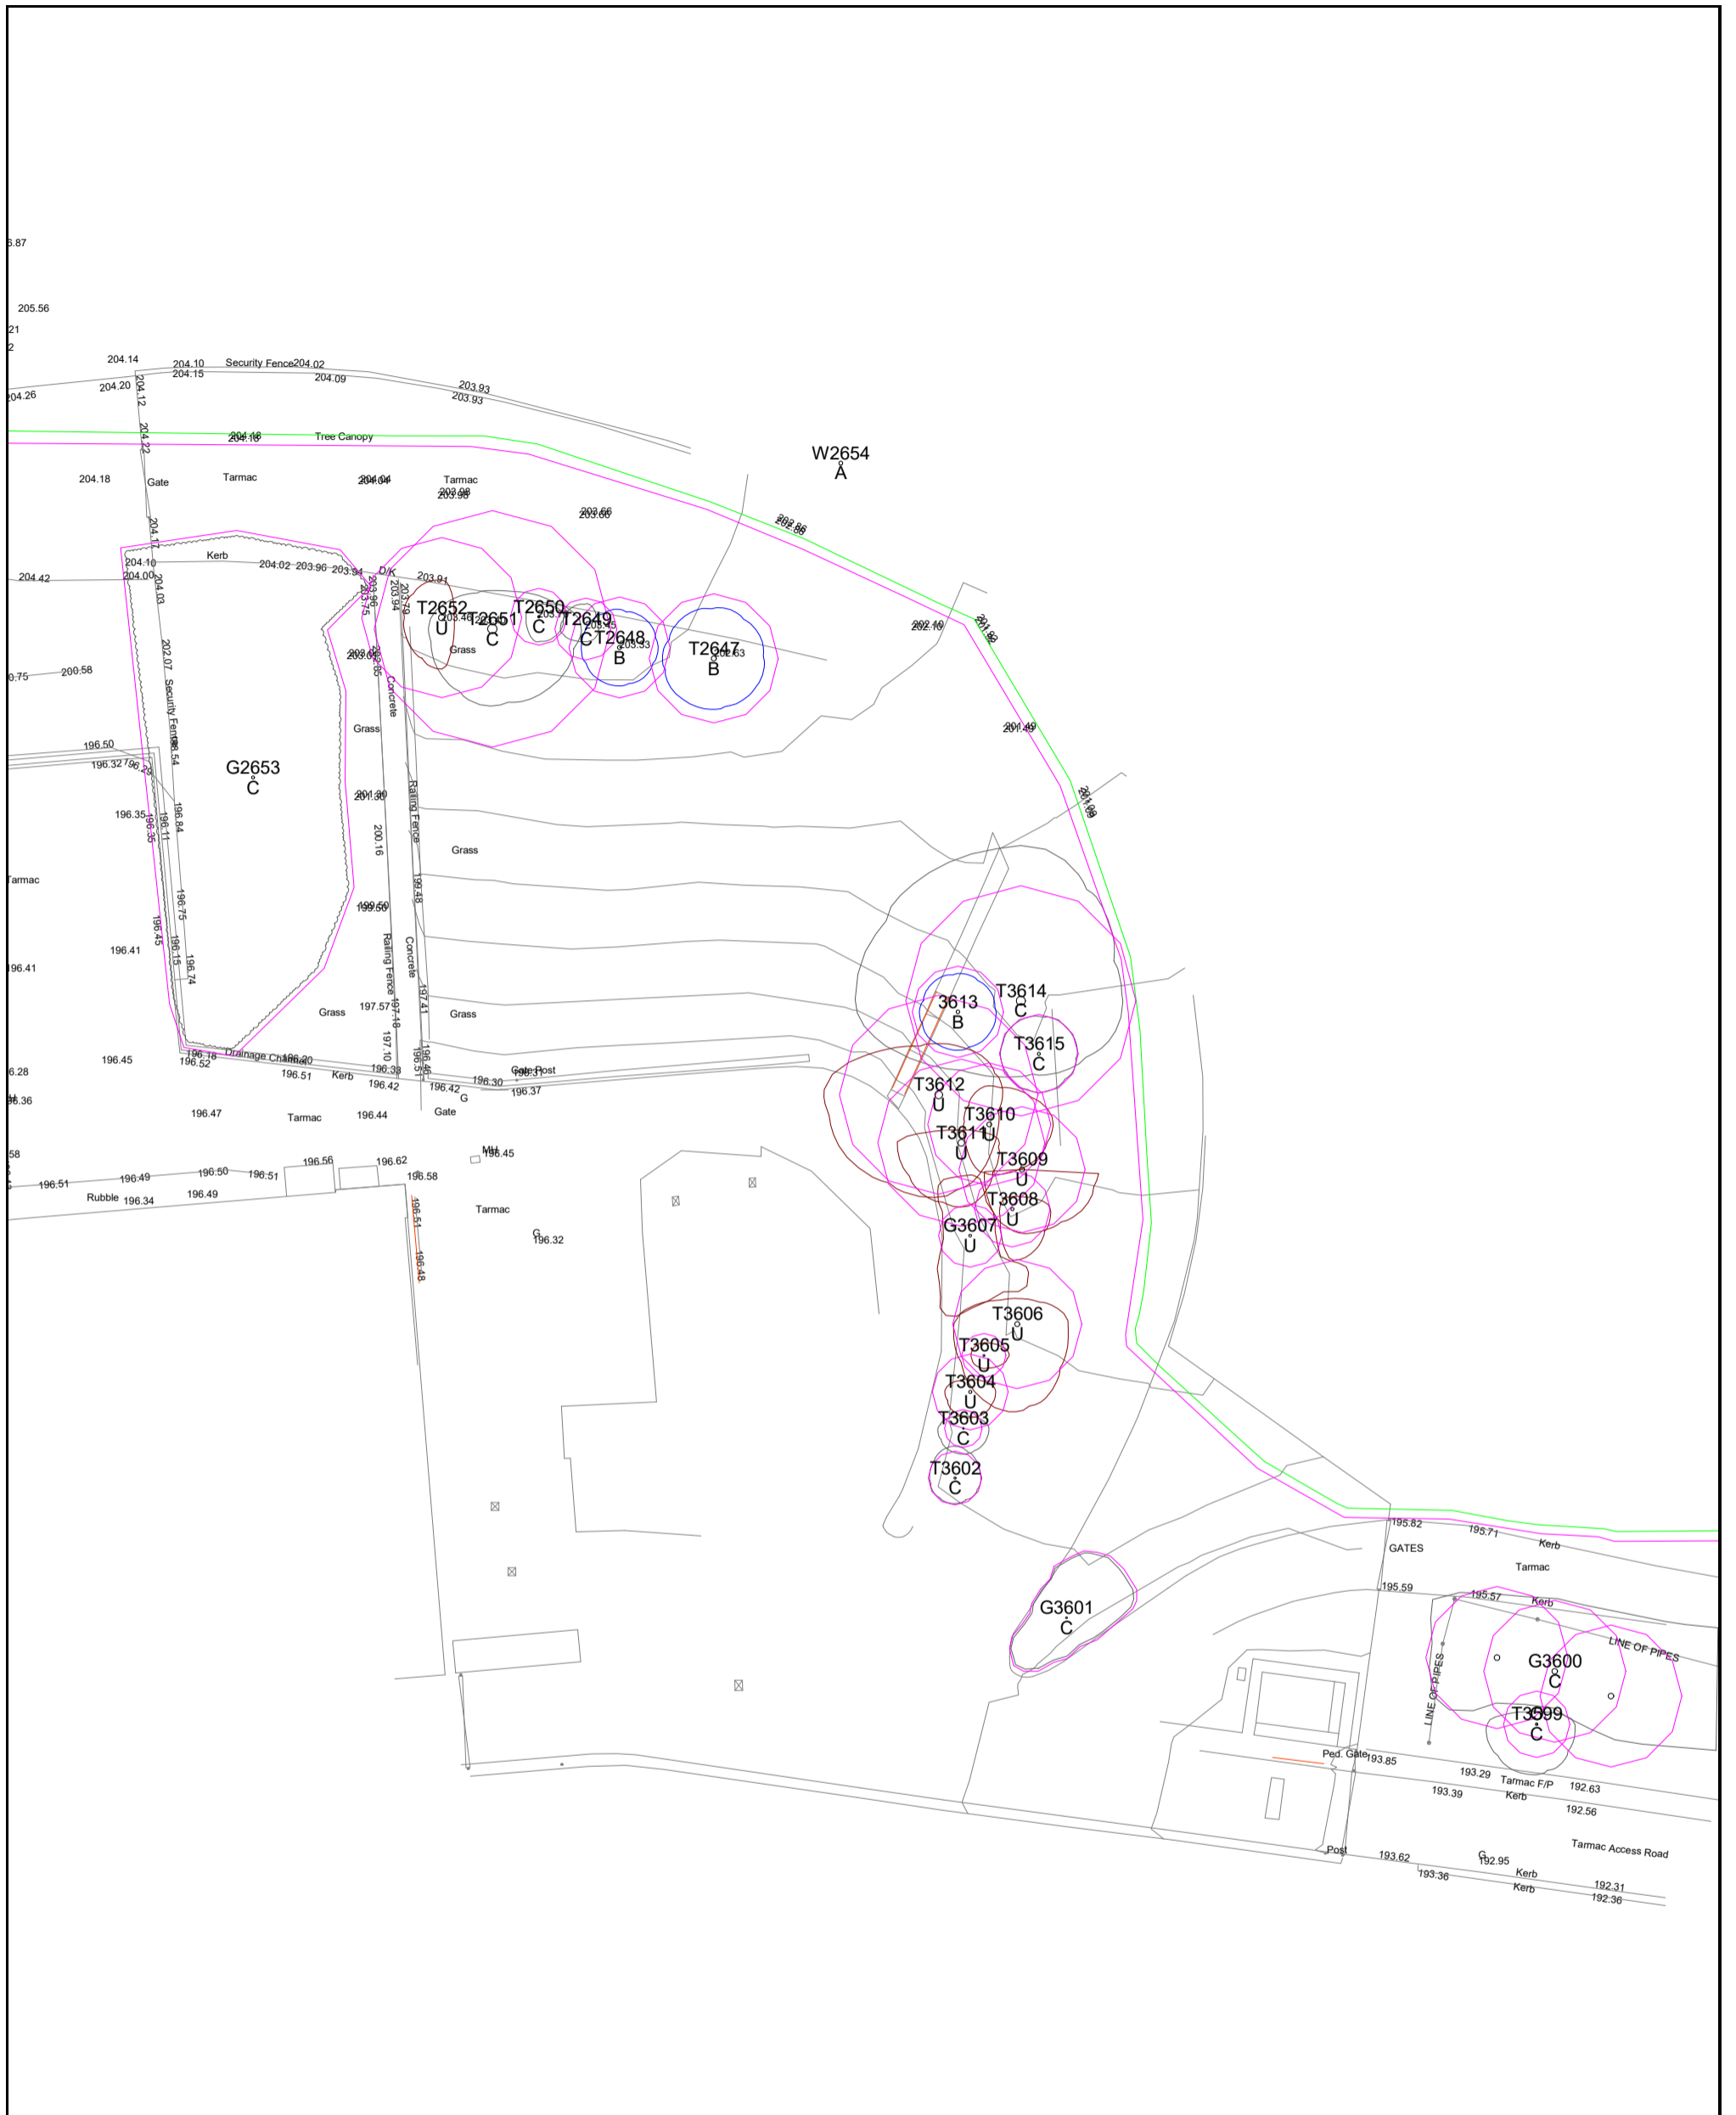
**Tree Constraints Plan**  
Equi-trek, Sheephouse Wood, Stocksbridge

- 3.3.1. The area of roots that need to be protected around a tree to try to ensure it does not suffer damage during the construction process is called the Root Protection Area (RPA).
- 3.3.2. As recommended in BS5837 we have plotted the RPAs (in magenta) onto the attached Tree Constraints Plan (TCP) taking full account of the surrounding topographical factors, tree condition and the overall likelihood of root disposition.
- 3.3.3. With the exception of the minor RPA breach to T2651, the proposed parking and retaining wall are located outside of the recommended areas. It would be reasonable to accept that subject to appropriate construction safeguards detailed in an Arboricultural Method Statement (AMS) the work could be safely implemented with minimal disturbance to trees to be for retained.

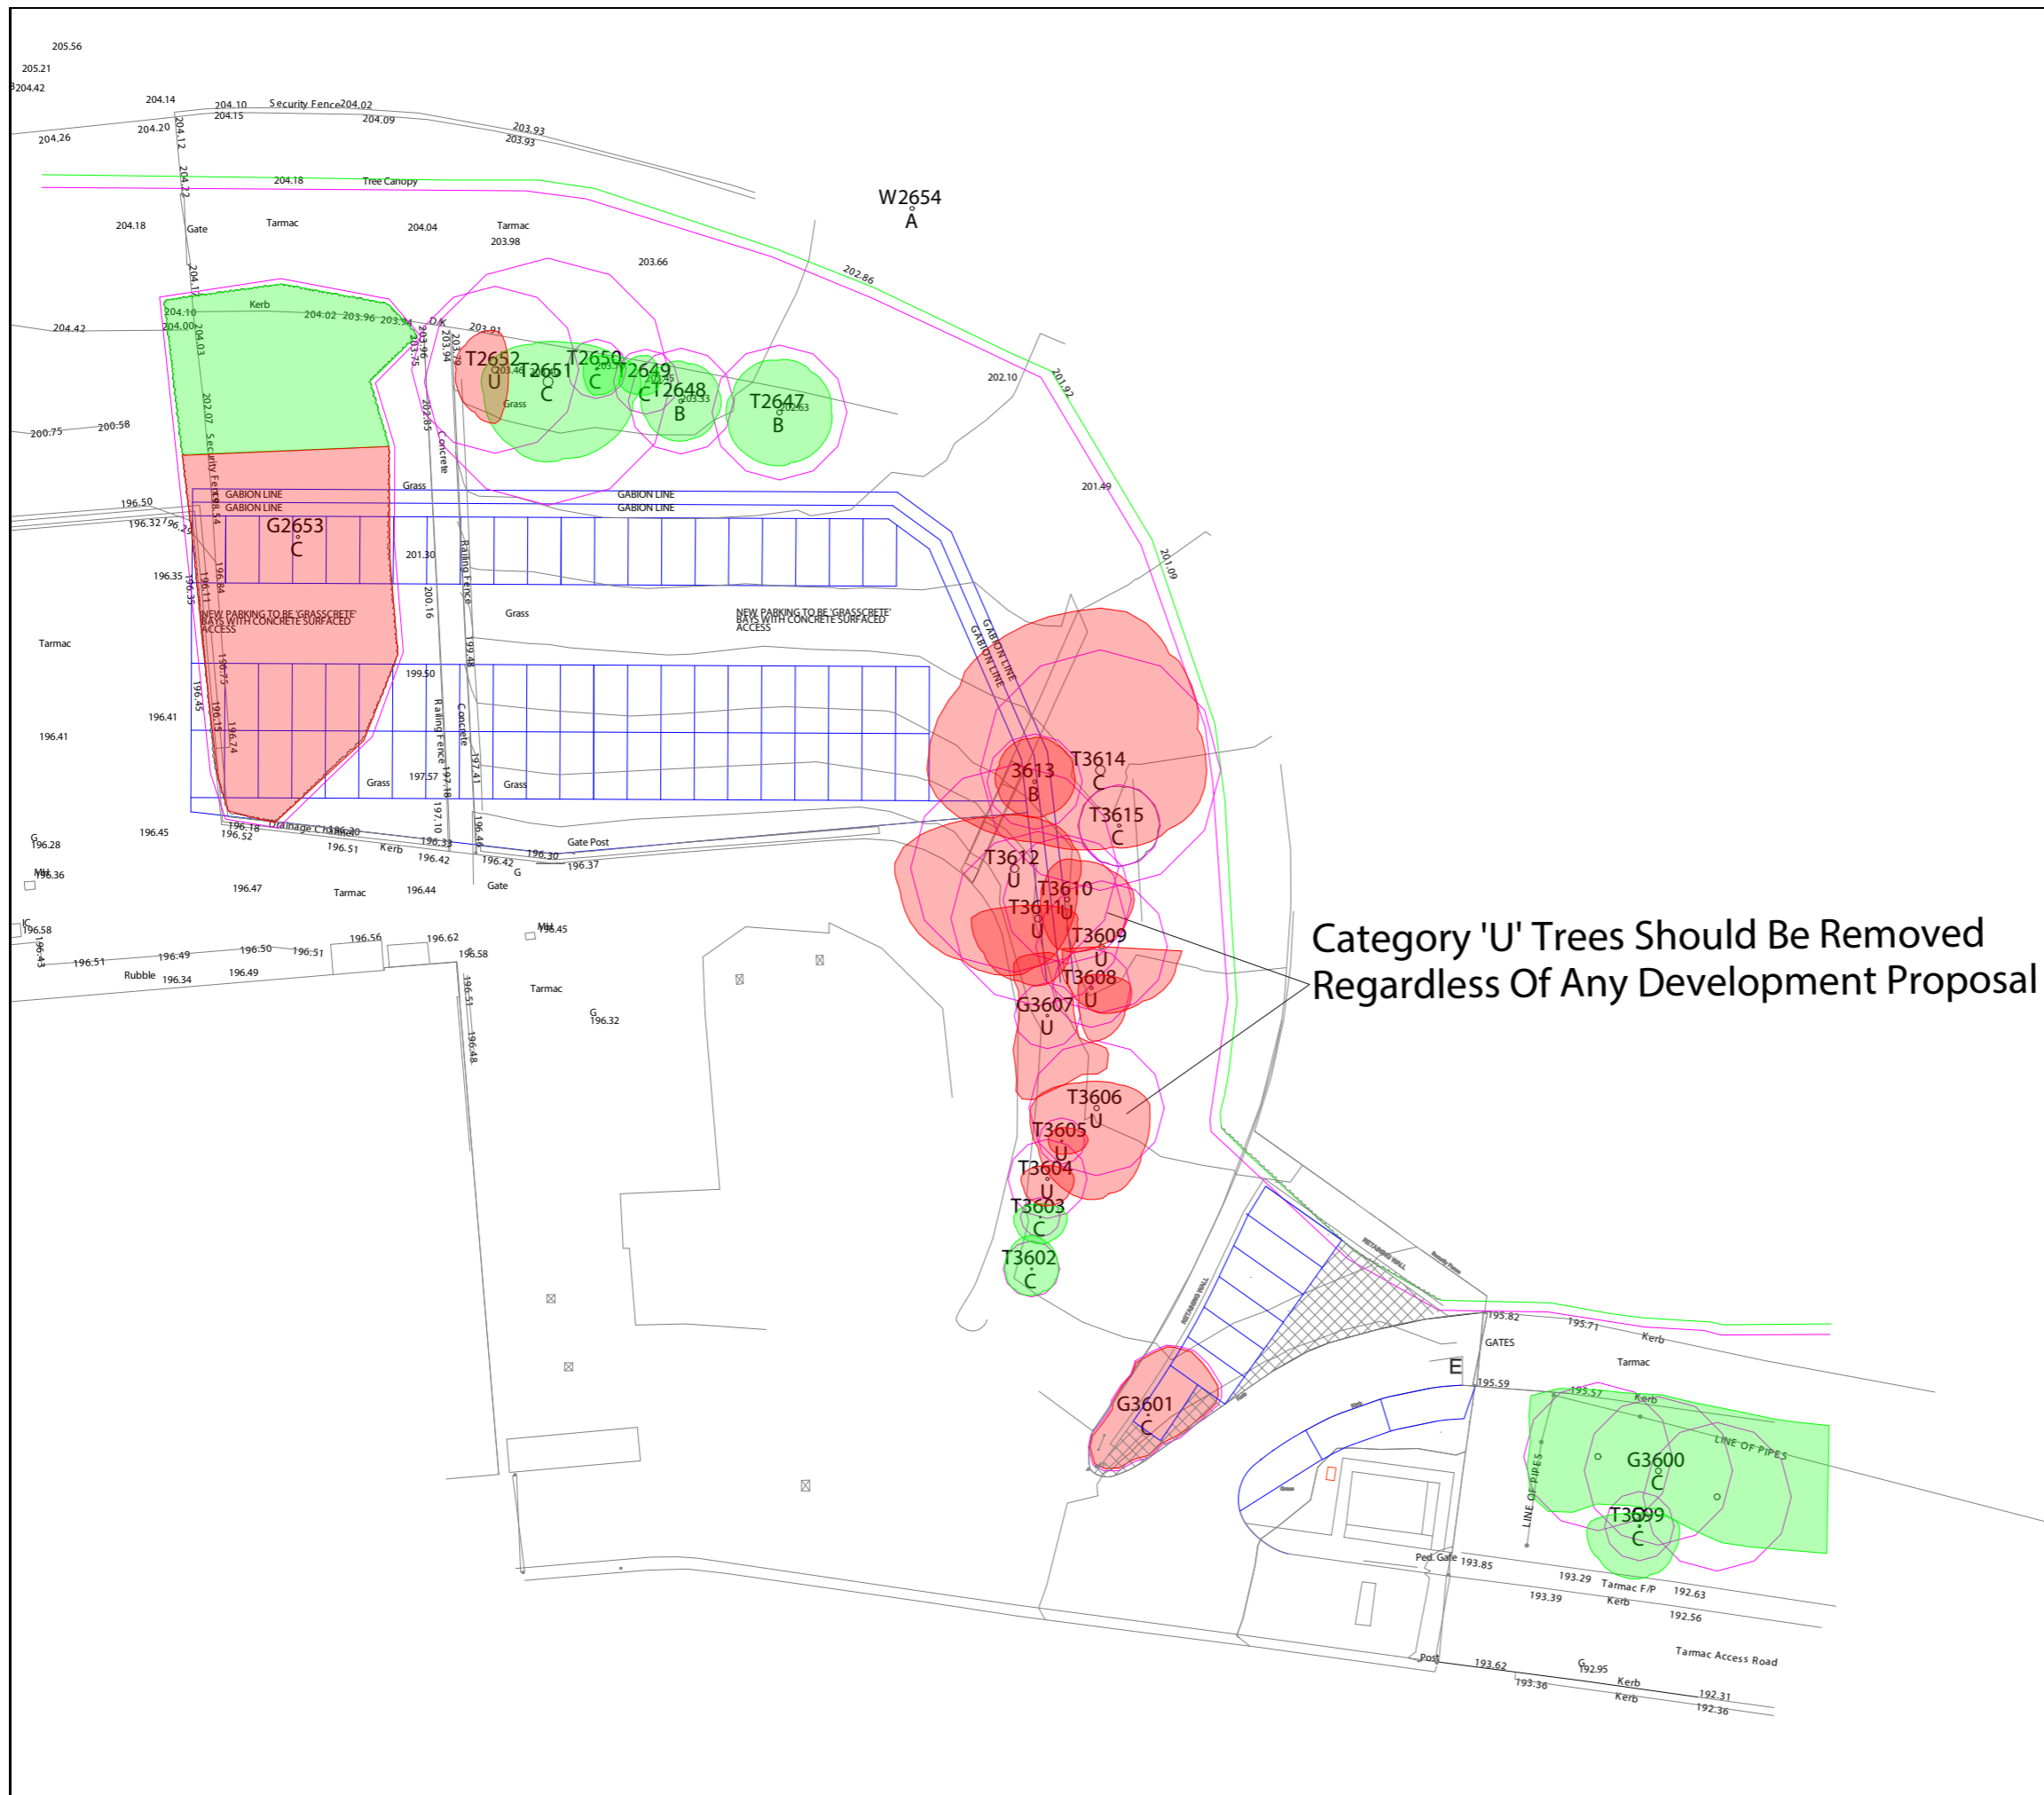
**Tree Constraints Plan (Proposal)**  
Equi trek, Stockbridge

3.2.1. During the design process the proposed layout has undergone amendments to ensure minimal impact on surrounding trees. As demonstrated in table 2, the current scheme requires the removal of 1 moderate category 'B' Copper Beech (T3613), 1No. low quality category 'C' Hybrid Poplar (T3614), the loss of 1No. low quality category 'C' tree group (T3601) and the partial loss of 1No. low quality category 'C' mixed species tree group G2653.

- 3.5.1. A protective fence will be erected prior to the commencement of any site works e.g. before any materials are brought on site. The fence will have signs attached to it stating that this is a Construction Exclusion Zone (CEZ) and that **NO WORKS** are permitted within the CEZ. The protected fence may only be removed following completion of all construction works.
- 3.5.2. The positioning and implementation of tree protection is one that can be embodied within a dedicated AMS . I would presume this is a matter the Local Planning Authority would be agreeable to conditioning as part of a detailed planning permission.
