## GYPSY LANE, WOMBWELL

### Arboricultural Impact Assessment and Arboricultural Method Statement

February 2019

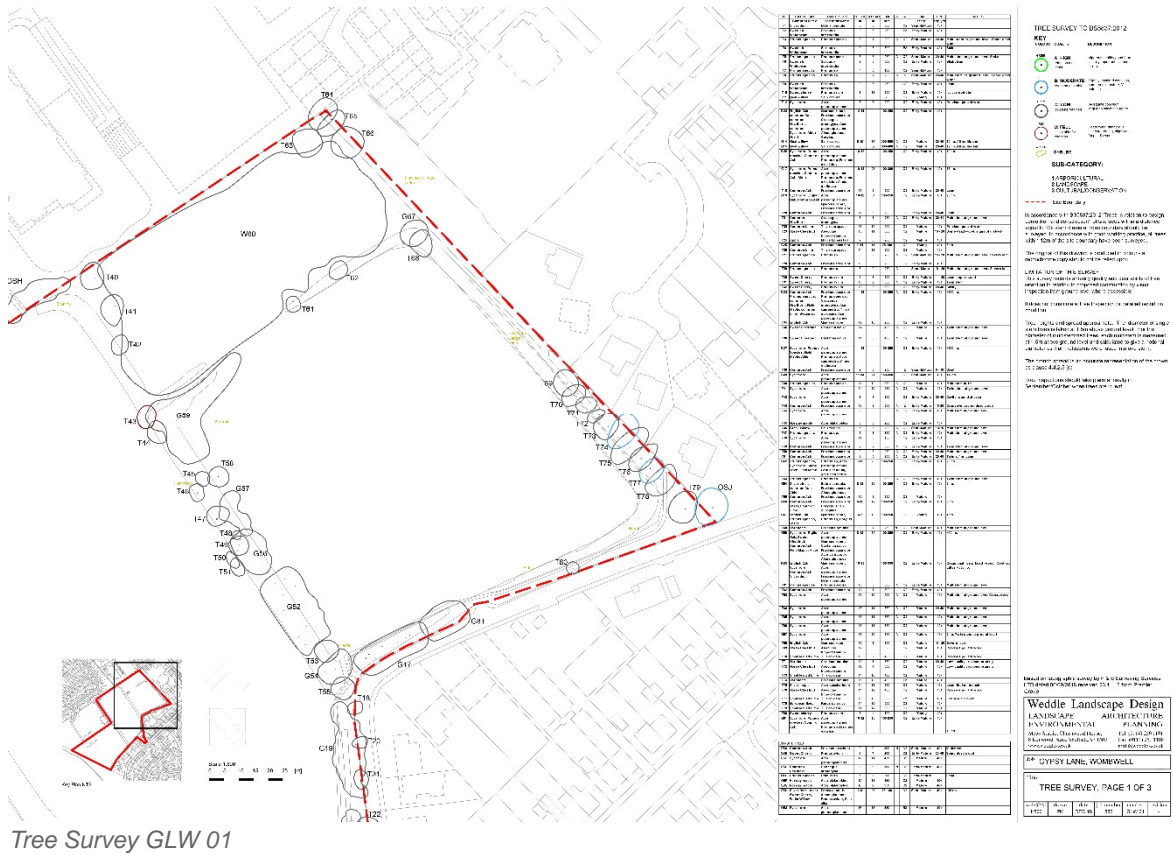
Tree Survey GLW 01

The tree survey revealed that:

- Swedish Whitebeams T2 and T4 are considered to be of moderate quality (category B) with a long life expectancy
- Prunus T3 and T5 are considered to have a reduced life expectancy and are considered to be low quality (category C)

- Prunus T8 while having a moderate life expectancy should be felled (category U)
- Goat Willow groups G12 and G15 due to the species have a reduced life expectancy and are considered to be low quality (category C)

- Ash trees T18 and T20 are leaning with a reduced life expectancy and are of low quality
- Hawthorn T21 has a reduced life expectancy
- Horse Chestnut T23 has dead wood and signs of dieback with a low life expectancy and are of low quality

- Cherries T27 and T29 have severe leans with a low life expectancy and is of low quality
- Cherry T30 is leaning and suppressed and has a low life expectancy and is of low quality

- Cherry T32 has a stem cavity and reduced life expectancy and is of low quality
- Ash T38 is dead with a very short life expectancy and should be felled

- Ash T43 has a short life expectancy with poor form caused by a significant crossover and should be felled
- Crack Willow T46 is multi-stemmed and this species is prone to collapse and therefore has a low life expectancy.

- Ash trees T50 and T51 are of low quality with a moderate life expectancy
- Sycamore T64 is of low quality with a moderate life expectancy
- English Oak T68 is of low quality with a severe lean and a short life expectancy

- Trees T69 – T72 have be subject to previous pruning work, some of which does not conform to BS3998:2010. These trees are of a low quality as a result.

- Hornbeam T74 is of moderate quality with a long life expectancy
- Lime T77 is of moderate quality with a long life expectancy and has epicormic growth to its base

- Woodland W60 is of low quality as there are a number of trees which are leaning or have dead wood or cavities and some thinning to improve the structure is required

- Offsite Sycamore OSJ is of moderate quality with a long life expectancy
- The remaining trees are considered to be of low quality (category C), the majority of which are located within densely spaced groups and woodlands and these have been left unmanaged and un-thinned since planting.

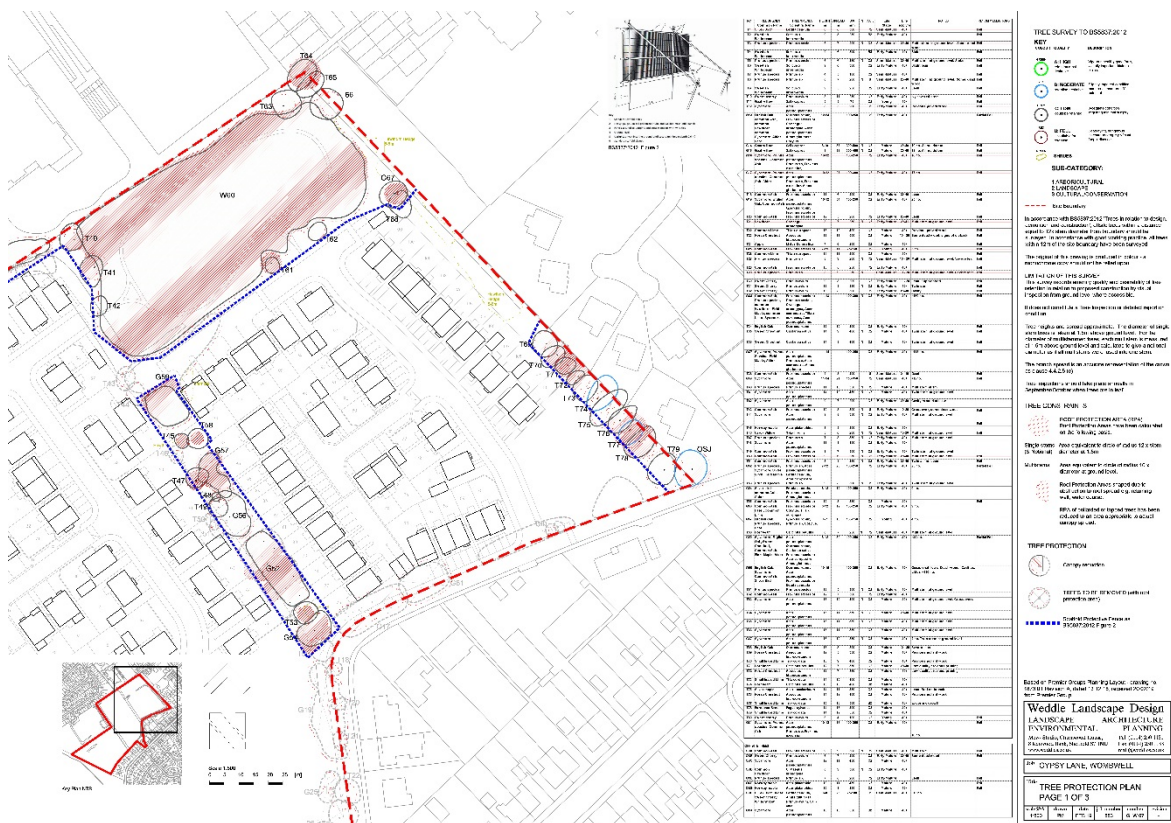
Tree Protection Plan GLW 07

55 No. Trees, Groups or Woodlands will be removed as part of the development. 1 No. Woodland and 2 No. Groups will be partially reduced or felled.

- T8 Prunus species and T43 Ash – Trees have dead wood and is fall into category U and are unsuitable for retention
- T38 Ash is dead

All other trees will be retained. The proposed development has the potential to impact on the retained trees and protective fencing will be erected to surround all retained trees. The location of protective fencing is shown on drawings GLW 07, GLW 08 and GLW 09 Tree Protection Plan.

Trees to be felled should be removed immediately prior to development.

Dead wood and Ivy removal should be undertaken on all trees to be retained including Woodland W60.

Protective fencing should then be erected immediately prior to development.
