# 3 Lower Collier Fold

## Planning Statement– Application Ref: 2019/0454

## INSPECTION REPORT & ESTIMATE

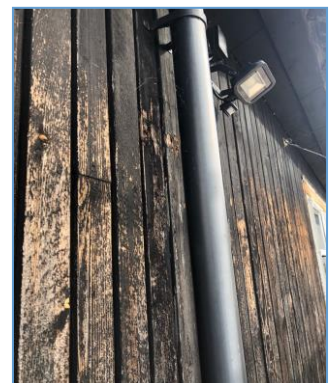
The property posed an immediate fire risk due to the nature of the building itself, and how it has been coated/treated in past years. The property is timber framed and made up of a 2x2 stud frame with tongue and groove timber boarding internally and externally. When erected, this was then coated externally in a highly flammable creosote to ensure it was water/weather proof. This has not been maintained by the previous occupant of many years and the structure is no longer water resistant. Originally, there was no insulation/plaster/fire boarding, internally or externally. In an effort to reduce fire risk, the property was initially fire boarded internally before plastering during initial renovation works in order to make the home safe and liveable. Externally was a much bigger issue due to the creosote coated timber, upon inspection it was highly recommended that the front of the property was immediately fire boarded and sealed fully, ideally with a silicone based render previously used on similarly fabricated properties. The timber structure must be left as a support, as removing this on such a large scale would hinder the stability. However, it is advised that once the timber structure itself is sandwiched between sufficient fire boarding, as it is at present. In terms of the retrospective planning application, the damaged timber was removed where possible to allow for the rear extension/front porch and replaced with Yorkshire stone, therefore removing the imminent fire risk. This will allow a sufficient amount of time for people to vacate the dwelling and await fire rescue in the event of a fire, whereas this time would have been very limited before the necessary alterations.

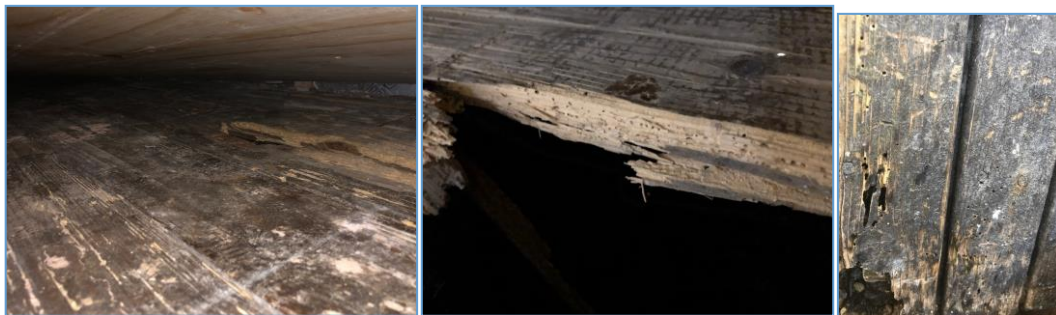
Upon initial internal renovations, the removal of carpeting/laminate flooring revealed evidence of rotting timber and active woodworm within the property throughout the ground floor. Where possible, damaged timber has been removed and replaced in order to provide a safe, family environment. [Please see report \(Fig.1\) and accompanying photographs attached.](#)

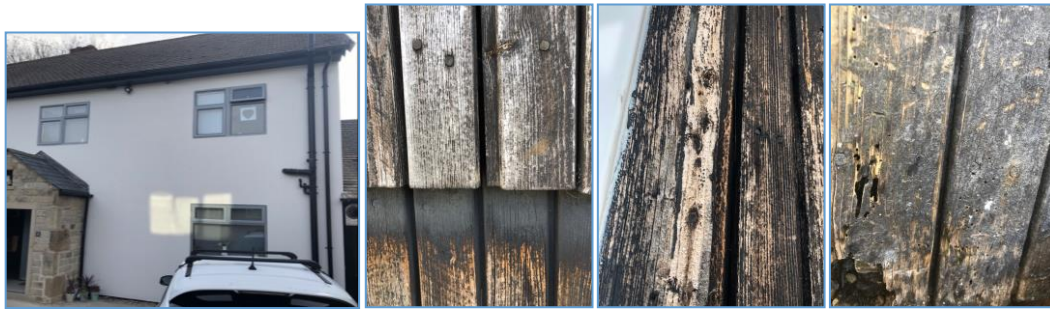
Current

was without sufficient central heating and lacked insulation throughout. As part of the fire boarding process, the walls were stripped back internally, timbered and insulated in order to classify as a robust design. Externally, posed the biggest issue going forward as due to the weathered exterior boarding, the property had become open to the elements with various open access points for wind and rain where the fascia had deteriorated significantly enough to create gaps. This was subsequently allowing cold air in to the property and warm air to escape. Again, the permanent solution to this is to support the original structure with fire boarding and coat in a silicone based render, this provided weather proofing and an additional depth to the exterior walls of the property, allowing the thermal efficiency to rise. Currently however, the side extension poses the same risk as the rest of the property did initially and it is unable to hold heat. We have therefore proposed that it be removed and a two-storey elevation be erected in stone in its place in order to provide further thermal efficiency and replace the dilapidated structure that currently stands.

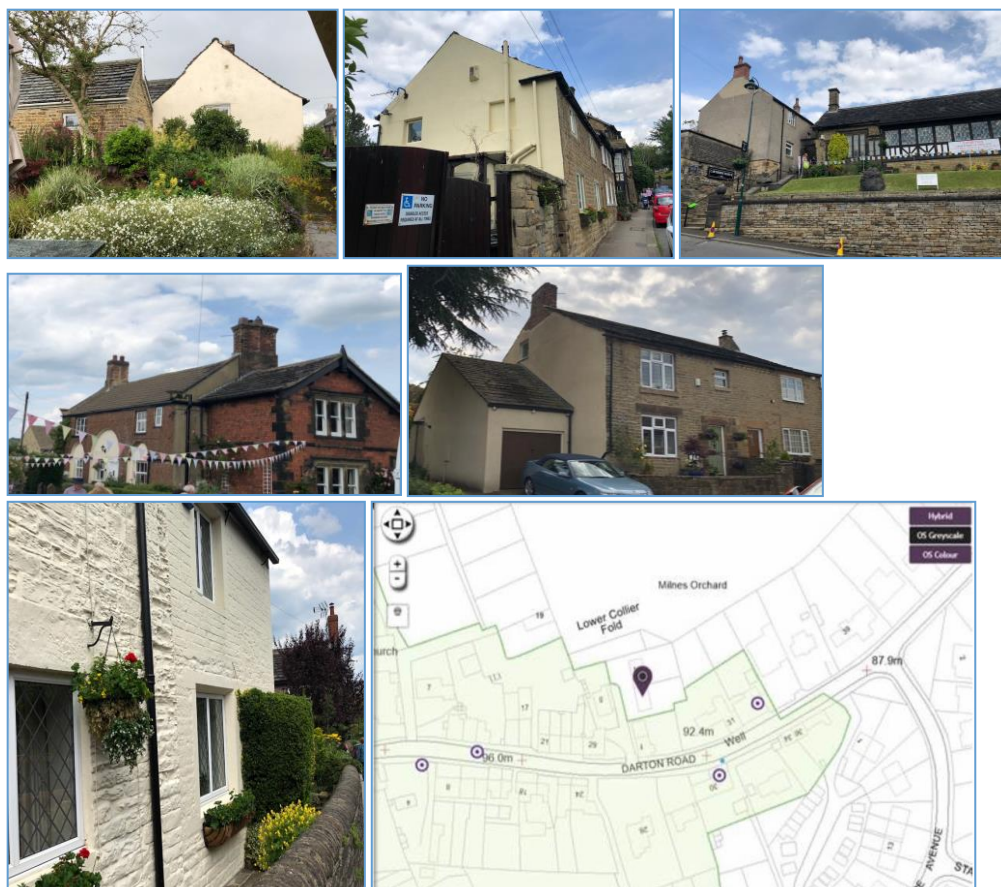
In accordance with the current conservation area plan for Cawthorne listed on the BMBC website, 3 & 4 Lower Collier Fold are not included within the outlined conservation area, a Heritage Impact Assessment is therefore technically not required however we are attaching one for your benefit. The proposed planning application outlines the use of both render and old Yorkshire stone in order to match with buildings in the nearby conservation area of which can be seen from the property.

[Please see attached photographs of surrounding properties](#)
