ARBORICULTURAL REPORT & Impact Assessment to BS5837:2012 at:

***50 Don Street
Penistone
South Yorkshire
S36 6HA***

Reference: *AWA2814*

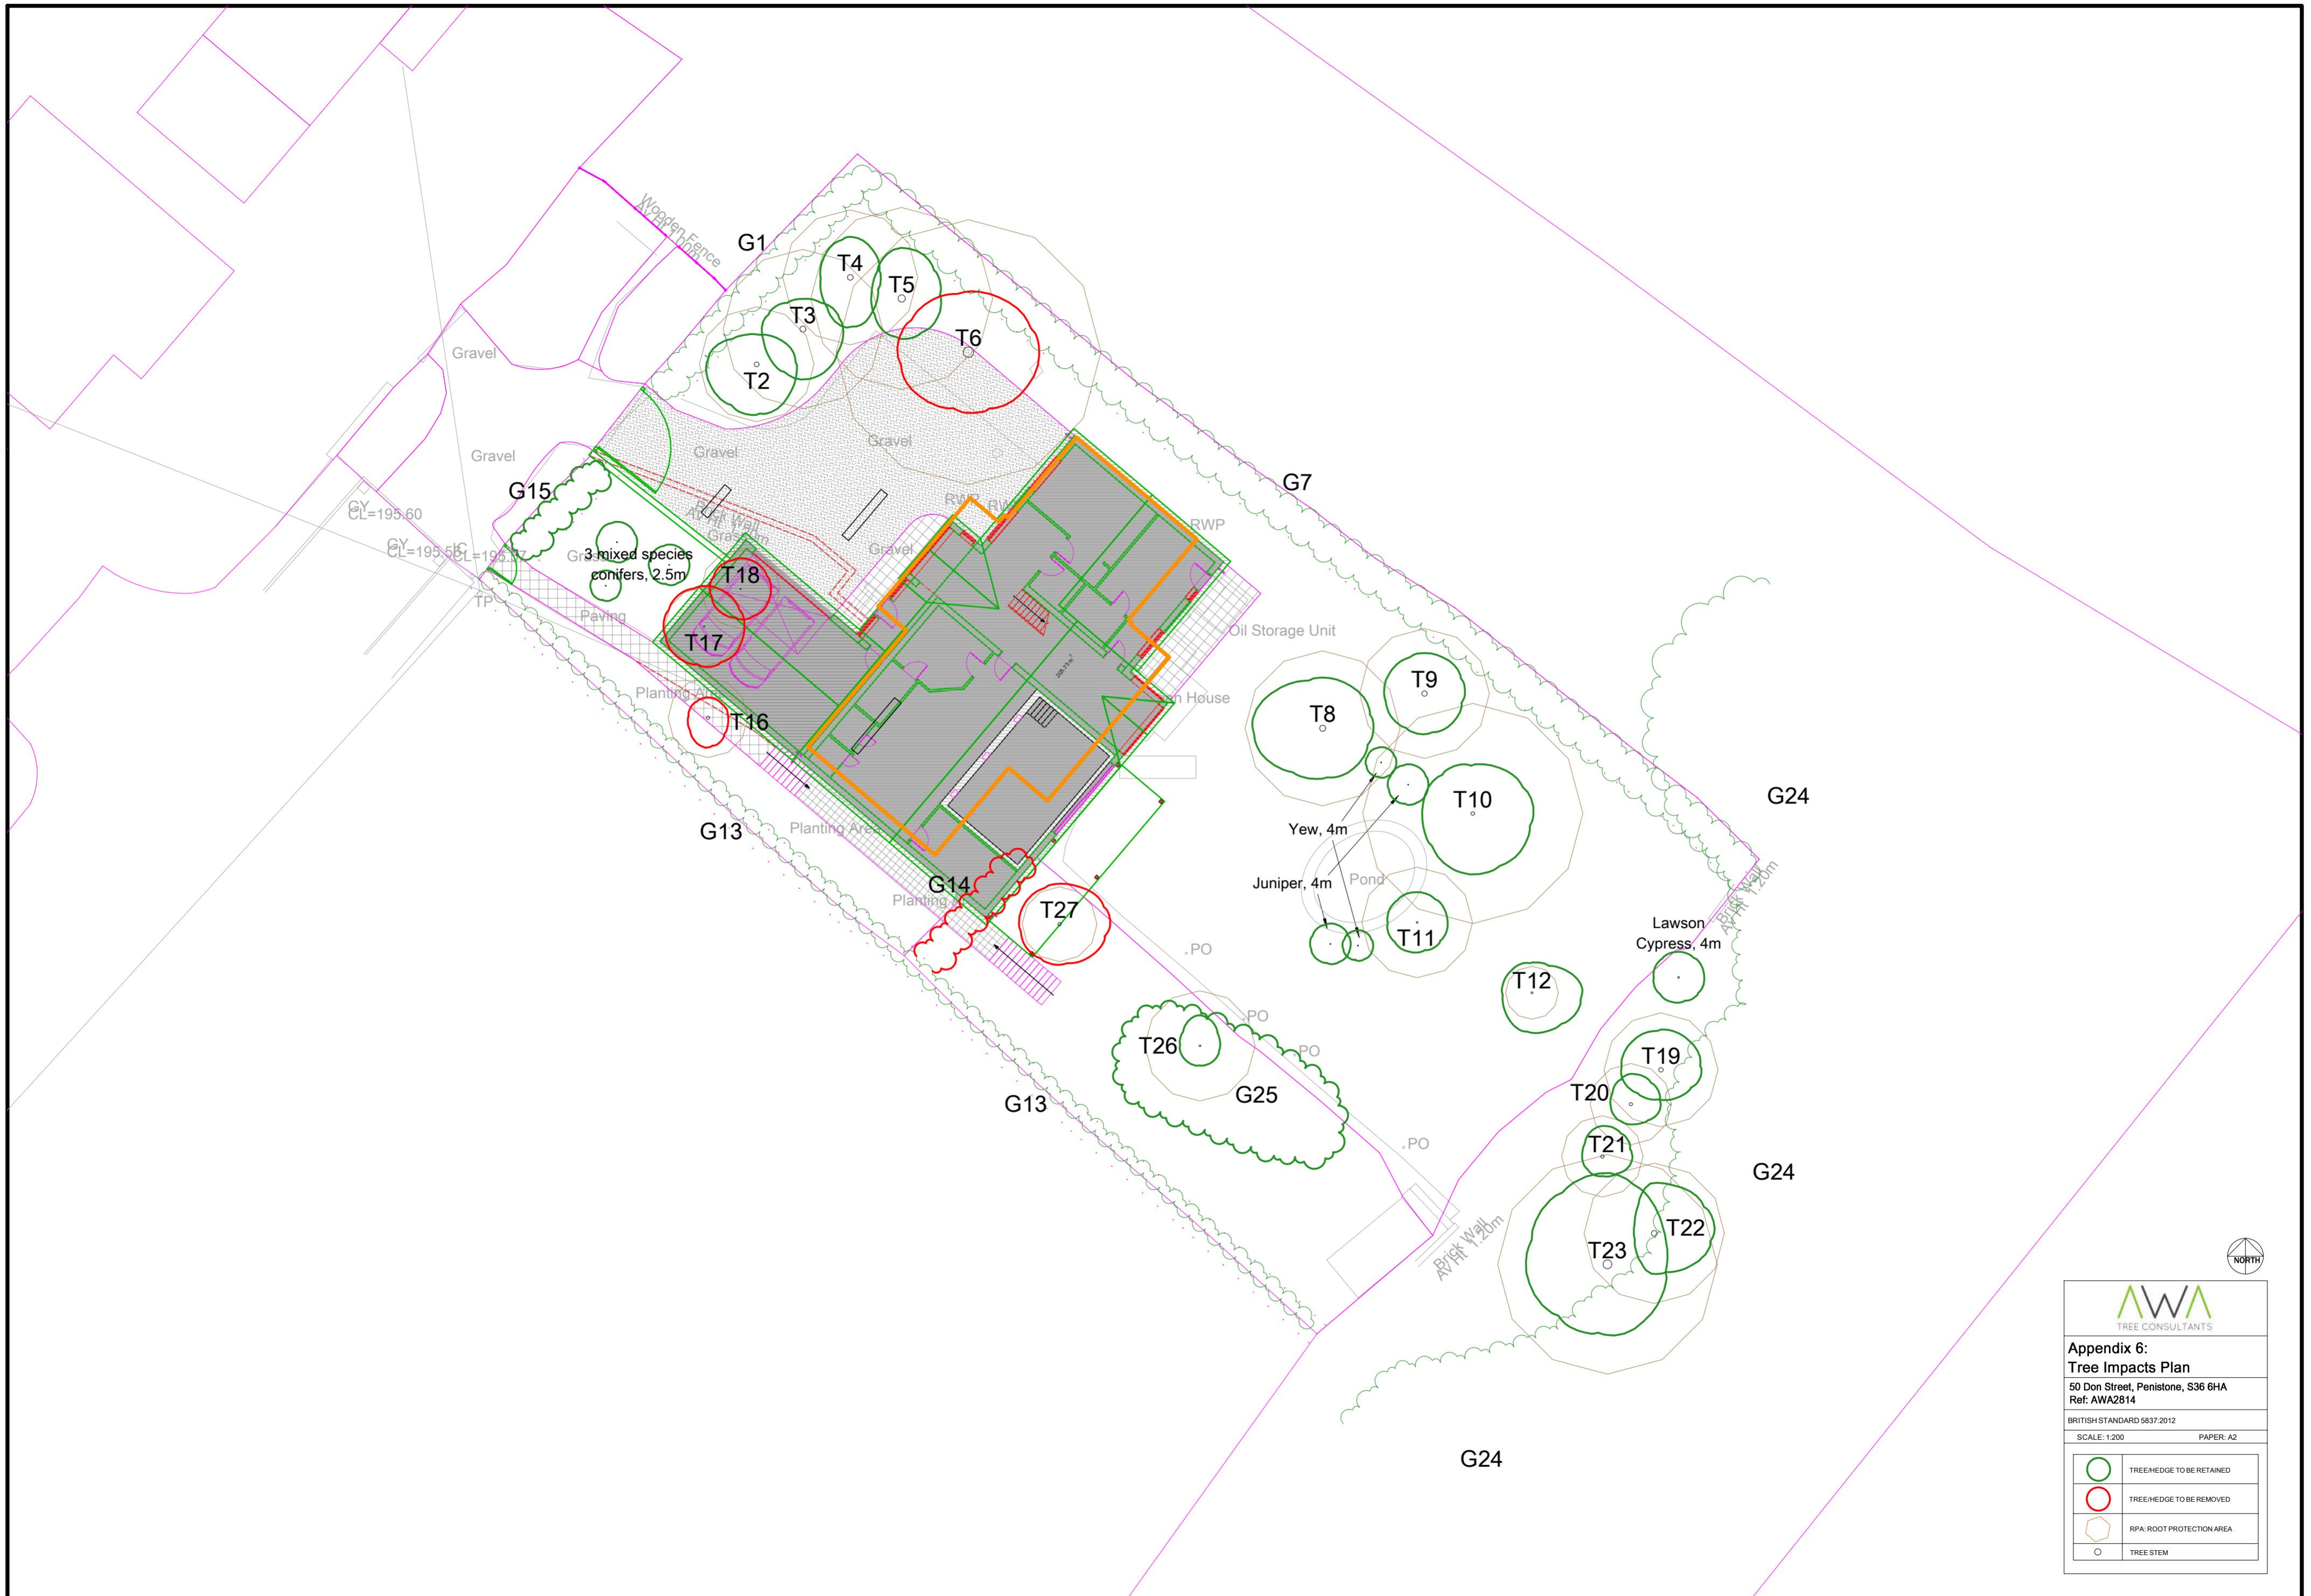
Appendix 6:
Tree Impacts Plan
50 Don Street, Penistone, S36 6HA
Ref: AWA2814

- 4.2.1 From assessing the new development proposals, 5 trees and 1 tree group will require removal as they are situated in the footprint of the structure or their retention and protection throughout the development is not suitable.
- 4.2.2 The trees that require removal are T6, G14, T16, T17, T18 and T27.
- 4.2.3 The trees that require removal are lower value, retention category 'C'. T16 and T27 are small fruit trees and T17 and T18 are Lawson Cypress, all of negligible value. G14 is a short section of Beech hedge within the site.
- 4.2.4 The loss of the Cedar, T6 will result in some minor loss of amenity value, although the tree has defects that limit its prospects in the longer term. The loss can largely be mitigated through the planting of more suitable tree species within the site once construction has been completed.

- 4.3.2 Potentially damaging activities are proposed in the vicinity of retained trees. The widening of the driveway encroaches into the RPA of T5. Construction within the RPA, can have negative impacts on tree roots. However, due to the low value of the tree it would be excessive to utilise a 'no dig' type construction method in this area. Provided that care is taken during construction and no excavation or compaction of the soil occurs beyond the footprint of the driveway within the RPA, the retained tree should readily tolerate the works provided care is taken during construction.

- 4.5.1 The retained trees will require protection by fencing in accordance with BS 5837: 2012, during the development phase.
- 4.5.2 If required by the Local Planning Authority, an associated Arboricultural Method Statement, detailing protective fencing specifications and construction methods close to the retained trees can be provided.
