# **ARBORICULTURAL REPORT**

### **to BS 5837:2012 at:**

***Bence Farm Court,  
Barnsley Road,  
Darton,  
Barnsley  
S75 5NT***

Reference: *AWA4596*

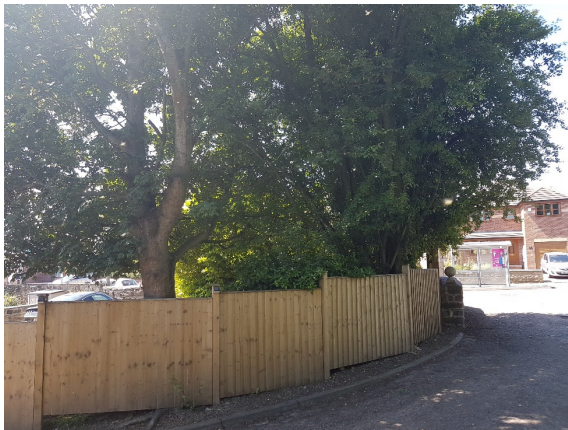
Photo 1: T1 and T2 from north

- 3.2.7 Managed Hawthorn and Beech hedge G3 provides some screening but is of low arboricultural value.
- 3.2.8 Plum T1 and Field Maple T2 are situated in an inaccessible adjacent garden and so were only given cursory inspections with measurements estimated and condition values indicative only.

| Tree Species | | | | Measurements | | | Crown (m) | | | | Tree Condition | | | | | | | Value | | Management | | |
|---|---|---|---|---|---|---|---|---|---|---|---|---|---|---|---|---|---|---|---|---|---|---|
| T1 | Plum | Prunus sp. | Early-mature | 11 | 8 | 120 | Yes | 1.5 | 2 | 3.5 | 3.5 | 3.5 | Limited access around base | Multiple stemmed at base. Vertical. Tight unions. Epicormic growths. Stubs. Old pruning wounds | Minor deadwood | Adjacent, no access. Overhanging access drive. Previously pruned over access drive. | Good | Good | 10 to 20 yrs | Low | C | No works required |
| T2 | Field Maple | Acer campestre | Semi-mature | 13 | 1 | 350 | Yes | 1.5 | 3 | 3.5 | 3 | 2.5 | Limited access around base | Single stemmed. Vertical. Epicormic growths | Minor deadwood | Adjacent, no access | Good | Good | >40 yrs | Moderate | C | No works required |

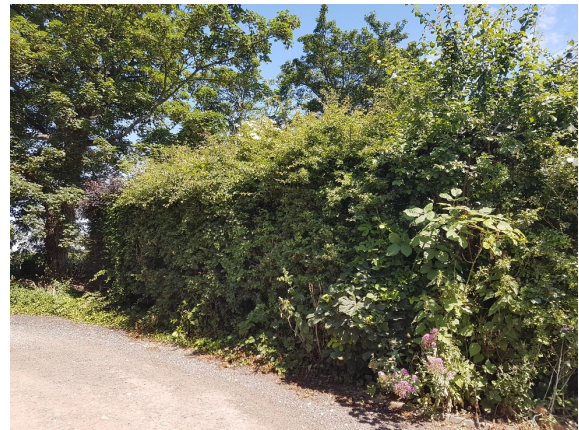
Photo 2: G3 from south west

| Tree Species | | | | Measurements | | | Crown (m) | | | | Tree Condition | | | | | | | Value | | Management | | |
|---|---|---|---|---|---|---|---|---|---|---|---|---|---|---|---|---|---|---|---|---|---|---|
| G3 | Hawthorn. Beech. | Crataegus sp. Fagus sp. | Semi-mature | 3.5 | 10 | 20 | No | 0.5 | See plan | | | | Managed hedge. Ivy covered. | | | | Good | Good | 20 to 40 yrs | Low | C | No works required |

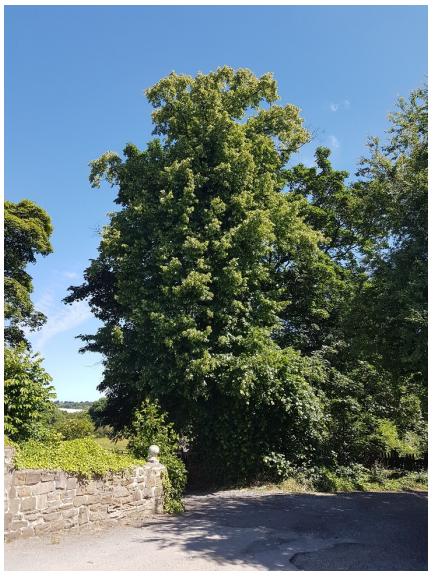
Photo 3: T4 from west

- 3.2.2 The highest value trees at the site are Lime T4 and Sycamore T5. These are large mature trees in good condition which are situated in prominent roadside positions and provide considerable amenity value to the site and the surrounding area. T4 appears to be situated in adjacent and was inaccessible and so was only given a cursory inspection with measurements estimated and condition values indicative only.

| Tree Species | | | | Measurements | | | Crown (m) | | | | Tree Condition | | | | | | | Value | | Management | | |
|---|---|---|---|---|---|---|---|---|---|---|---|---|---|---|---|---|---|---|---|---|---|---|
| T4 | Lime | Tilia x europaea | Mature | 19 | 1 | 650 | Yes | 3 | 5 | 4.5 | 4.5 | 3.5 | Limited access around base. Ivy covered | Single stemmed. Vertical. Epicormic growths. Ivy covered | Minor deadwood. Minor snapouts | Adjacent, no access. Situated on opposite side of fence. Very dense epicormic growths at base. Ivy covered. Ivy and epicormic growths prevented detailed inspection. | Good | Good | >40 yrs | High | A | No works required |

- 4.3.4 The proposed new bin store within the RPAs of retained trees T4 and T5 will have little negative impact on the retained trees provided care is taken during its installation, with no excavations or significant increases in ground levels within the RPAs of the retained trees.

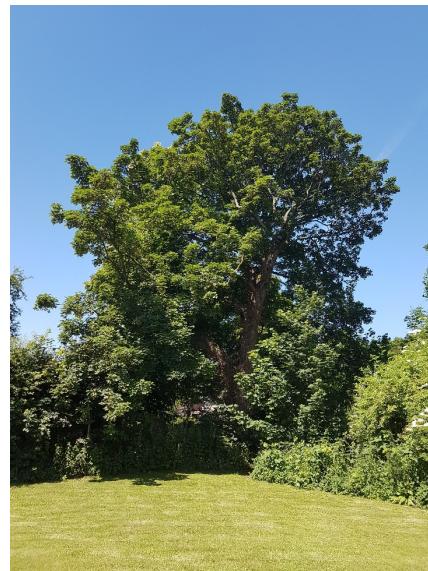
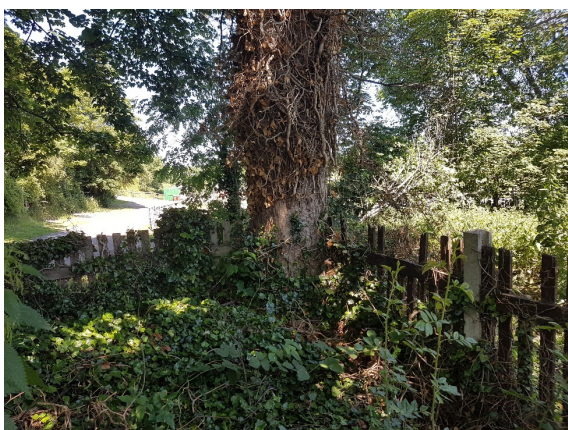
Photo 4: T5 from east

Photo 5: Stem of T5 from south

| Tree Species | | | | Measurements | | | Crown (m) | | | | Tree Condition | | | | | | | Value | | Management | | |
|---|---|---|---|---|---|---|---|---|---|---|---|---|---|---|---|---|---|---|---|---|---|---|
| T5 | Sycamore | Acer pseudoplatanus | Mature | 22 | 1 | 780 | No | 1.5 | 8.5 | 9.5 | 8 | 6.5 | No visual defects. Ivy covered | Single stemmed. Vertical. Dead Ivy covered | Minor deadwood | Dense Ivy covering ground and base of stem. Ivy prevented detailed inspection. Situated at junction of 3 fences. Dead Ivy covering stem. | Good | Good | >40 yrs | High | A | No works required |

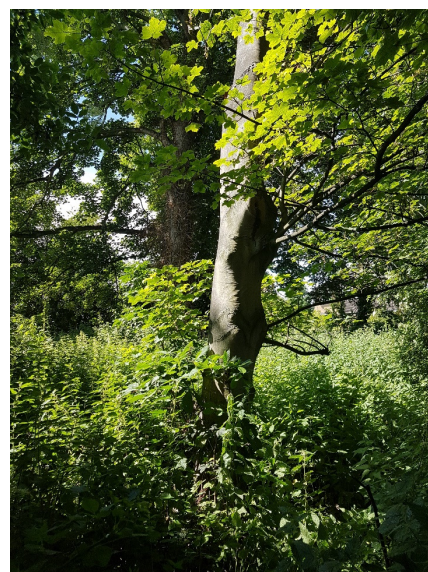
Photo 6: T6 from north east

- 3.2.4 Sycamores T6 to T9 are situated to the centre of the site. T6, T7 and T8 are relatively large early mature trees, while T9 is a small insignificant young tree. T6, T7 and T8 have large long bark wounds to their stems; there is little visible decay to the stem of T7, but there is decay to the stem of T6, and significant and extensive decay to the stem of T8.

| Tree ID | Tree Species | | Maturity | Measurements | | | | Crown (m) | | | | Tree Condition | | | | | | | | Value | | Management |
|---|---|---|---|---|---|---|---|---|---|---|---|---|---|---|---|---|---|---|---|---|---|---|
| T6 | Sycamore | <i>Acer pseudoplatanus</i> | Early-mature | 18 | 1 | 450 | No | 1.5 | 4.5 | 3.5 | 1 | 4.5 | Increase in soil level | Single stemmed. Slight lean north west. Bark damage. Minor decay. | Minor deadwood | Large bark wound to northern side of stem from 2.5m to 6m with some decay. Limited stem flare at base, likely previous increase in ground level around base. | Fair | Fair | 20 to 40 yrs | Moderate | C | No works required |

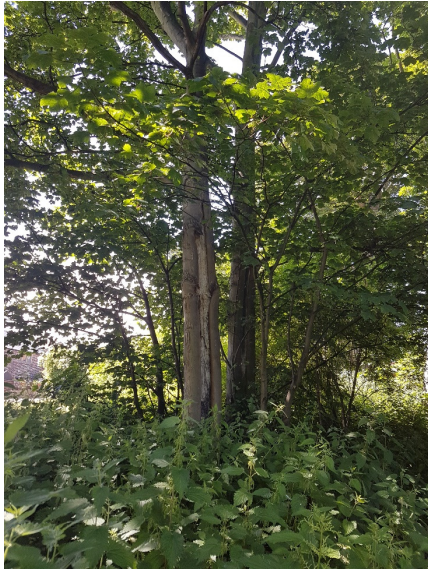
Photo 7: T7 and T8 from north east

| Tree ID | Tree Species | | Maturity | Measurements | | | | Crown (m) | | | | Tree Condition | | | | | | | | Value | | Management |
|---|---|---|---|---|---|---|---|---|---|---|---|---|---|---|---|---|---|---|---|---|---|---|
| T7 | Sycamore | <i>Acer pseudoplatanus</i> | Early-mature | 17 | 1 | 500 | No | 3 | 3 | 7 | 4 | 4.5 | No visual defects | Single stemmed. Vertical. Bark damage | Minor deadwood. Minor snapouts. Bark damage | Long bark wound to northern side of stem from 1m to 5m but with no visible decay | Good | Fair | 20 to 40 yrs | Moderate | C | No works required |
| T8 | Sycamore | <i>Acer pseudoplatanus</i> | Early-mature | 17 | 1 | 450 | No | 3 | 3.5 | 6.5 | 6.5 | 1 | No visual defects | Single stemmed. Vertical. Bark damage. Major cavity. Moderate decay | Minor deadwood | Large long bark wound to northern side of stem from base to 3.5m with significant and extensive decay | Fair | Poor | 10 to 20 yrs | Moderate | U | No works required |

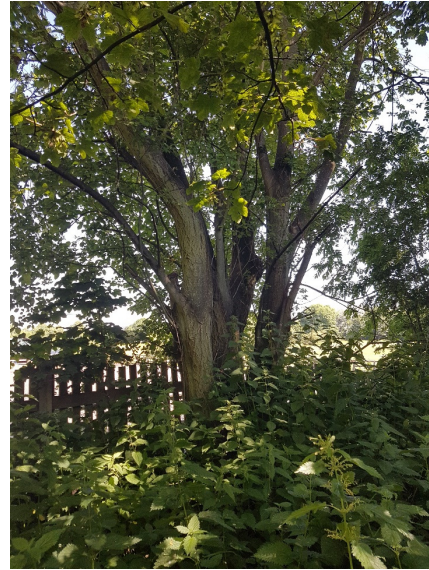
Photo 8: T10 from south

- 3.2.5 Goat Willow T10 is situated at the site's northern boundary fence and significantly overhangs the adjacent access track to the north. The tree has several significant included bark unions to its stems and numerous pruning wounds and stubs to its northern crown.

| Tree ID | Tree Species | | Maturity | Measurements | | | | Crown (m) | | | | Tree Condition | | | | | | | | Value | | Management |
|---|---|---|---|---|---|---|---|---|---|---|---|---|---|---|---|---|---|---|---|---|---|---|
| T10 | Goat Willow | <i>Salix caprea</i> | Semi-mature | 13 | 4 | 280, 310, 300, 300 | No | 1.5 | 6 | 5 | 1.5 | 3 | No visual defects | Multiple stemmed at base. Slight lean north. Tight unions. Old pruning wounds. Stubs. Partially included bark. Bark damage | Minor deadwood | Numerous tight unions and included bark. Previously pruned from north, leaving stubs. Crown significantly overhangs access track to north. | Good | Fair | 20 to 40 yrs | Low | C | No works required |

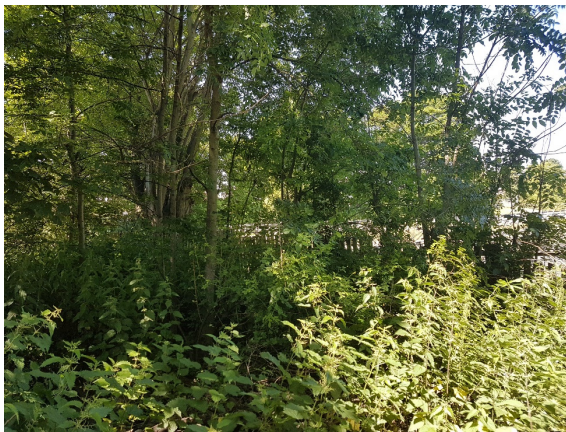
Photo 9: G11 from south east

- 3.2.6 G11 and G12 form boundary groups of young to semi mature Ash and Sycamore. The Ash within the groups have symptoms of the fungal disease Ash Dieback and likely have limited future prospects regardless of development at the site; once a tree is infected, the disease is usually fatal, either directly or indirectly.

| Tree Species | | | | Measurements | | | | Crown (m) | | | | Tree Condition | | | | | | | Value | | Management | |
|---|---|---|---|---|---|---|---|---|---|---|---|---|---|---|---|---|---|---|---|---|---|---|
| G11 | Ash. Sycamore. | Fraxinus sp.<br>Acer sp. | Young | 10 | 10 | 70 | No | 1.5 | See plan | | | | Boundary group of young to semi mature Ash and Sycamore. Ash have symptoms of Ash Dieback. Crowns slightly overhang access track to north. | | | | Poor | Fair | 10 to 20 yrs | Low | C | No works required |

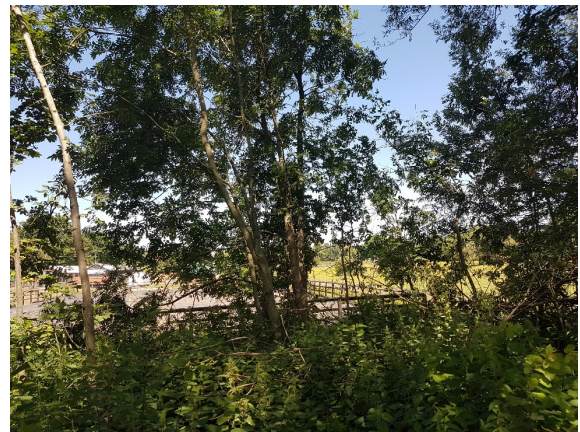
Photo 10: G12 from south

| Tree Species | | | | Measurements | | | | Crown (m) | | | | Tree Condition | | | | | | | Value | | Management | |
|---|---|---|---|---|---|---|---|---|---|---|---|---|---|---|---|---|---|---|---|---|---|---|
| G12 | Ash. Sycamore. | Fraxinus sp.<br>Acer sp. | Young | 10 | 10 | 90 | No | 1.5 | See plan | | | | Boundary group of young to semi mature Ash and Sycamore. Ash have symptoms of Ash Dieback. Crowns slightly overhang access track to north. | | | | Poor | Fair | 10 to 20 yrs | Low | C | Removal required to facilitate development |

- 4.2.1 From assessing the new development proposals, 1 tree group will require removal as it is situated in the footprint of the development or its retention and protection throughout the development is not suitable.
- 4.2.2 The tree group that requires removal to facilitate the proposed development is G12.
- 4.2.3 G12 is low value retention category 'C' and its removal will have little negative impact. The Ash within G12 have symptoms of the fungal disease Ash Dieback and likely have limited future prospects regardless of development at the site.
- 4.2.4 New trees are to be planted as part of the proposed new development which will easily mitigate for the required removal of G12 and will improve the site's tree cover in the longer term.
- 4.2.5 Pruning works are recommended to Willow T13 regardless of the development, heavily reducing the tree to around 4m from ground level.

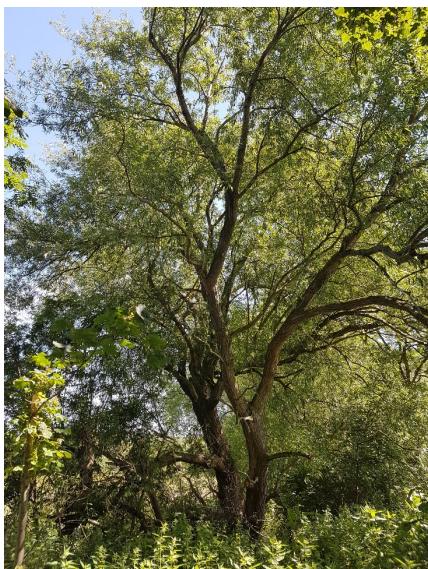
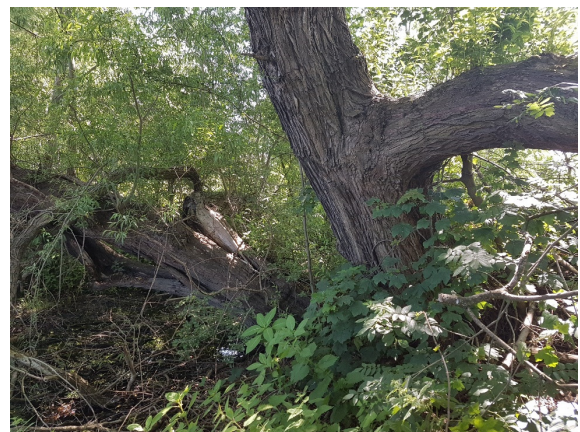
- 3.2.3 Crack Willow T13 is situated at the site's northern corner, on the edge of a stream. The tree appears to have been previously twin stemmed, but a large north eastern stem has previously split and failed. The tree is in poor structural condition, with several large included bark unions and numerous significant cavities with decay to its stems and fungal brackets and several significant snapouts in its crown. It is recommended to undertake pruning works to T13 regardless of development at the site, heavily reducing the tree to around 4m from ground level.

Photo 11: T13 from south west

Photo 12: Stem of T13 from west

| Tree Species | | | | Measurements | | | | Crown (m) | | | | Tree Condition | | | | | | | Value | | Management | |
|---|---|---|---|---|---|---|---|---|---|---|---|---|---|---|---|---|---|---|---|---|---|---|
| T13 | Crack Willow | Salix fragilis | Mature | 15 | 1 | 1000 | No | 0.5 | 11 | 6 | 10 | 12 | Soil erosion. Exposed roots | Single stemmed. Slight lean north. Bark damage. Moderate cavities. Moderate decay. Split stem. Failed stem. Old pruning wounds | Minor deadwood. Moderate deadwood. Minor snapouts. Moderate snapouts. Major snapouts. Fungal brackets | Situated on edge of stream. Previously twin stemmed, but large north eastern stem has previously split and failed. Numerous significant cavities with decay to stem and crown. Fungal brackets to crown. Numerous significant snapouts from crown. Very large western scaffold limb at 1.5m extends significantly to west. | Fair | Poor | 10 to 20 yrs | Moderate | U | Pruning works recommended regardless of development - Heavily reduce to around 4m from ground level |

Pruning works recommended to T13 regardless of development  
Heavily reduce to around 4m from ground level
