LYONS CMC
COAL MINING & GEOTECHNICAL
CONSULTANCY

Date: 3rd February 2026
Your ref: (S63 8NF).
My Ref: CMRA 00448

COAL MINING RISK ASSESSMENT (CMRA)- FOR PROPOSED RESIDENTIAL DEVELOPMENT AT LAND ADJACENT 2 CEMETARY ROAD, BOLTON UPON DEARNE, ROTHERHAM S63 8NF

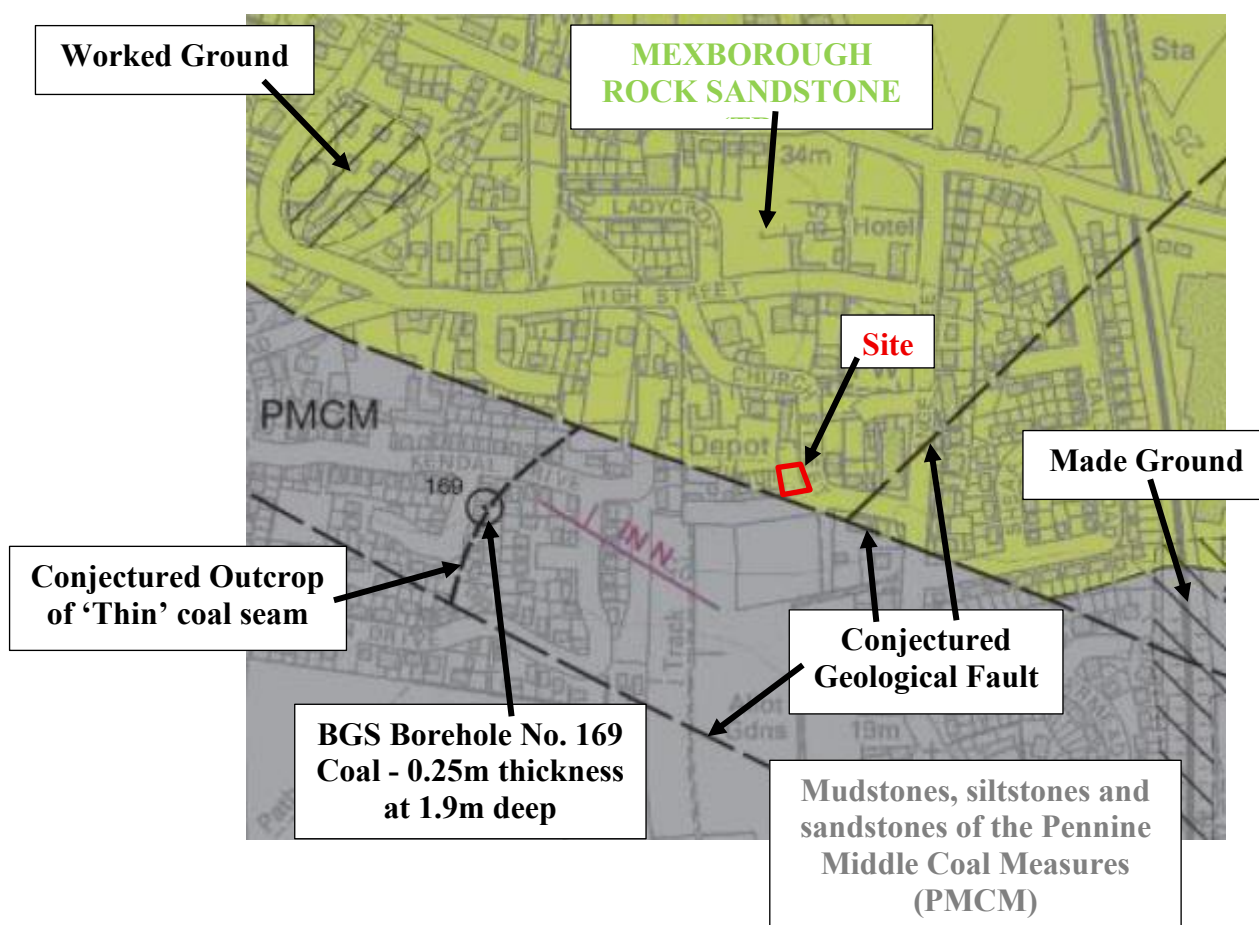
Records indicate the site to be located on the Mexborough Rock Sandstone of the Pennine Middle Coal Measure series from the Carboniferous formation. Mudstones and siltstones may also be encountered should part of the site be located on the south-western side of the conjectured fault along that boundary of the site as detailed below. No superficial deposits are indicated in this vicinity. The strata is shown to dip to the east-north-east at a rate of around 1 in 19 (3°) in this vicinity. A summary of the surface geology is illustrated on the image below which is an extract from the BGS Sheet SE40SE 2005 Edition:

Geological faulting is conjectured to pass close to the south-western corner of the site from west-north-west to east-south-east as indicated above (*it should be noted that as this is based on 'conjecture' the actual position may differ, in some case quite significantly*) which throws the strata down to the north-east; along with another two conjectured faults some 30m to the south-east and 180m south as shown above. Although no fissuring of sandstone bedrock is known in this vicinity, there will be some potential for such natural features of which there are no records that may have been 'opened out' to some degree by the past deep coal mining in the area.

As outlined on the extract image above, on the southern side of the fault a thin coal seam is conjectured to outcrop some 150m away to the west of the site. BGS borehole no. 169 indicates this coal seam as being of 0.25m thickness and the seam will dip beneath the land eastwards, being beneath the site (only on the southern side of the fault however) at around 8m deep.

BGS records show no made ground beneath the site; the closest is illustrated in the BGS extract image above over 200m away to the east associated with the railway embankment.

- 3) A watching brief should be employed during future ground/foundation works for any signs of the geological fault (broken/fractured/ 'stepped' bedrock) and/or any opened-out fissures within sandstone bedrock. If encountered then foundations may need to be strengthened/redesigned as necessary (to the advice of a suitably qualified structural engineer) and prior ground remediation/treatment may be required in severe instances.

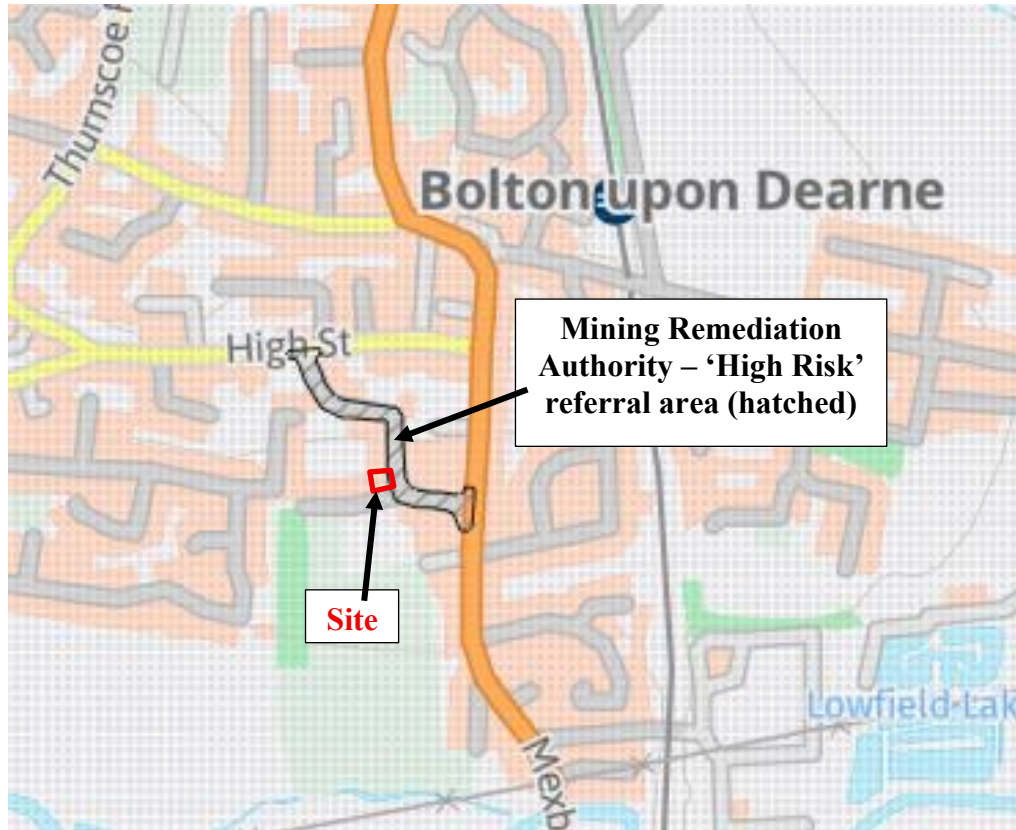
As can be seen on the image below, which forms an extract from the Mining Remediation Authorities interactive viewer information, the site is located partially on a 'high risk' area. As far as we are aware, this is due to fugitive ground gasses having been encountered in the past that may have been linked to mine gas emissions. In this case it would appear that the occurrence would have been during the time of highway construction/resurfacing of Church Street. Given the geological position (porous sandstone and geological faulting) there will be some tangible

‘pathways’ for such mine gasses to migrate from deep coal workings, particularly as flooding of underground workings (which progressively takes place over many years after cessation of mining) displaces any associated pockets of gas, generally upwards, through pathways such as: other mining voids, faulted/fissured/fractured strata, old mine shafts/adits, made ground/backfill/superficial material etc.

- 4) In terms of the fugitive mine/ground gas risks, and considering the overlaying sandstone deposits (which may be faulted/fissured) it would be prudent, in the absence of any further gas monitoring (*note informative no. 3 in appendix 2*), to include gas protection measures (such as a methane membrane for example) within future foundation designs; which could also protect from radon issues if required. Of course, should a future gas monitoring programme be undertaken (by an appropriately qualified geotechnical engineer) then it may be concluded that no such precautions are necessary.
