**BEN BANK ROAD, SILKSTONE COMMON****ARBORICULTURAL IMPACT ASSESSMENT AND ARBORICULTURAL  
METHOD STATEMENT**

March 2025

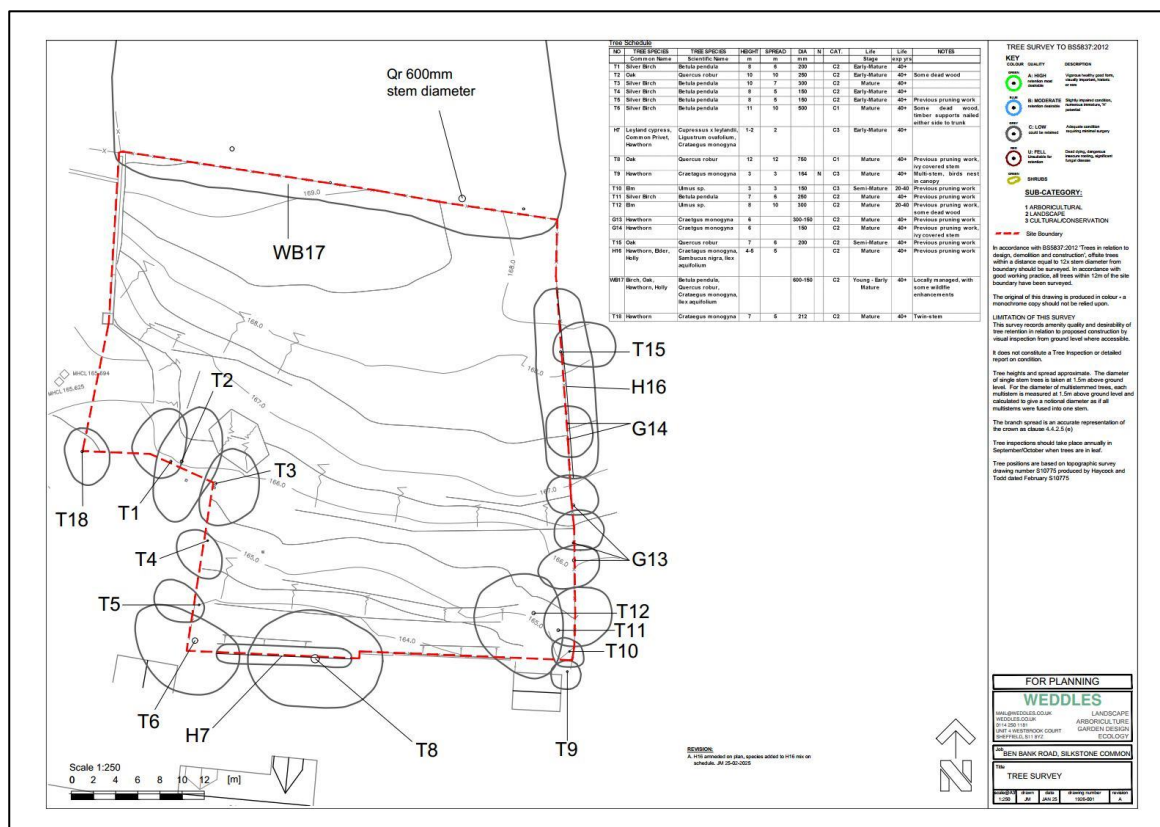
Figure 3: Tree Survey 1926-001

The tree survey includes an assessment of life stage, life expectancy, general observations on condition and categorisation in accordance with BS 5837:2012 'Trees in Relation to Design, Demolition and Construction – Recommendations' Section 4.5 and Table 1. Specific This information is presented in the tree schedule on drawing 1926-001.

The survey included 12no. trees and 2no. groups, 2no. hedges and a woodland block.

- All trees and hedges on site that were survey are rated as category C.
- Many of the trees have undergone some pruning work, and T6 has been damaged by timber supports nailed directly into the trunk
- The woodland block neighbouring the northern site boundary

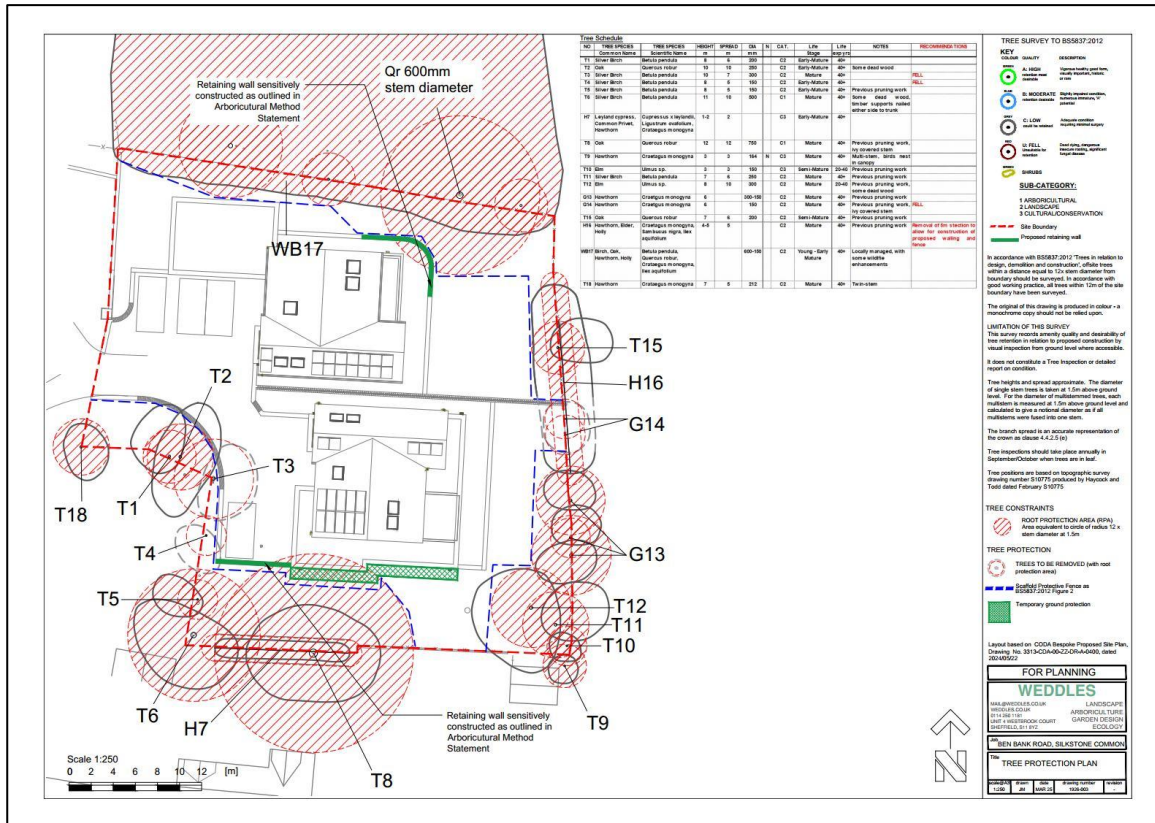
Tree Protection Plan – 1926-003

4 No. trees (T3, T4 and G14) and a 5m section of H16 will be removed as part of the development. This will be done to allow the construction of proposed walling that will separate the two plots.

The proposed development also has the potential to impact the RPA of T8 in the south and the RPA of woodland block to the north. To reduce this impact temporary ground protection and the sensitive construction of external works is recommended and outlined in the method section.

The removal of G14 and 5m section of H16 will be mitigated through the planting of new hedgerow and new tree planting.

- Construction of the wall will only commence once the scaffold protection fence has been erected and positioned as shown.
- Excavation of soil will be undertaken with care from the north side of the tree protection fencing when working within the RPA T8, and from the southern side of the fencing when working with the RPA of the WB17 (please refer to drawing 1926-003).
