# **ARBORICULTURAL REPORT & Impact Assessment to BS 5837:2012 at:**

***17 Willowbrook Close,  
Darton,  
Barnsley,  
S75 5PX***

Date: *June 2023*

Reference: AWA5503

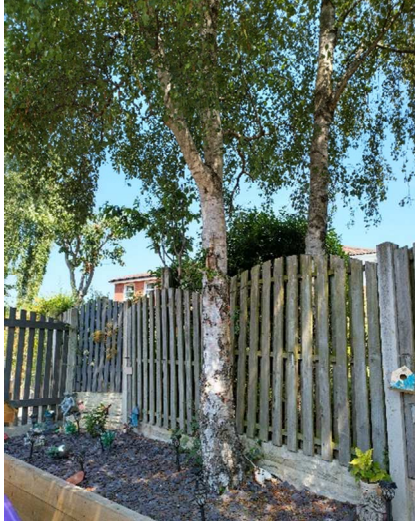
- 3.2.6 The ground level within the site, to the south of the Birch T1 to T8, is lower than the base of the tree stems, by up to a depth of 1.5 m. The ground level changes are within 0.5 - 1 m of the stems. It is unclear when the ground level changes occurred, yet there is the possibility of associated root severance and damage. While most of the Birch had crowns of fair or good vigour, root damage and loss can cause the decline of the tree condition in the long term, and root severance close to the stem can lead to instability. Due to this, the condition of these trees should be monitored in the future.

Photo 1: T1 from south

| Tree Species | | | | Measurements | | | Crown (m) | | | | Tree Condition | | | | | | | | Value | | Management | | |
|---|---|---|---|---|---|---|---|---|---|---|---|---|---|---|---|---|---|---|---|---|---|---|---|
| | T1 | Silver Birch | Betula pendula | Semi-mature | 8 | 1 | 240 | No | 2 | 3 | 2 | 4 | 3.5 | Ground level lower to south of stem | Single stemmed. Vertical. Pruning wounds - healing poorly with some decay. Stubs. Minor cavities | Minor deadwood. Overhanging adjacent land | In raised area. Retaining wall 0.5 m to south. | Good | Fair | 10 to 20 yrs | Moderate | C | No works required to facilitate development |

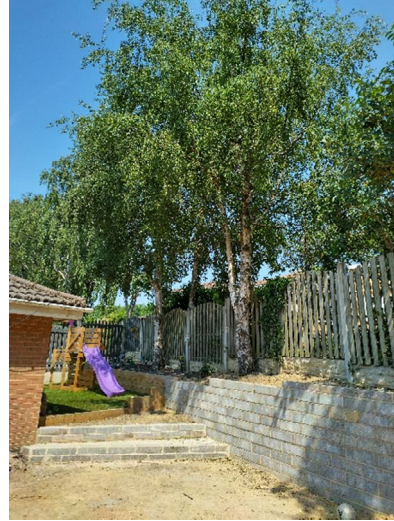
Photo 2: T1 and T4 from south

| Tree Species | | | | Measurements | | | Crown (m) | | | | Tree Condition | | | | | | | | Value | | Management | | |
|---|---|---|---|---|---|---|---|---|---|---|---|---|---|---|---|---|---|---|---|---|---|---|---|
| | T4 | Silver Birch | Betula pendula | Semi-mature | 10 | 1 | 290 | No | 2 | 4.5 | 4 | 3.5 | 3.5 | Ground level lower to south of stem | Single stemmed. Vertical. Old pruning wounds. Stubs. Bark damage. Tight union. Twin stemmed at 2m. | Overhanging adjacent land. Normal. Minor deadwood | Retaining wall 0.5 m to south. Possible root damage. Bark damage to lower western stem. Codominant stems at 1.8 m | Fair | Fair | 10 to 20 yrs | Moderate | C | No works required to facilitate development |

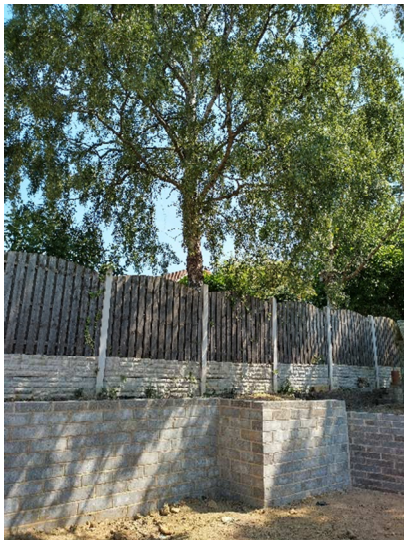
Photo 3: T7 and T8 from west.

- 4.3.2 Potentially damaging activities are proposed in the vicinity of retained trees. The new development encroaches close to and into the edge of the RPA of T7. Construction within the RPA can have negative impacts on tree roots. However, the encroachment is very minor, and due to ground level changes, the detailed RPA for these trees is likely to be an exaggerated representation of the trees actual rooting area. As such, it is unlikely that significant roots will be within these areas and the retained tree should remain largely unaffected by the works, provided care is taken during construction.

| Tree Species | | | | Measurements | | | Crown (m) | | | | Tree Condition | | | | | | | Value | | Management | | |
|---|---|---|---|---|---|---|---|---|---|---|---|---|---|---|---|---|---|---|---|---|---|---|
| T7 | Silver Birch | Betula pendula | Semi-mature | 12 | 1 | 340 | Yes | 1.5 | 4 | 3.5 | 4 | 4.5 | Limited access around base. Ground level lower to south of stem | Single stemmed. Vertical. Old pruning wounds. Stubs. | Normal | Adjacent Birch. Limited access prevented detailed inspection. Ground level lower immediately to south west within 0.5 m of stem, to a depth of 1.5m. | Fair | Fair | 10 to 20 yrs | Moderate | C | No works required to facilitate development |
| T8 | Silver Birch | Betula pendula | Semi-mature | 10 | 1 | 300 | Yes | 2 | 3.5 | 3.5 | 3.5 | 3 | Limited access around base. Ground level lower to south of stem | Single stemmed. Vertical. Old pruning wounds. Stubs. | Sparse. Low vigour. Old pruning wounds. Minor dieback. | Adjacent. Limited access prevented detailed inspection. | Fair | Fair | 10 to 20 yrs | Moderate | C | No works required to facilitate development |

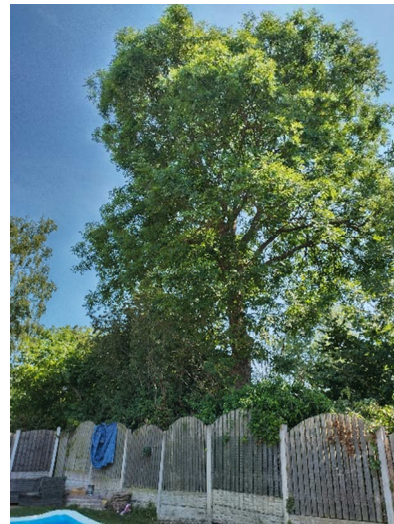
- 3.2.7 G9 is a linear boundary group of semi-mature Hazel and Hawthorn, providing good habitat and screening from adjacent properties.
- 3.2.8 A mature Ash, T10, is situated to the east of the site, beyond the boundary fence. This tree is prominent throughout the site and surrounding area and provides a good level of amenity value. This tree is not currently showing any sign of Chalara or Ash Dieback Disease. However, many Ash trees in the wider region are being impacted this, and once a tree is infected, the disease is usually fatal, either directly or indirectly. While this tree may continue to provide landscape and wildlife benefits for some time, its long-term prospects are likely to be limited as a result of Ash dieback.

Photo 4: T10 from southwest

| Tree Species | | | | Measurements | | | Crown (m) | | | | Tree Condition | | | | | | | Value | | Management | | |
|---|---|---|---|---|---|---|---|---|---|---|---|---|---|---|---|---|---|---|---|---|---|---|
| T10 | Ash | Fraxinus excelsior | Mature | 18 | 1 | 600 | Yes | 3.5 | 5.5 | 6.5 | 6.5 | 5.5 | Limited access around base. | Single stemmed. Vertical. Old pruning wounds occluded well. Stubs. | Minor deadwood. Minor dieback. | Adjacent. Limited access prevented detailed inspection. Healthy crown no sign of Ash Die Back. Small lower branches on north western side cut back to boundary. | Good | Good | 20 to 40 yrs | Moderate | B | No works required to facilitate development |
