# St Barnabas Hall, Barnsley

## Bat Survey Report

7<sup>th</sup> June 2024

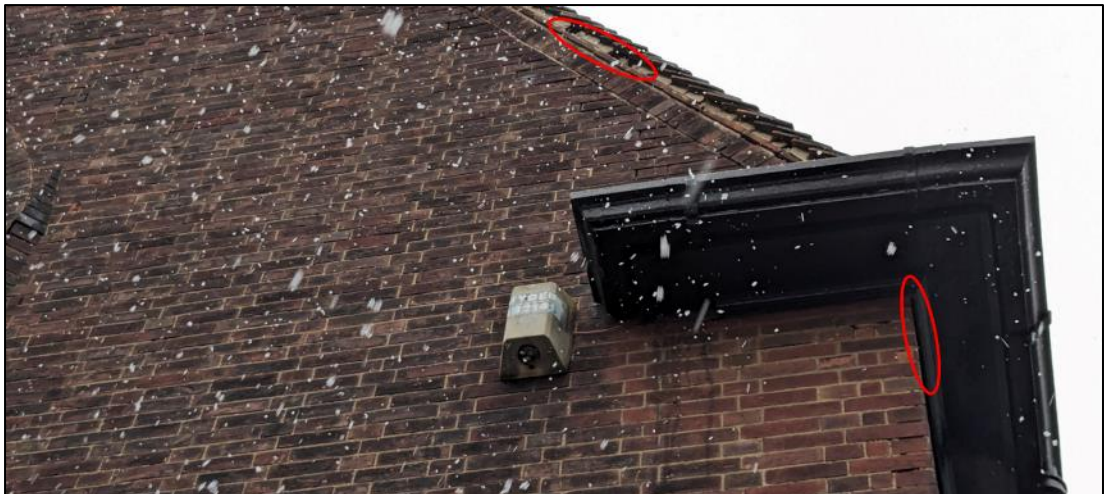
- Gaps in verge mortar, allowing potential access beneath roof covering (Plate 6).
- A Gap present between much of the base of the wooden soffits and the adjacent brickwork (Plate 6).
- Occasional slipped and lifted tiles associated with the roof covering.

**Plate 6. Gaps in verge mortar and between base of soffit and wall on B1 (church)**

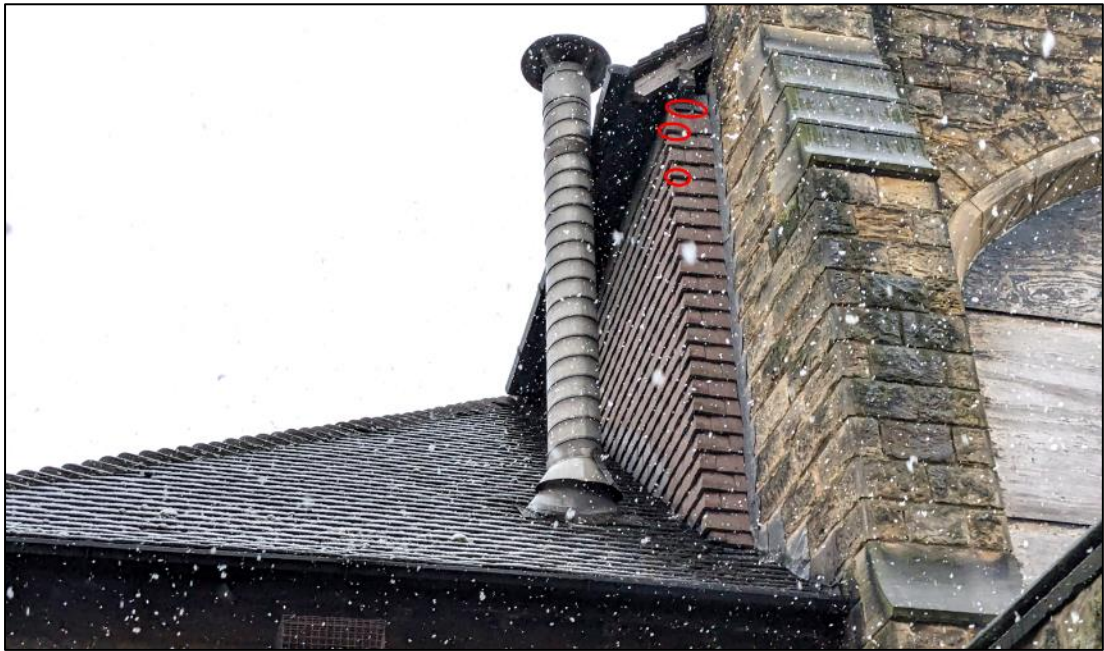
- Gaps around the edge of some hanging tiles and associated with flashing above hanging tiles (Plate 7).
- Open joints in masonry on southwest gable.
- Access into the roof space via wood louvre vents in gables.
- Access behind wood shuttering on windows, via gaps between shutters and glazing.
- Access to wall tops via gaps at eaves.
- Occasional broken slates on roof pitches and gaps beneath hip tiles.

**Plate 7. Crevices associated with hanging tiles on B2 (church hall)**

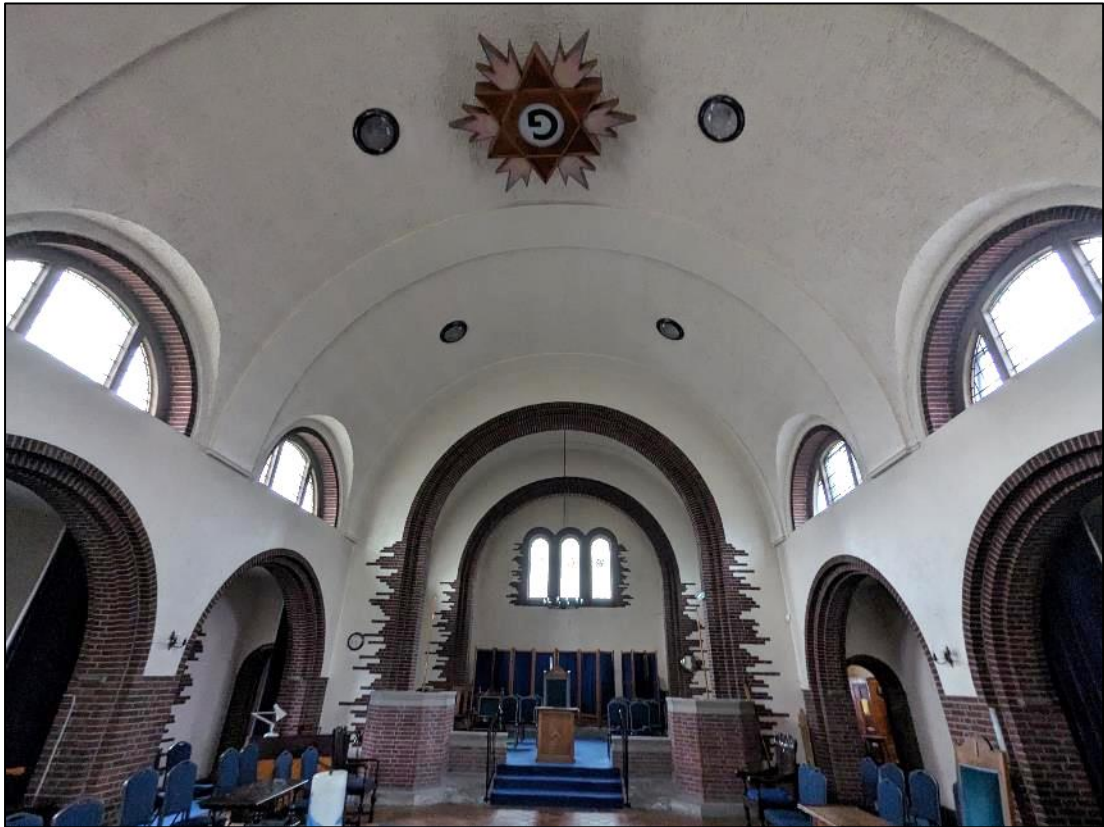
- 5.2.7 Building 1 (church) had a curved vaulted ceiling (Plate 8). A roof void would have been present above this ceiling, however, no access point exists into this space.

**Plate 8. Interior of B1 (church), showing curved ceiling, lacking any access into small void above**

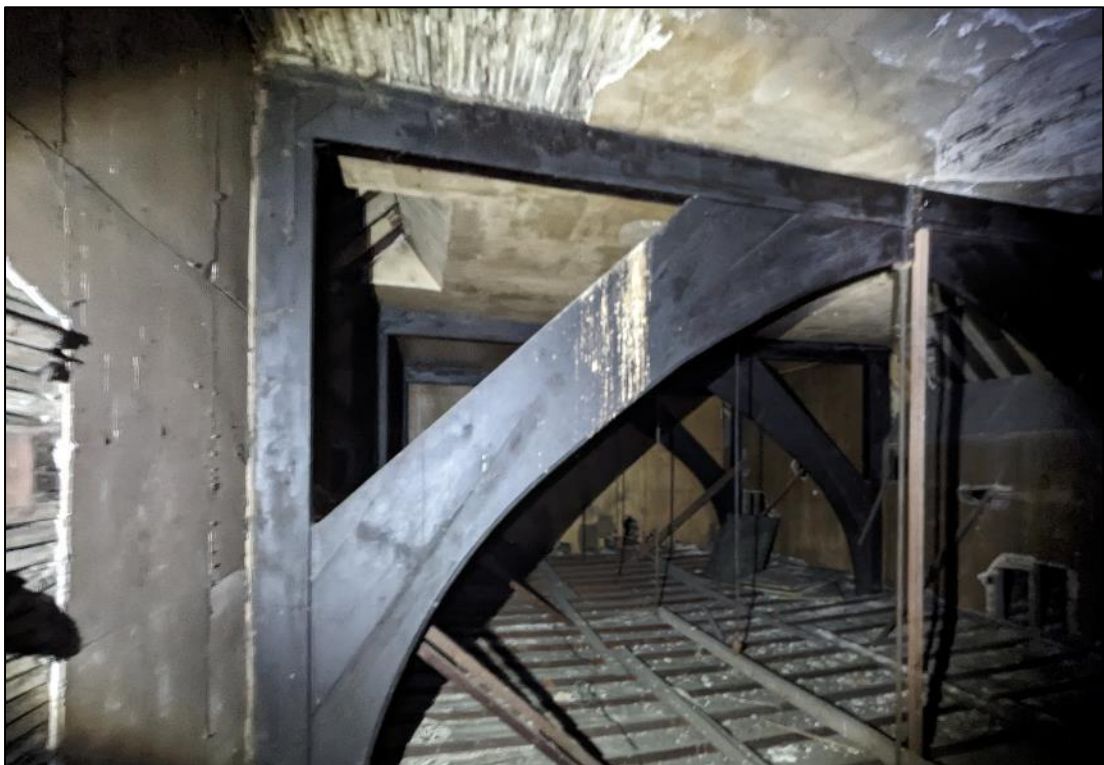
- 5.2.8 Building 2 had a suspended ceiling at a height of c.5m, above which was a c.4m high void between an original ceiling and the suspended ceiling (Plate 9). Within this void it could be seen that the roof was lined with hessian backed Type 1F bituminous felt and was suspended on broad timber trusses, a ridge beam, purlins, rafters and battens. No insulation was present on the ceiling with this void being dusty. No signs of bats were recorded from any location, including between glazing and wood shuttering on the gable windows (Plate 10). A smaller roof void above the original ceiling could only be glimpsed through the occasional collapsed section of this ceiling.

**Plate 9. Void between false ceiling and original ceiling in B2 (church hall)**

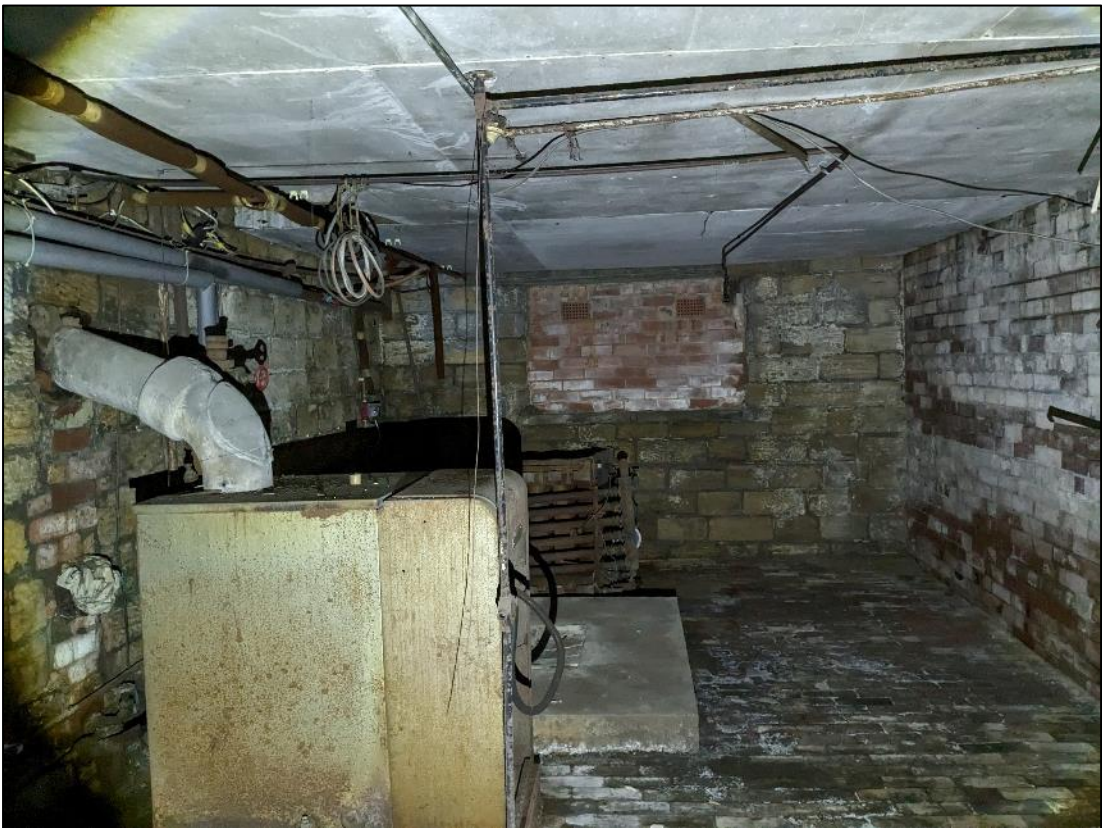
- 5.2.9 A stone-walled cellar was also present in B2 (Plate 11). No potential bat access points into this cellar or signs of bat presence were however noted. Overall, the cellar was considered to be inaccessible to bats.

**Plate 11. Cellar within B2**

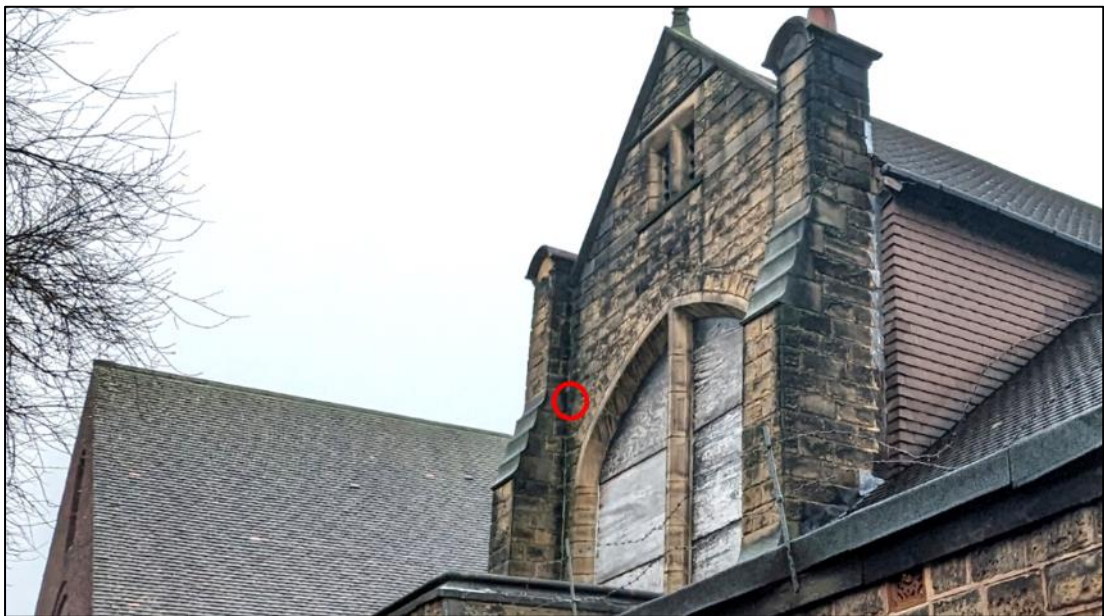
- 5.2.13 At 21:14 (26 minutes after sunset) a single common pipistrelle was recorded emerging from an open joint in masonry on the southwest gable of the former church hall (see Plate 12 and video clip: <https://youtu.be/xiC4w3xXGq4> )

### **Plate 12. Common pipistrelle day roost location**

- 6.1.1 One of the surveyed buildings (B2 - the former church hall) supported a single common pipistrelle day roost. This roost was considered to be of low conservation value (Mitchell-Jones, 2004), and of no more than site level importance to the resident common pipistrelle population (Reason & Wray, 2023). Maternity roosts appear to be absent from the surveyed buildings.

- 6.3.2 The roost location is within the solid stone southwest gable of B2 (the former church hall)(Plate 12). It may be feasible to retain this feature during the re-development. If there are concerns about water ingress into the walls, these could be mediated through one of two measures. A small horizontal lip of flashing could be pointed into a joint above the roost, to re-direct water running down the wall away from the roost, and/or mortar could be used to create a slope at the bottom of the (crevice) roost, in order that any water entering the joints runs back out (Plate 13).

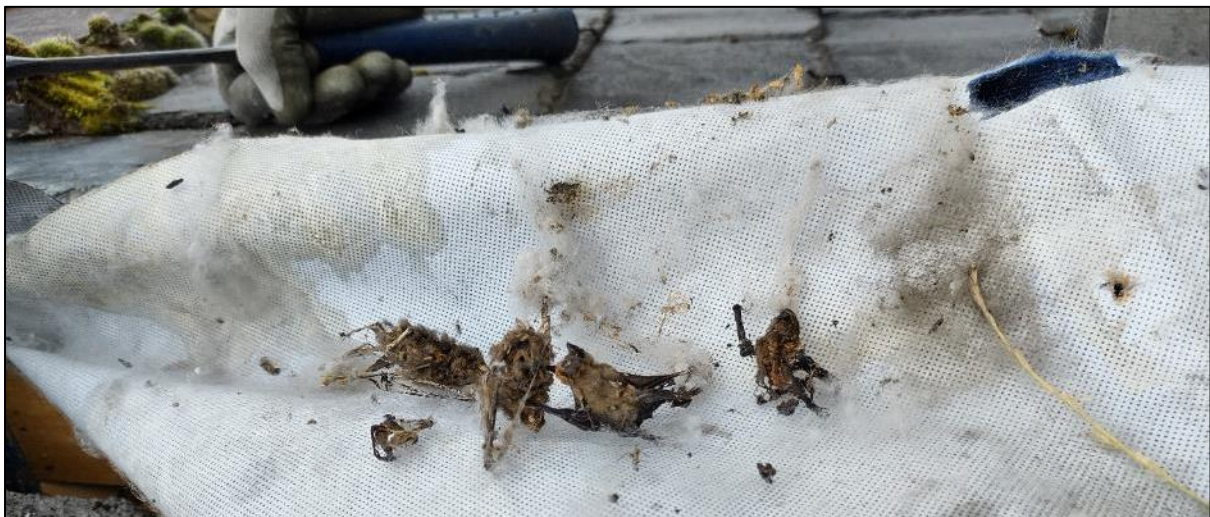
One example we have encountered comprised a pipistrelle roost which formed in a building extension constructed in 2009. Over the course of just 13 years the roofing felt degraded to the extent that it trapped and killed more than 10 bats. Fortunately, the problem in this roost was identified and remedial work was undertaken to replace the roofing membrane in 2022.

### Plate A1.1. Four dead pipistrelles tangled in breathable roofing felt

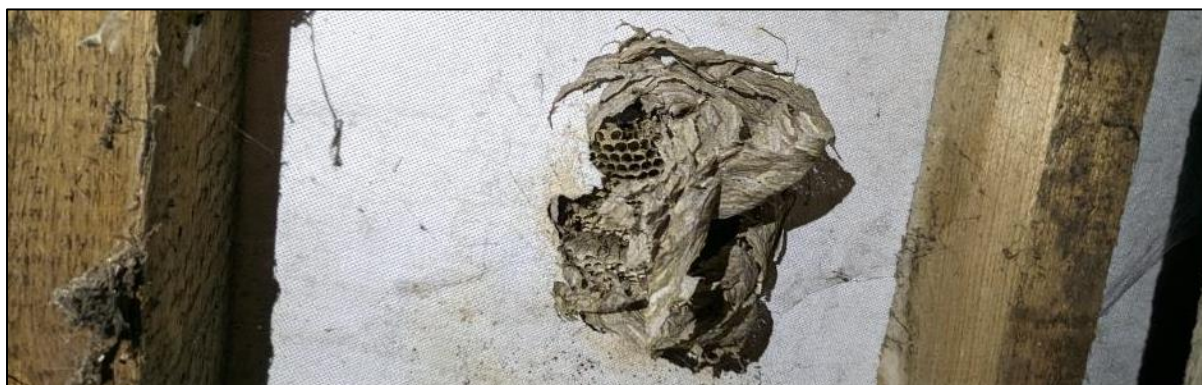
In recent years a fairly substantial proportion of the lofts we have surveyed which had existing breathable felt, were found to have been damaged by wasps (Plate A2.2). In these situations, the wasps appear to have chewed holes in the felt and formed nests in the holes. This doesn't appear to be a problem associated with the traditional bitumen coated roofing felt. Obviously, any holes within roofing felt would be likely to significantly reduce its functionality as a secondary weather barrier. Where bats or birds do come into contact with breathable roofing membranes, they can damage the membrane causing it to leak and they can also significantly reduce the breathability of the felt in that location.

#### Plate A1.2. Damage to a breathable roofing membrane adjacent to a wasp nest
