Date: May 2025

**COAL MINING RISK ASSESSMENT**  
For land at  
**LILEY FARM, LILEY LANE, MILLHOUSE GREEN,  
SHEFFIELD, SOUTH YORKSHIRE, S36 9NG**

| <b>REPORT TYPE:</b> | Coal Mining Risk Assessment | | |

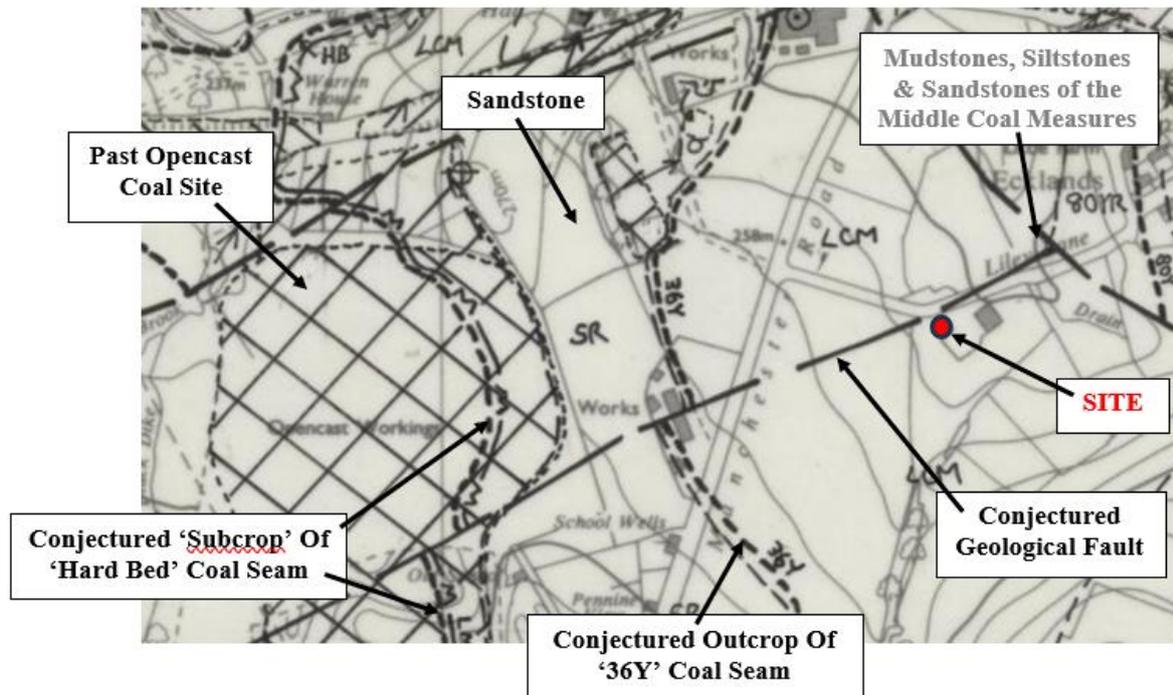
Records indicate the site to be located on mudstones, siltstones and sandstones of the Pennine Lower Coal Measure series from the Carboniferous formation. No superficial deposits are shown in the vicinity of the site. Strata are shown to dip towards the north-east in this vicinity at around 5° (1 in 12). A summary of the surface geology is illustrated on the image below which is an extract from the BGS SE20SW 1989 Edition:

A geological fault is conjectured to pass close to the north of the site as indicated above, travelling roughly in a WSW to ENE direction; which throws the strata down by a few meters or so to the south. No fissuring is known in this vicinity and given the anticipated geology the likelihood of such is considered low.

As shown above, the '36Y' coal seam is conjectured to outcrop some 260m away to the south-west which will dip beneath the site at around 20m deep should the conjectured detail be accurate (given the lay of the land combined with strata dip). Very little information is known about this coal seam which is not detailed in mining records in these parts; indicating that the coal is very likely to be of thin/inferior in nature.

is shown to 'sub-crop' some 500m away to the south-west as indicated. The 'sub-crop' relates to the remaining unworked edge of the coal seam at the base of the former opencast workings as detailed below. Local historic mining details suggest that underground workings of this strata consisted in the region of 1m of coal along with around 0.4m of underlaying fireclay (ganister). The former 'Bullhouse Colliery' shafts, some 330m away to the NNE (north-north-east) recorded the Hard Bed at 56m deep at that location. Given the details, the Hard Bed seam is considered to be at a similar depth beneath this site; i.e. around 50m deep or so.
