Barn at Liley Farm, Millhouse Green

Bat Survey Report

3rd July 2025

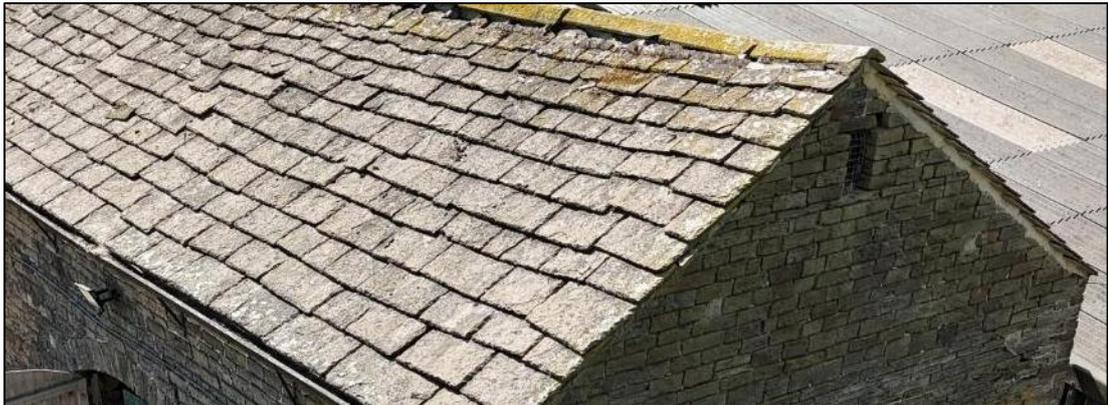
- 5.2.6 No droppings were recorded from the external walls of the barn.
- 5.2.7 Bats could access the interior of the barn via the many openings in hatches, windows, the uncovered dovecote, arrow slits or sections of missing roof slates.
- 5.2.8 Potential roost locations on the exterior of the barn included the following.
- Gaps between roof slates, particularly on gable verges (Plate 6).
 - Access to the space between concrete slates and plastic sheeting used to line the southwest pitch.
 - Open joints in the masonry (Plate 6).
 - Access to lintel gaps, above windows, doors and hatches.

Plate 6. Close view of roof, showing uneven stone slates. Open joints in masonry visible

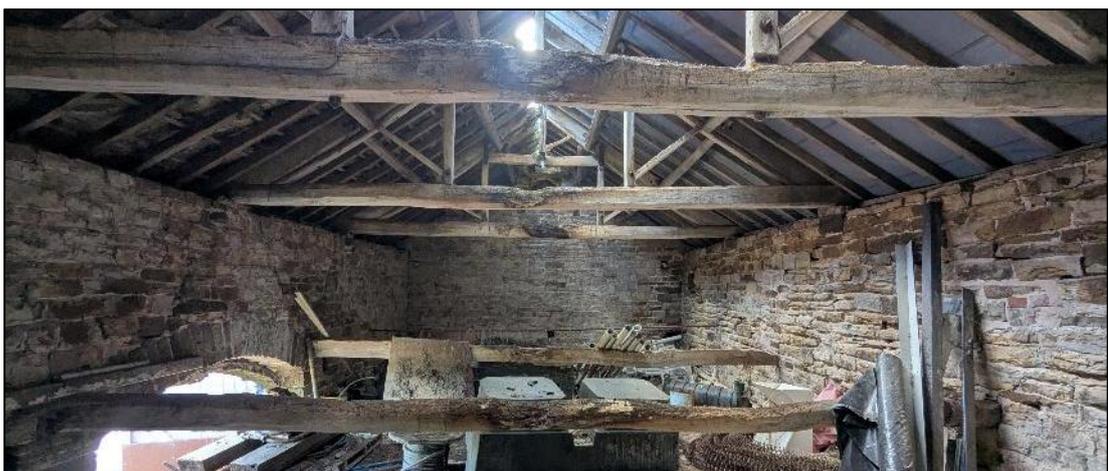
Plate 7. First floor of northwest section of two-storey part of barn

- 5.2.9 The southwest pitch of the two-storey section of the barn was lined with plastic sheeting, whilst the northeast pitch was unlined (Plate 7). The roof was suspended on queen-post trusses, purlins, rafters and battens. The top course of slates had slipped away from the ridge tiles on the northeast pitch and the first floors of the barn were long disused and in a derelict state (Plates 7 & 8). A cluster of ten relatively fresh (black) barn owl *Tyto alba* pellets were present below a rafter at the southeast end of the two-storey section of barn, indicating a perch in this location. The ground floors of the two-storey section of barn were used for storage, with four disused swallow nests present on the joists supporting the first floor (Plate 9). No bat droppings were recorded from this section of the building.

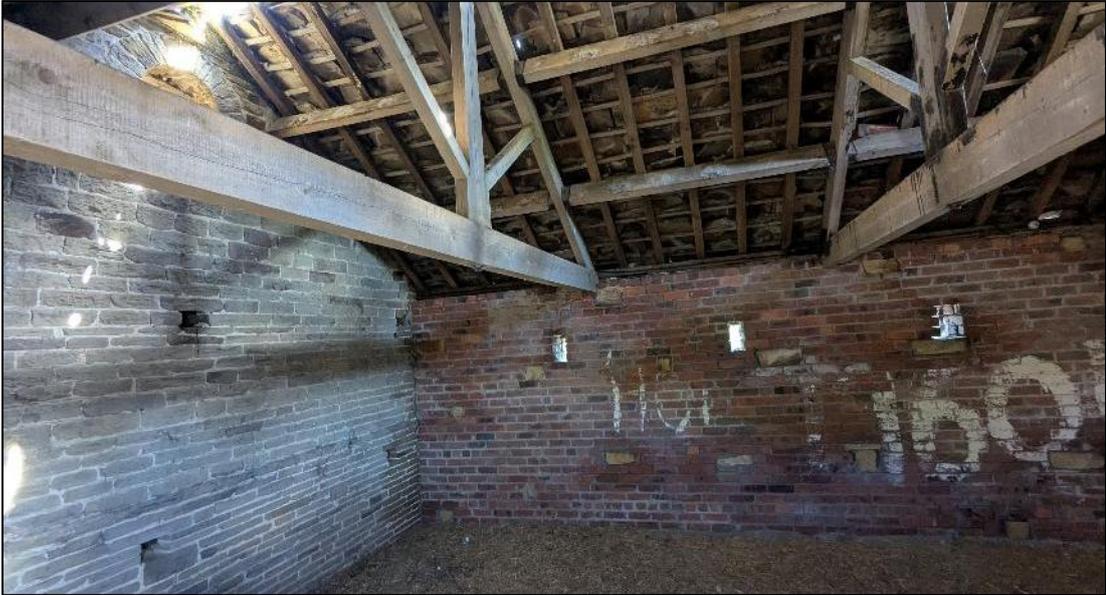
5.2.2 Evidence of a barn owl *Tyto alba* perch was recorded from the barn, together with four historic swallow *Hirundo rustica* nests.

Plate 8. First floor of southeast section of two-storey part of barn, with barn owl pellets just out of view below right hand truss. The arch of the dovecote opening is visible on top left of image

6.3.4 To mitigate for the lost barn owl perch a replacement roost site should be created on Liley Farm. This replacement roost site may comprise either a barn owl loft (Figure 4) to be included in the renovated barn, or a purpose made barn owl box, which could be attached to either the inside or outside of one of the modern barns on the site. A barn owl loft could be created within the former dove cote in the southeast gable of the barn (Plate 3). Were a barn owl box to be fixed to an existing modern barn then a suitable design of box would comprise the [Eco Barn Owl Nest Box](#) and Middleton Bell Ecology would be happy to advise further on suitable locations.

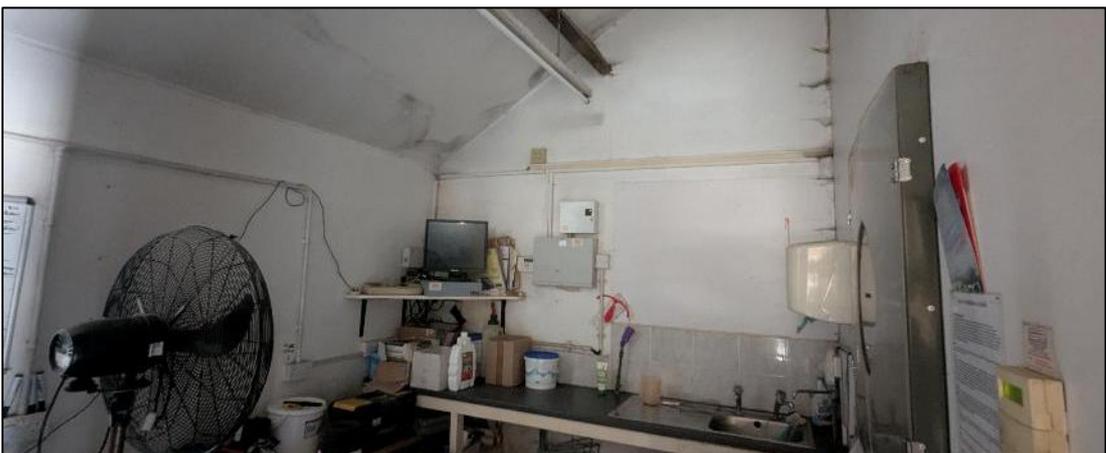
Plate 10. Office within single-storey section, at southeast end of barn

- 5.2.10 The roof of the single-storey section of barn was unlined and supported by purlins, rafters and battens. The southwest pitch had been vaulted, with this half of the building used as an office (Plate 10), whilst the northeast half of the single storey building housed electrical systems supporting the farm. No signs of bird or bats were recorded from this section of the building.

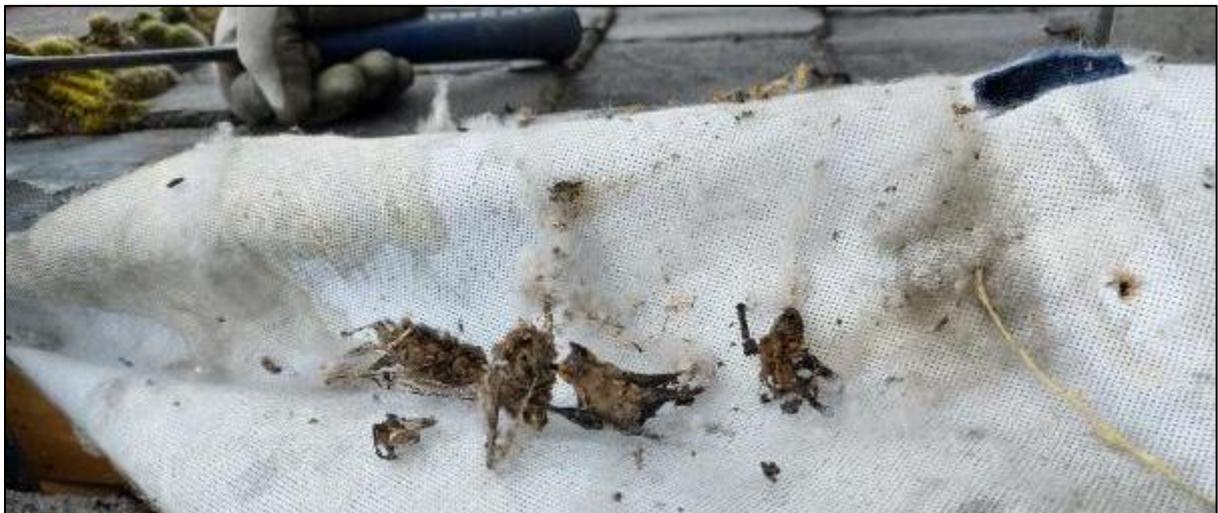
One example we have encountered comprised a pipistrelle roost which formed in a building extension constructed in 2009. Over the course of just 13 years the roofing felt degraded to the extent that it trapped and killed more than 10 bats. Fortunately, the problem in this roost was identified and remedial work was undertaken to replace the roofing membrane in 2022.

Plate A1.1. Four dead pipistrelles tangled in breathable roofing felt

The best roofing membrane option for areas where bat roosts are expected is traditional Type 1F bitumen coated hessian backed roofing felt. Bitumen coated roofing felts have been widely and safely used as a secondary weather barrier since approximately the 1950s/1960s. Wooden sarking has also been used for many decades and if appropriately treated, is safe for use in bat roosts, or where bats could be, present. Most commercially available products come

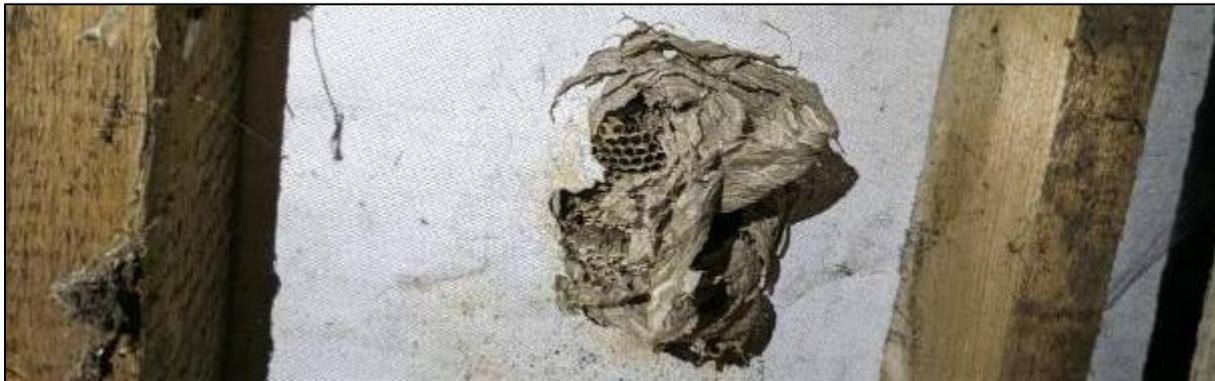
In recent years a fairly substantial proportion of the lofts we have surveyed which had existing breathable felt, were found to have been damaged by wasps (Plate A2.2). In these situations, the wasps appear to have chewed holes in the felt and formed nests in the holes. This doesn't appear to be a problem associated with the traditional bitumen coated roofing felt. Obviously, any holes within roofing felt would be likely to significantly reduce its functionality as a secondary weather barrier. Where bats or birds do come into contact with breathable roofing membranes, they can damage the membrane causing it to leak and they can also significantly reduce the breathability of the felt in that location.

Plate A1.2. Damage to a breathable roofing membrane adjacent to a wasp nest
