**ARBORICULTURAL REPORT  
AND  
ARBORICULTURAL IMPACT ASSESSMENT  
to BS 5837:2012  
at  
Osbourne House  
Burton Road  
Barnsley  
South Yorkshire  
S71 2JS**

**Client:**  
CRS Plant Ltd

**JCA Ref:**  
16008/ChC – Rev 1

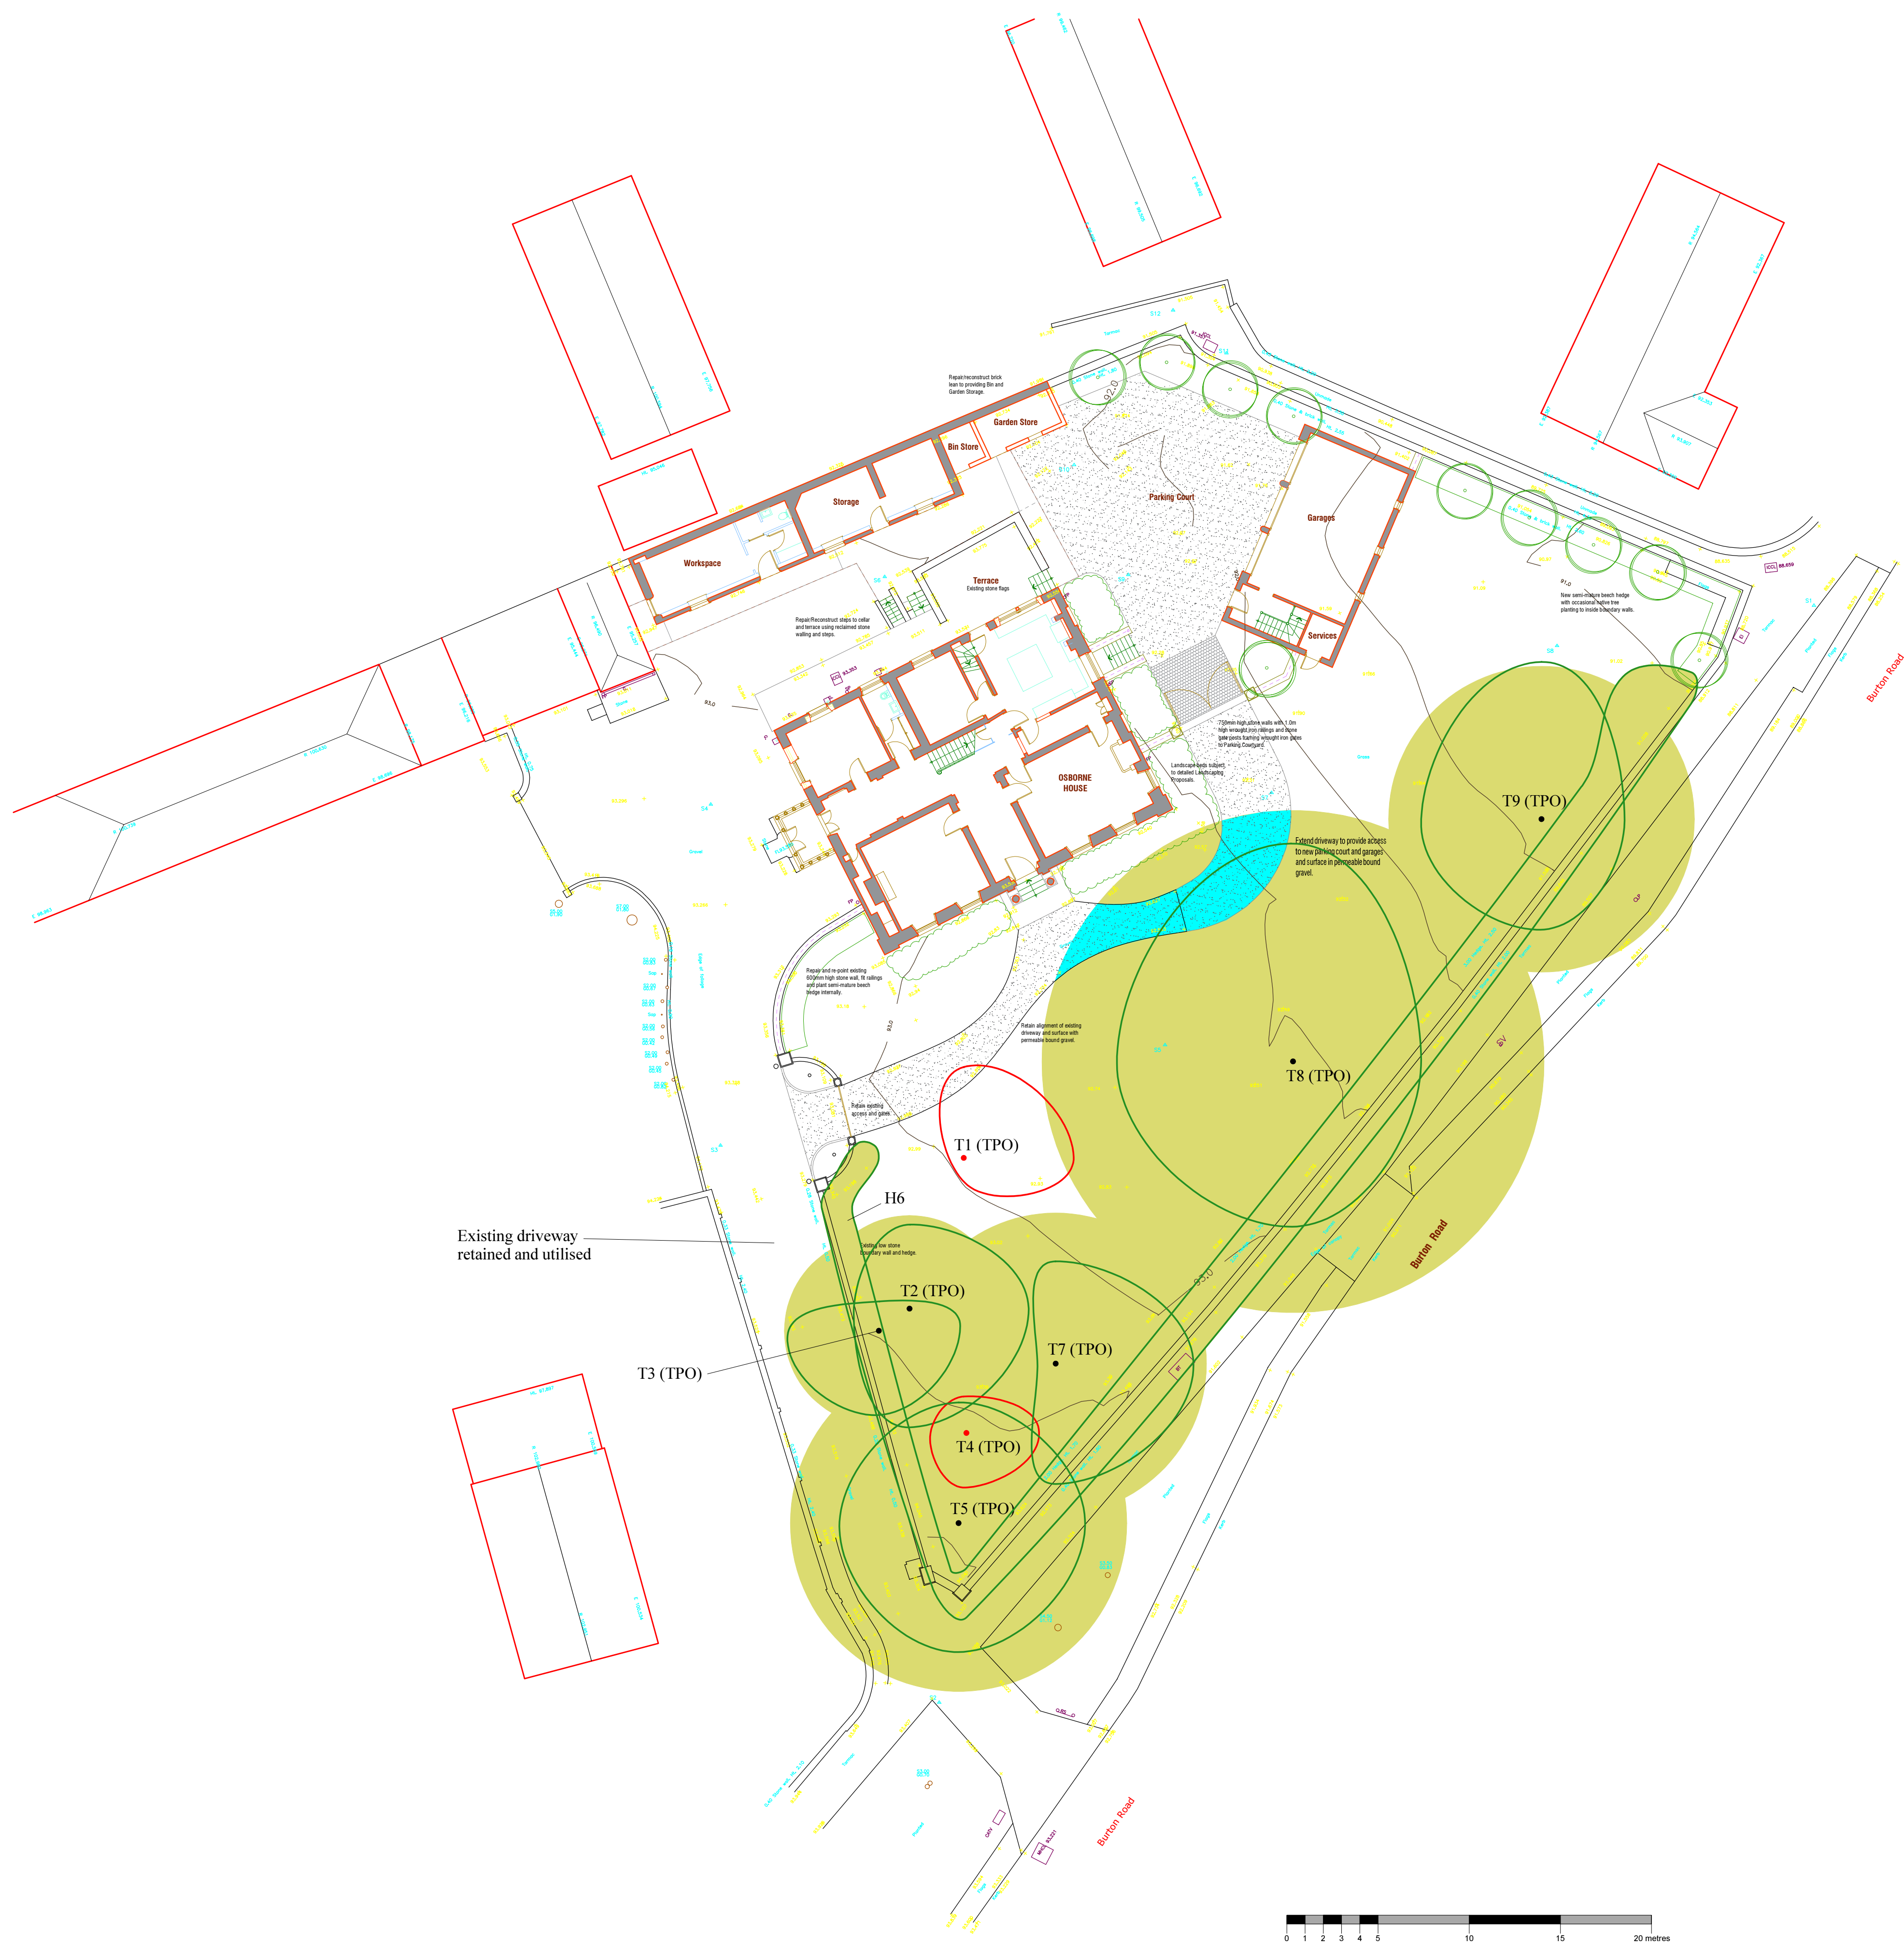
### Appendix 7: Arboricultural Implications Plan

- 6.4.1.3 Where work is required within the RPA of **T8** for the access driveway to the garages, specialist measures and Arboricultural supervision will be required. This area is highlighted in blue on the Arboricultural Implications Plan at **Appendix 7**.

- 6.4.2.1 The alignment of the existing driveway is to be used where this runs passed the house to the proposed garages, and this will be finished/surfaced with a permeable gravel to avoid damage to **T8**. No excavations are to be carried out to achieve this and any works within the RPA of **T8** must be supervised by JCA at all times, and not begun until protective fencing is in place. This is to ensure that the works are carried out sympathetically and that damage to the tree is avoided.
