# **TASE Barnsley – BS5837:2012 Tree Survey, Arboricultural Impact Assessment and Arboricultural Method Statement**

**Bowmer and Kirkland**

**December 2021**

Version: **V2.0**  
Issue Date: **December 2021**  
Report Ref: **18221**

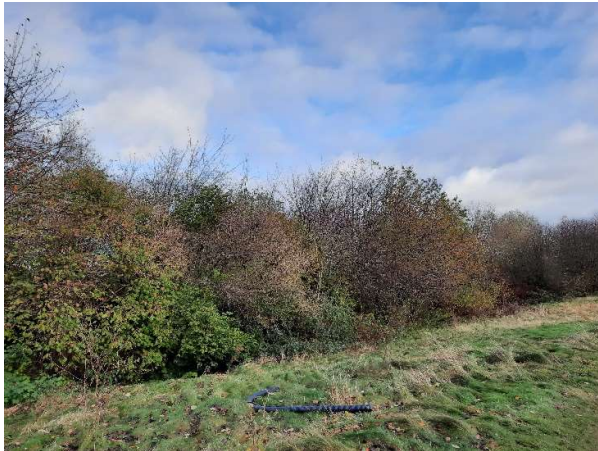
**Plate 1:** Mixed species group G2 from the south west

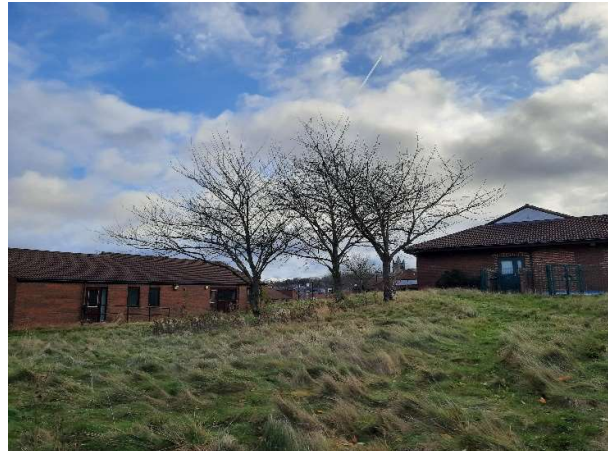
**Plate 2:** T3, T4 and T5 from the north west

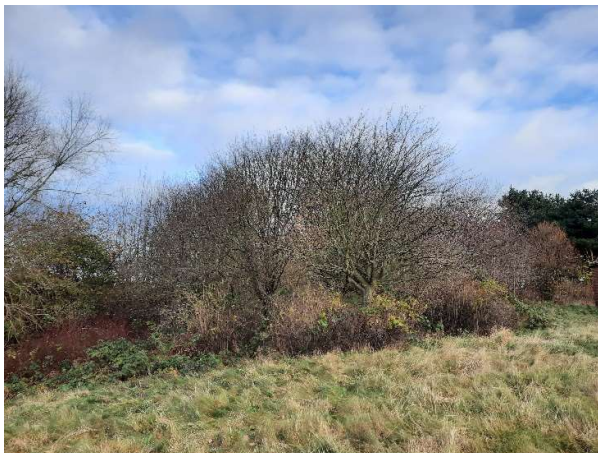
**Plate 3:** T7 to T11 with boundary groups in the background from the south west

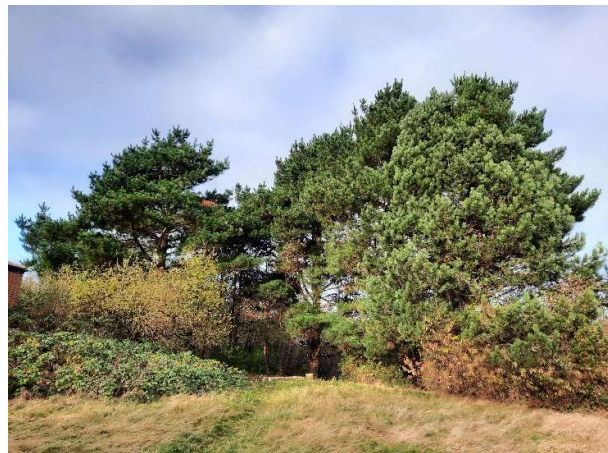
| Tree No | Species | Ht (m) | Stem Diam @ 1.5 m (mm) | Canopy Spread (m)<br>N- E- S- W | | | | Height of Crown Clearance | Age Class | Est yrs | Overall Condition | Comments | Management Recommendations<br><i>incl. Arboricultural Method Statement</i> | BS 5837 Category | RPA Radius (m) | RPA (m <sup>2</sup> ) |
|---|---|---|---|---|---|---|---|---|---|---|---|---|---|---|---|---|
| T016 | Goat Willow<br>( <i>Salix caprea</i> ) | 6 | 140 x8 | 1.5 | 5 | 5.5 | 1 | 0.5 | Semi Mature | 10+ Years | Poor | Multi-stemmed at base with several included bark unions, suppressed form, various snapped branches & signs of decay | <b>Removal required to facilitate development</b> | C2 | 4.752 | 72 |

**Plate 4:** T16, T17, G18 and G19 from the south east

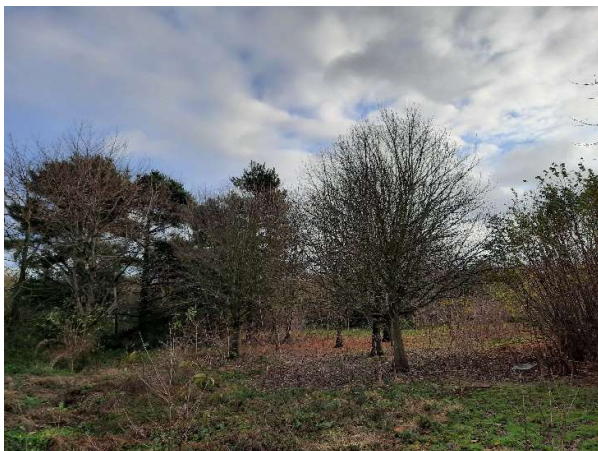
**Plate 5:** T33 to T39 with boundary groups in the back ground from the east

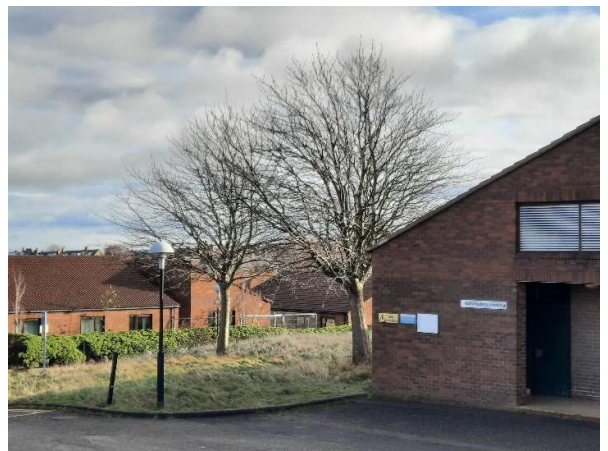
**Plate 6:** T68 and T69 from the west

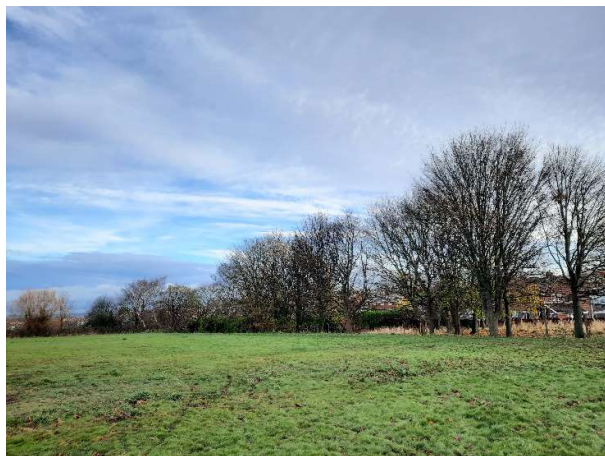
- 3.2.6 The willow T59 and sycamore T97 were both in a particularly poor condition with the potential to

cause some level of damage or harm in the current context of the site. A large pine tree had also failed within the group G42 and was resting in the canopy of surrounding trees. It is advised that T59, T97 and the failed tree within G42 are removed to ground level regardless of any development of the site.

**Plate 7: T84 to T99 from the north west**

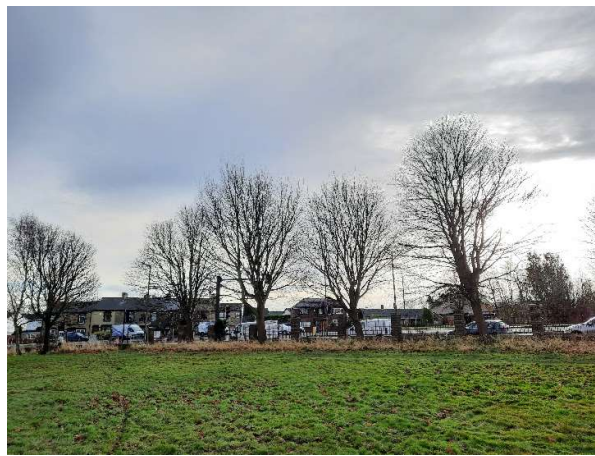
**Plate 8: T101 to T105 from the north**
