Re: 2012/0681 Treetops House, Workbank Lane, Thunkstone

**ARMITAGE (UK) LTD**  
**TREE SURVEY**  
**LAND OFF INBIRCHWORTH RD/  
WORK BANK LANE**  
**THURLSTONE**

TREE SURVEY  
LANE OFF  
INBIRCHWORTH RD/  
WORK BANK LANE  
THURLSTONE

Our Ref AA/JEA/500  
14 September 2007

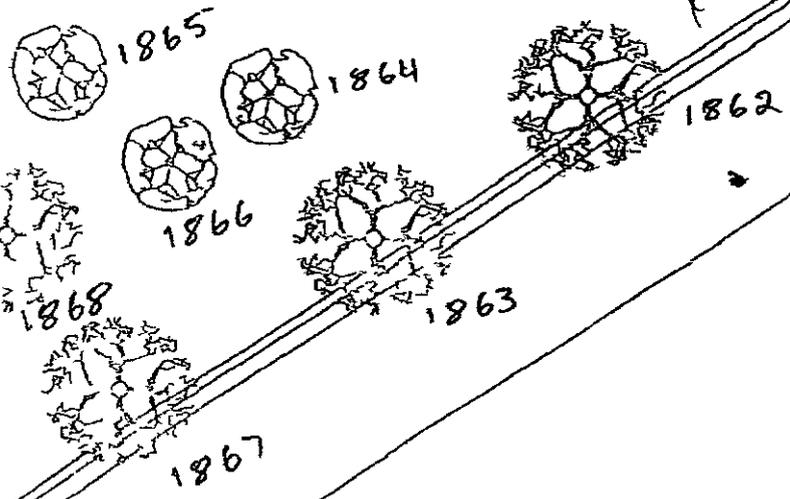
The site plan attached shows the location of the trees surveyed.

All the trees that are to be retained should be protected by stout fencing to avoid damage to their root systems by severance or asphyxiation. The fencing should run in a continuous line which runs along the position of the working zone as depicted on the site plan. Such fencing should be erected before any materials or machinery are brought on site and before development commences. Once erected it should not be removed without prior consultation with a specialist in arboriculture.
