Report No: C632
Date: February 2025

COAL MINING RISK ASSESSMENT
For land at
BISMARCK STREET, WORSBROUGH COMMON,
BARNSELY, SOUTH YORKSHIRE, S70 4NA

| REPORT TYPE: | Coal Mining Risk Assessment | | |
| SITE: | Land at Bismarck Street, Worsbrough Common, Barnsley, South Yorkshire S70 4NA | | |

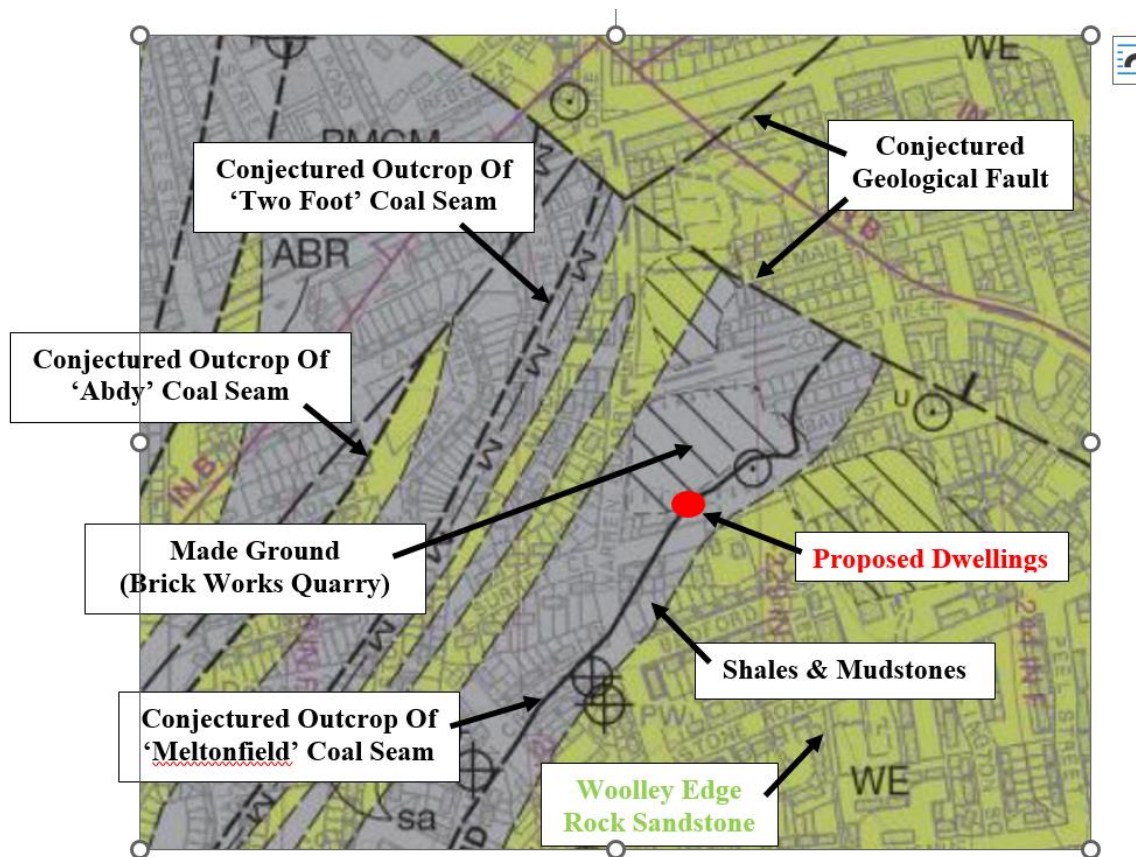
Records indicate the site to be located on shales, mudstones and possibly the base of the 'Woolley Edge Rock Sandstone' of the Middle Coal Measure series from the Carboniferous formation (although note the potential for made ground as detailed below). No superficial deposits are indicated in the vicinity of the site itself. Strata is shown to dip towards the SE (south-east) at around 7° (1 in 8) in this vicinity. A summary of the surface geology is illustrated on the image below which is an extract from the BGS SE30NW 2005 Edition:

A geological fault is conjectured to pass clear of the site by over 70m away to the north-east as indicated above, which throws the strata down to the north-east. No fissuring of bedrock is known in the vicinity and considering the information the likelihood of such features being present is considered low.

As outlined above, the 'Meltonfield' coal seam, of around 0.9m workable thickness in these parts, is conjectured to outcrop just to the north as shown. Given the information it is likely to be the case that the outcrop follows the base of the old brickworks quarry detailed below, or they were within the associated high-wall. This would make for the seam being at shallow depth beneath the dwelling (within 5m or so) rather than at the surface; unless historically removed via the quarrying.

The Two Foot seam, of around 0.8m workable thickness, is shown to outcrop some 170m away to the north-west as indicated. This coal is known locally to lie beneath the Meltonfield seam by around 15m or so.

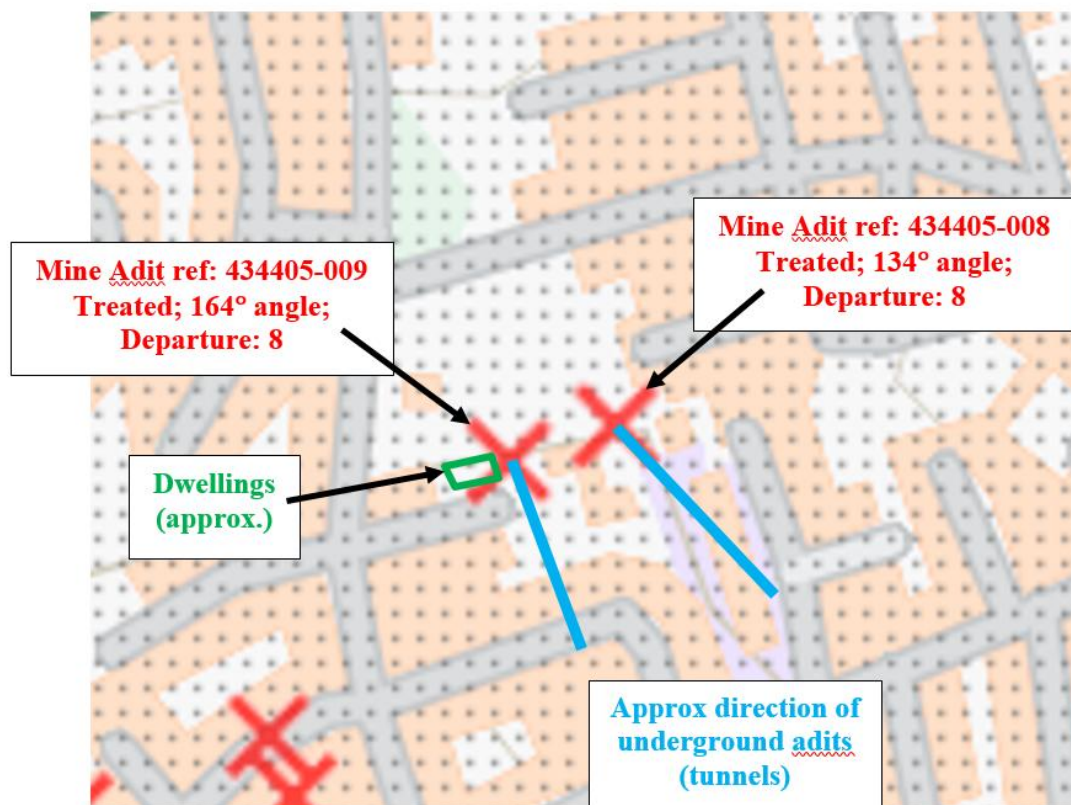
An old mine adit (tunnel entrance) is shown to be present within 20m of the eastern dwelling as indicated on the following image which forms an extract of the Mining Remediation Authorities interactive viewer information.

As can be seen, the mine adit ref: 434405-009 is known to be treated and have an '8m departure' - which is a contingency factor for the feature being out of the recorded plan position by. It should be noted however that the historic abandonment plan shows the two adits encountered, and illustrates that 434405-009 may indeed be just to the north of the proposed dwellings (in which case it could travel beneath the eastern plot). It is also possible that the historic quarrying activity has totally removed the features to beneath land further southwards – as was considered the case for the neighbouring development - boreholes 1 and 2 as detailed in G&M Consulting report ref: C632/01/ATS dated 20th April 2024 and illustrated in the extract image below:

- 2) Given the shallow coal mining position and location of mine adit ref: 434405-009, it would seem a balanced approach to undertake 4 rotary boreholes to 25m deep just outside of the corners of the dwellings to the east and west in the first instance, plus a further 2 between the properties if necessary to determine the quarry high wall and presence, or otherwise, of mine adit (as mentioned below). The suggested boreholes are outlined on the location plan presented in Attachment B of this report. Water flush methods should be utilised to reduce gas and spontaneous combustion risks and a permit from the Mining Remediation Authority should first be obtained prior to an investigation of their interests. The boreholes should determine the depth of any made ground associated with the adjacent historic quarry and whether any coal seam/workings are beneath the property at a critical depth from a stability aspect. It is felt unlikely in this instance that there will be any 'interaction' between the different coal seams from a void migration aspect. As such, boreholes could be terminated within the firm ground beneath the first coal seam/workings encountered. If no coal seams or associated workings are noted (beneath any made ground for instance) then holes should be extended to 25m deep to confirm the position. It should be noted that further holes may be necessary should it be difficult to ultimately prove the geological/mining position and/or location of the mine adit itself which will need similar considerations to shallow mining voids if encountered. Should made ground be proved in the vicinity of the mine adit (mainly the eastern plot) in excess of 5m then it would seem reasonable to assume that the feature has been historically removed.

- 5) Although a low risk, a watching brief should be employed during any future ground works for any signs of the mine adits or other unrecorded mine entries. If suspected the Mining Remediation Authority (as owners) should be notified immediately for appropriate deliberations.

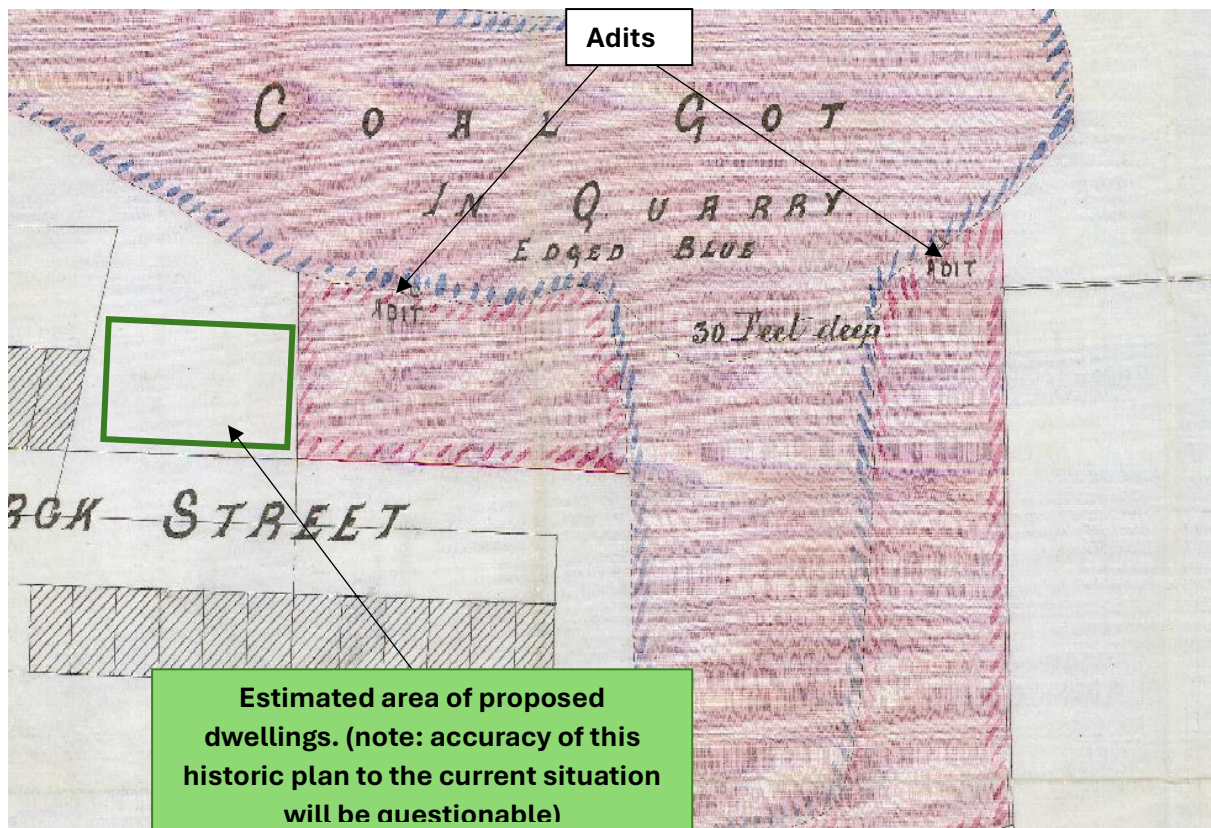
ATTACHMENT A

No opencast coal operations are known within 250m of the site; however, the historic 'brick works' are shown to have 'removed the shallow coal' to the extent as shown on the attached abandonment plan in Attachment A of this report. Due to the historic nature and origin of these records, the precise location of quarry sides/high walls will be difficult to predict; and subsequent works, of little or no record, may have change the actual position considerably.
