# **Barnsley Youth Zone – BS 5837:2012 Arboricultural Report, Impact Assessment and Method Statement**

## **OnSide Youth Zone**

**February 2024**

**Report Title:** Barnsley Youth Zone– BS 5837:2012 Arboricultural Report,  
Impact Assessment and Method Statement

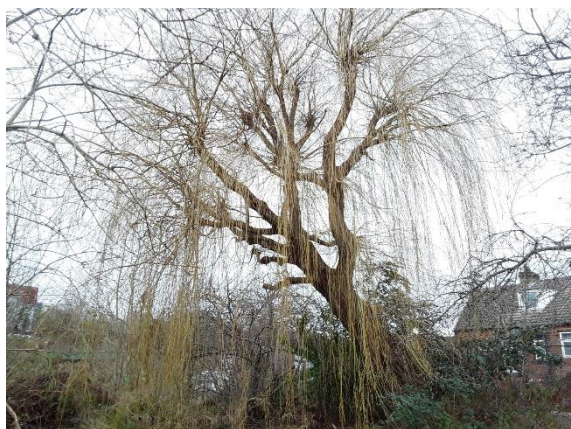
| Tree No. | Species | Height (m) | No. of Stems | Stem Dia. @ 1.5m (mm) | Crown Spreads (m) | | | | Height of Crown Clearance (m) | Age Class | SLE | Overall Condition | Comments | Management | Category | RPA Radius (m) | RPA Area (m <sup>2</sup> ) |
|---|---|---|---|---|---|---|---|---|---|---|---|---|---|---|---|---|---|
| T003 | Weeping willow ( <i>Salix babylonica</i> ) | 13 | 1 | 750 | 4 | 3.5 | 7.5 | 6 | 0 | Mature | 20+ Years | Fair | Prominent tree within setting providing good amenity value to neighbouring dwellings to north, forms part of linear row of trees along verge, likely limited rooting extents north and south due to hard surfacing and poor rooting conditions, stem collar buried and surrounded by material waste therefore limiting detailed inspection, approximately 20 degree lean south, but self correcting, old pruning wounds and stubs, previously pollarded with good regenerative growth forming. | <i>Remove spoil heap from under tree and mulch, manage pollard on a 3-5 year cycle</i> | B1,2 | 9 | 254 |

**Plate 1:** Looking north at weeping willow T003.

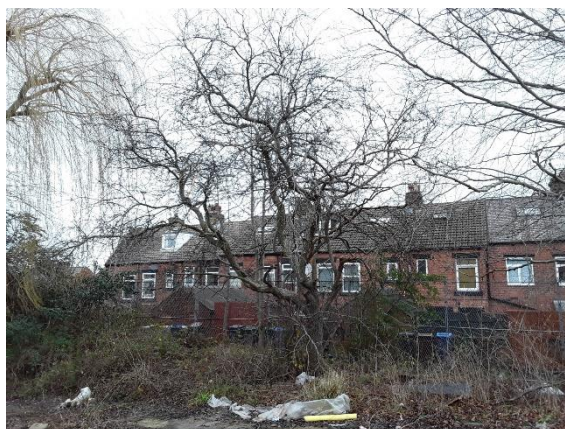
| Tree No. | Species | Height (m) | No. of Stems | Stem Dia. @ 1.5m (mm) | Crown Spreads (m) | | | | Height of Crown Clearance (m) | Age Class | SLE | Overall Condition | Comments | Management | Category | RPA Radius (m) | RPA Area (m <sup>2</sup> ) |
|---|---|---|---|---|---|---|---|---|---|---|---|---|---|---|---|---|---|
| T005 | Apple ( <i>Malus sp.</i> ) | 6 | 1 | 320 | 3 | 3.5 | 4.5 | 4 | 3 | Early Mature | 20+ Years | Fair | Tree tag number on stem 000615<br>Forms part of linear row of trees along verge, providing good level of amenity value to neighbouring residential properties to north, likely limited rooting extents north and south due to hard surfacing and poor rooting conditions, old pruning wounds and stubs, minor deadwood throughout crown, rubbish around base with scrub | | B2 | 3.8 | 45 |

**Plate 2:** Looking north at apple T005.

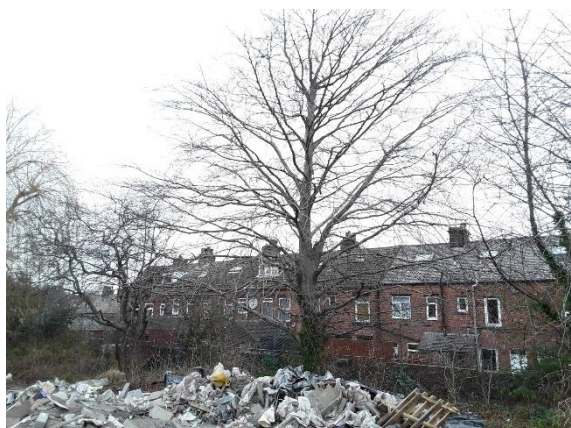
**Plate 3:** Looking north at copper beech T007.

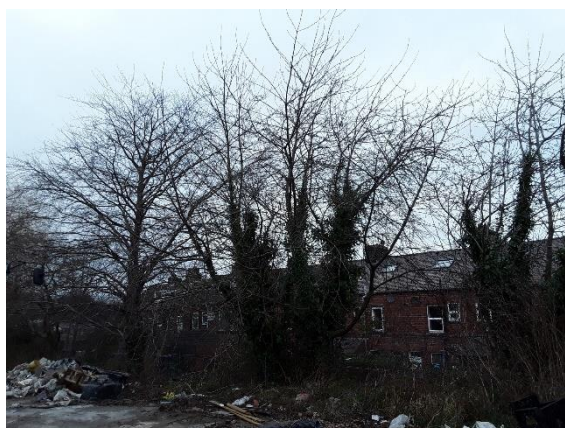
**Plate 4:** Looking north at wild cherry T008.

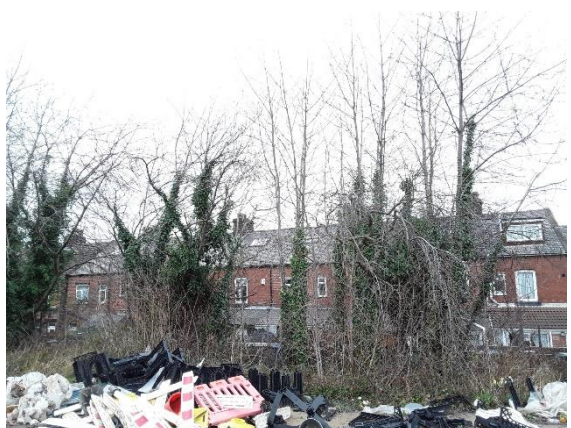
**Plate 5:** Looking north at dense cluster of wild cherries.

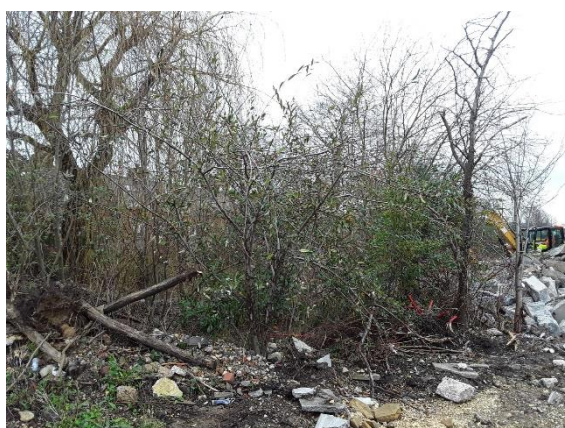
**Plate 6:** Looking north east at low quality mixed species group G010.

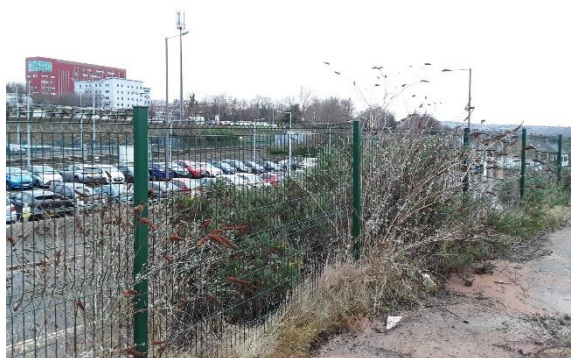
**Plate 7:** Looking west at group G013 (shrubs on verge embankment).

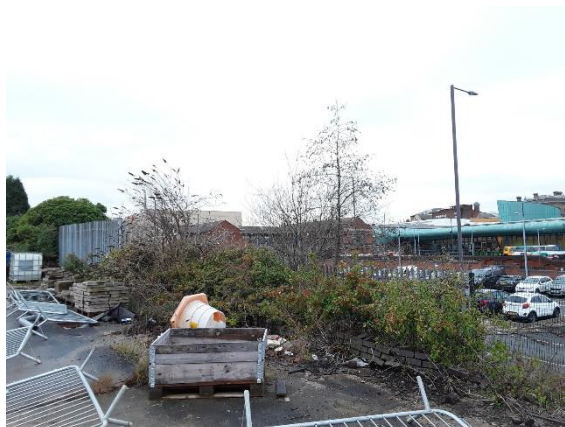
**Plate 8:** Looking south west at G014.

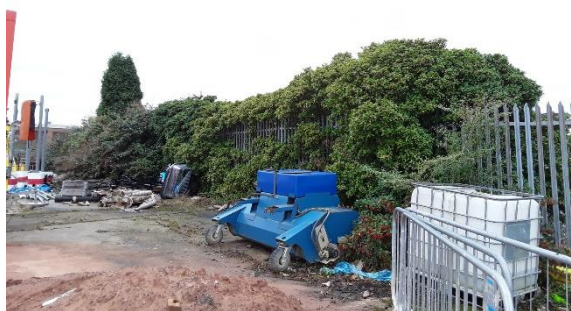
**Plate 9:** Looking south west at mixed species group G015.

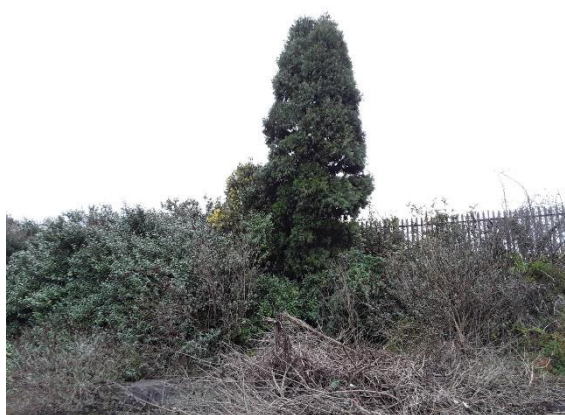
**Plate 10:** Looking east at lawson cypress T016.

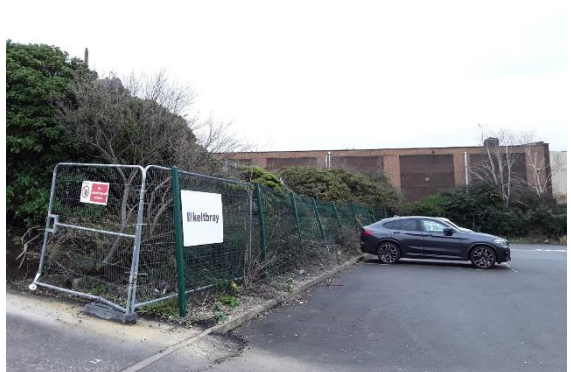
**Plate 11:** Looking south at mixed species group G017.

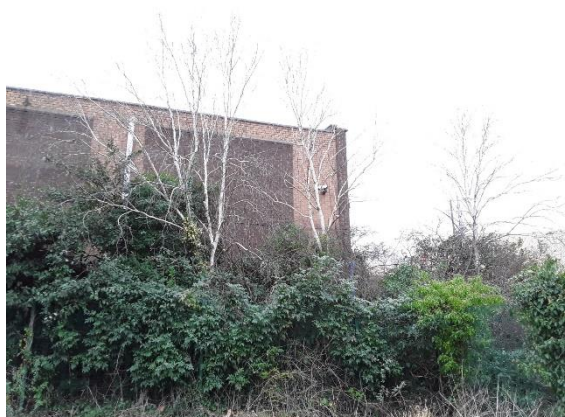
**Plate 12:** Looking south at himalayan birch G018.
