## RECORD of EXISTING TREES

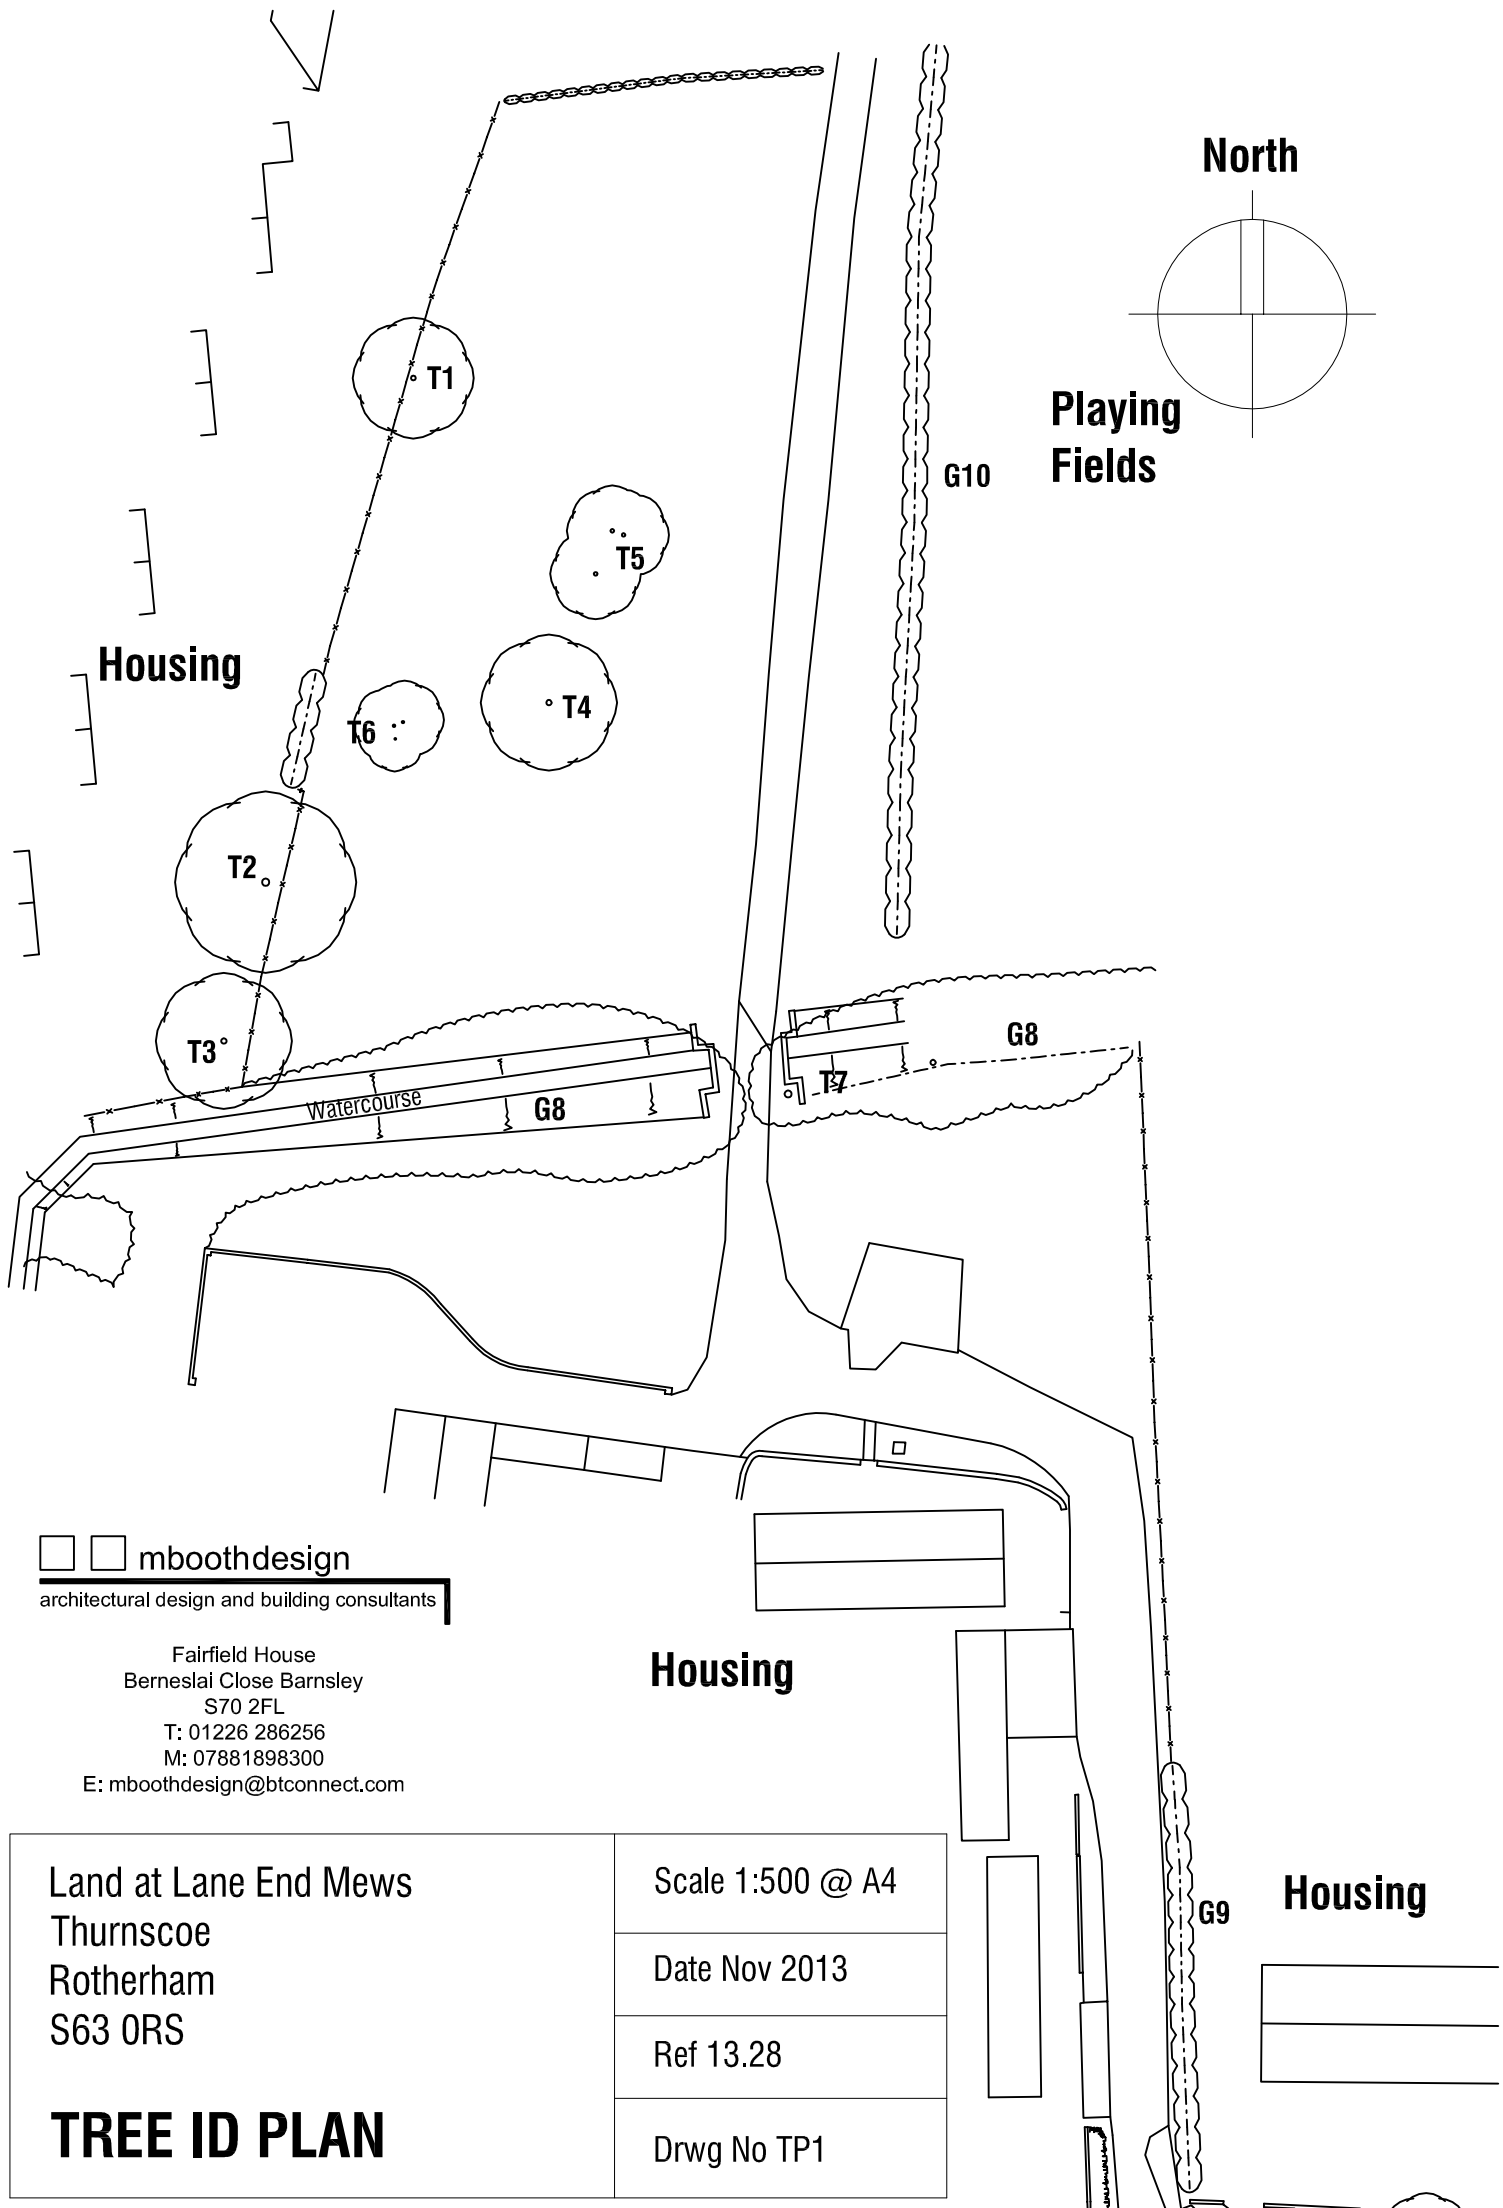
- The site contains unmanaged self-sewn trees and a hedge (G8) which crosses the site and follows the line of a watercourse.
- Other than T2 which is a mature Silver Birch located on land outside the site, the remainder of existing trees have limited amenity value.

- G8 is an out grown self-sewn hedge comprising a mix of Ash Elder and Hawthorne. It will need to be removed to allow the watercourse to be realigned and accommodate the new access road.
- T7 is a young Ash tree that could be said to form part of G8 and along with T4 and T5 would need to be removed.
- T1 is in poor condition and should be removed and replaced.
- T6 is a semi mature multi-stemmed Silver Birch and could be retained subject to detailed design.
- G9 is a conifer hedge that will need to be removed to facilitate road widening.

- The majority of the trees on site have medium to low amenity value. T2 T3 which are outside the development site and will be at the rear of back gardens will not be affected by the works. T6 is capable of being retained. These and any other retained trees would need to be protected during the course of the works by suitable fencing details of which would be submitted and approved by the LPA at detailed design stage.
- Adequate space is available on the site to allow for replacement planting to take place which should be based upon a detailed landscaping layout submitted to and approved by the LPA prior to the commencement of development.
