# Lakeside View, Silkstone Common

## Bat Survey Report

20<sup>th</sup> November 2023

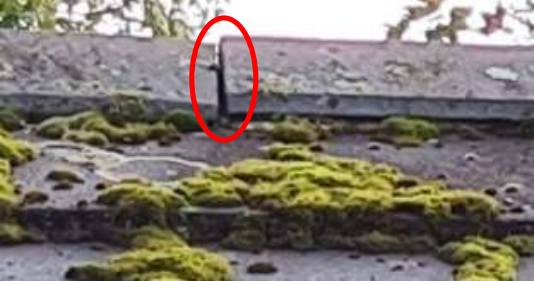
Gaps between ridge tiles.
D

- how to remove or open up suitable bat roost features where work is required, and
- what to do in the event a bat is discovered.
- The missing mortar in the masonry must be retained unpointed, and the ridge tiles retained without rebedding or repointing them.

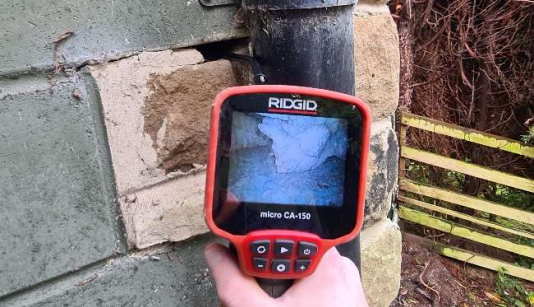
Missing mortar in masonry (being checked with an endoscope).
E

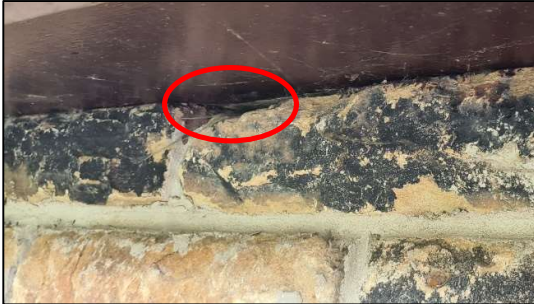
Gap beneath soffit box allowing access onto the wall top.

- If the soffits / barge boards require replacement, they should be subject to a destructive search by or under the supervision of a bat survey licenced ecologist. They must be replaced with wooden soffits / barge boards and access points into these locations recreated.

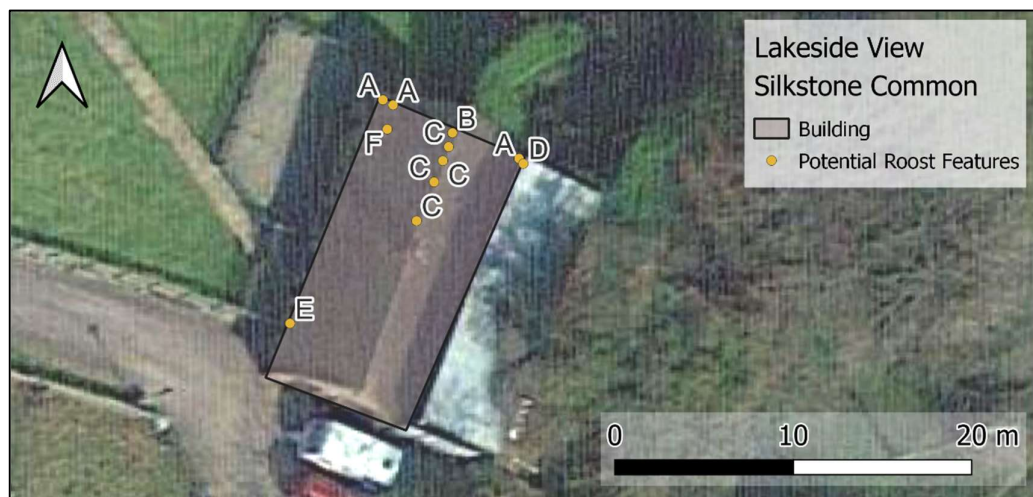
**Figure 3. PRF Locations**

5.2.5 Gaps with potential to be used by roosting bats comprised gaps between ridge tiles, gaps allowing access onto the wall top, and gaps allowing access into the soffit box at the northern end of the building and a single section of missing mortar between masonry. The PRFs are shown in Table 3 and Figure 3 below.

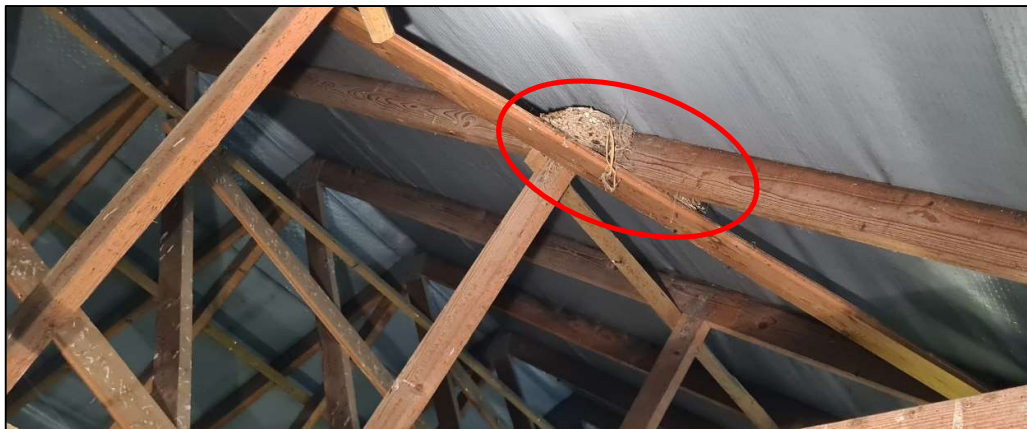
- 5.2.7 Some bird and rat droppings were present on the ceiling of the stables / tack room but no bats or signs of bats were recorded during the inspection. Features A, B, D, and E could all be inspected with an endoscope and no bats or bat droppings were recorded. It is considered likely that droppings would have been present within the features and that they would have been recorded during the endoscope inspection, if these features had been recently used, or regularly in the past summer season. The gaps between the ridge tiles could not be closely inspected.
- 5.2.8 At the northern end of the building three swallow nests were recorded on the rafters (Plate 5). The swallow nest locations are shown as Feature F on Figure 3.

**Plate 5. Swallow nests on rafters inside the building**

6.2.5 As swallow nests were recorded within the barn it is recommended that the work is timed to avoid the nesting bird season (March to September inclusive), or that a nesting bird check is completed by an ecologist prior to the start of the work. If active nests are present they must be retained in-situ until the young have fledged.

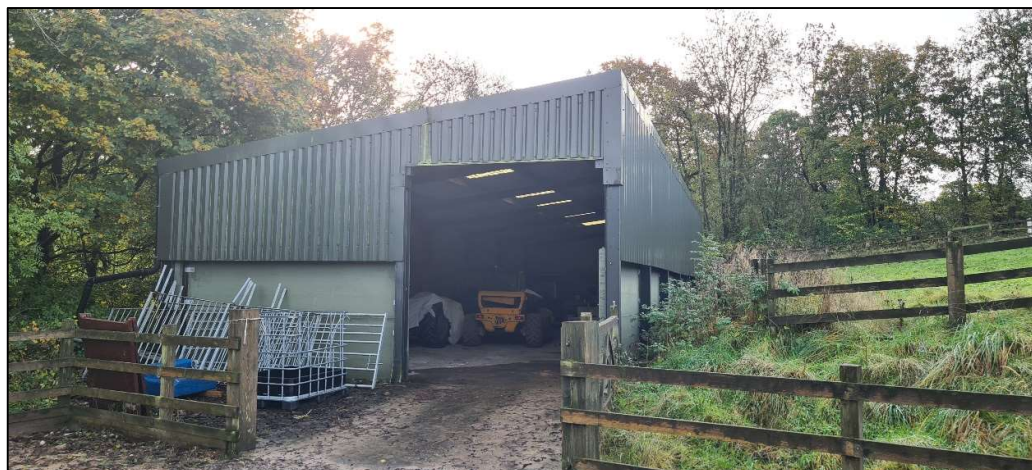
**Plate 6. Building proposed as alternative swallow nest site**

6.2.6 To replace the lost nesting bird habitat, it is recommended that three new swallow nest cups are installed within a different building within the site. The client has identified a storage barn located approximately 70 m south of the stables that would be suitable. The barn was inspected during the site visit and found to be an open fronted concrete block and steel framed building with timber bracing within the steel frame which would be suitable to attach swallow nest cups to (Plate 6). No evidence of existing use of the building by swallows was recorded.
