ARBORICULTURAL REPORT

to **BS5837:2012** at:

***Greenland Cottages,
High Hoyland,
Barnsley,
South Yorkshire
S75 4AZ***

Reference: *AWA1983*

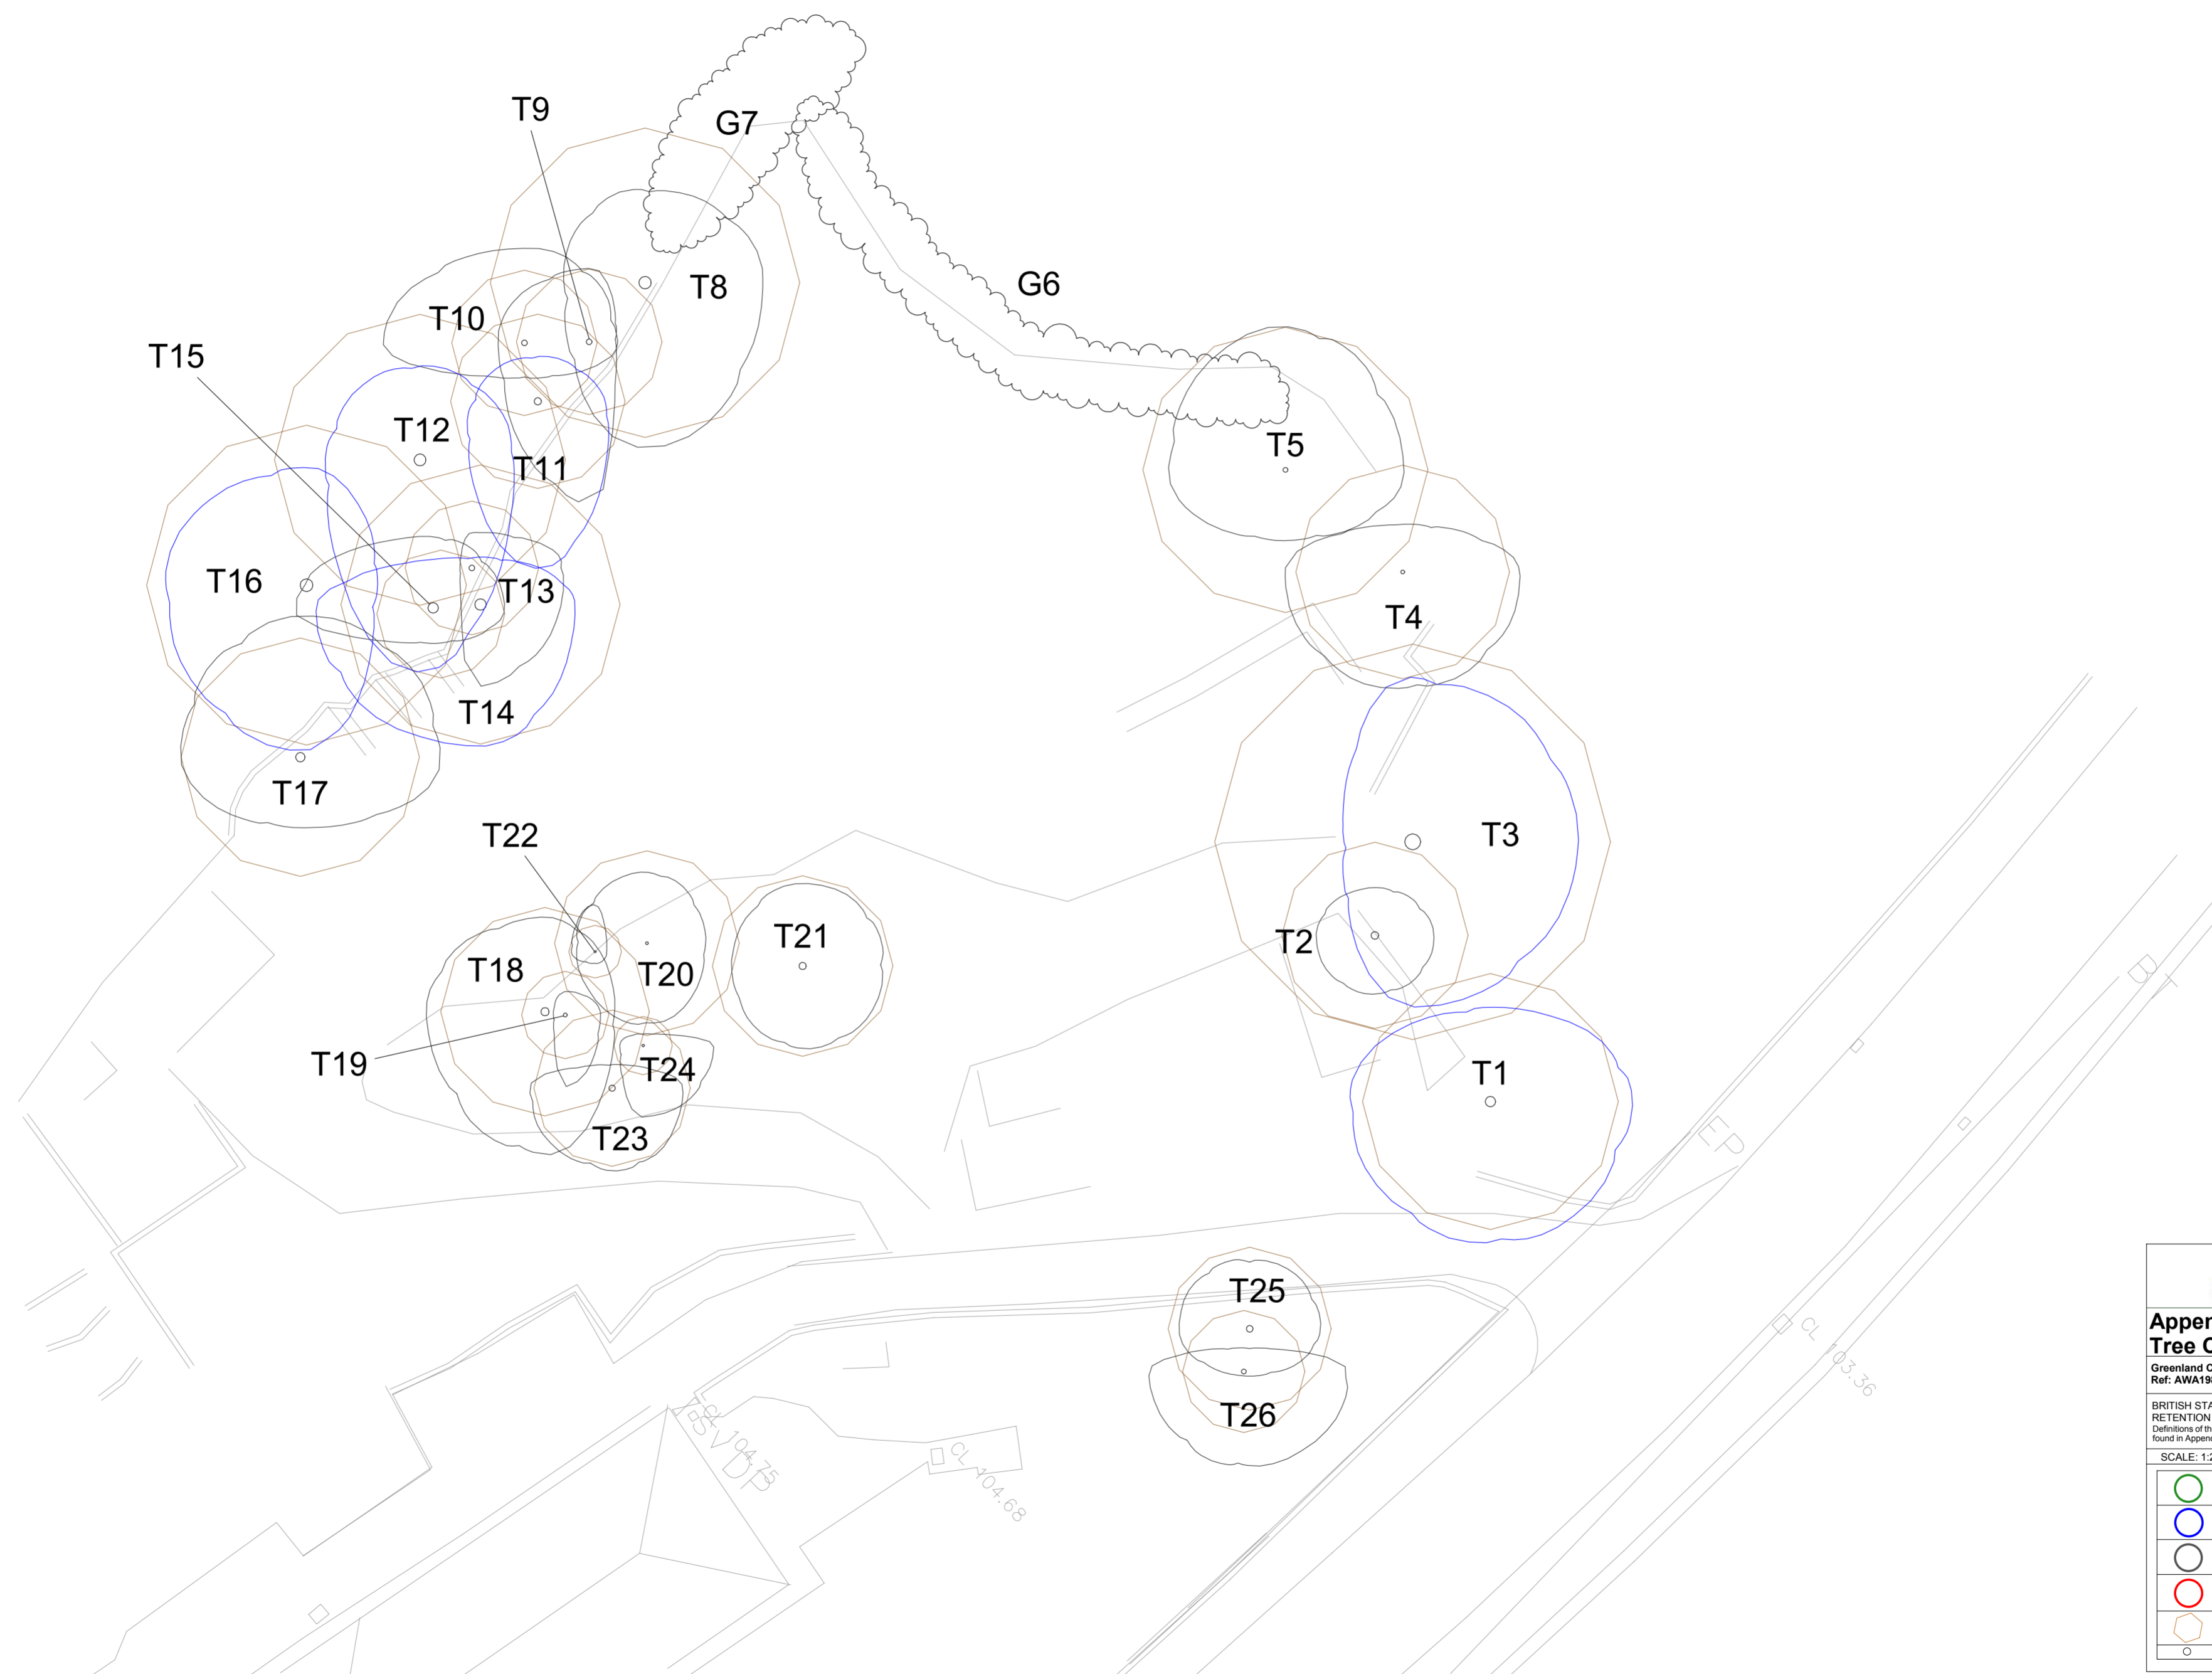
Appendix 5:
Tree Constraints Plan
 Greenland Cottages, High Hoyland, Barnsley
 Ref: AWA1963

- 3.2.1 The tree survey revealed 26 items of woody vegetation, comprised of 24 individual trees and 2 groups of trees or shrubs. Of the surveyed trees: 6 trees are retention category 'B', and the remaining 18 trees and groups are retention category 'C' (explanatory details regarding the retention categories are included within Appendix 3).

- 4.3.1 The tree Root Protection Area (RPA) detailed on the Tree Constraints Plan at Appendix 5, has been used as a layout design tool, to inform on the area around a tree where the protection of the roots and soil structure is treated as a priority.

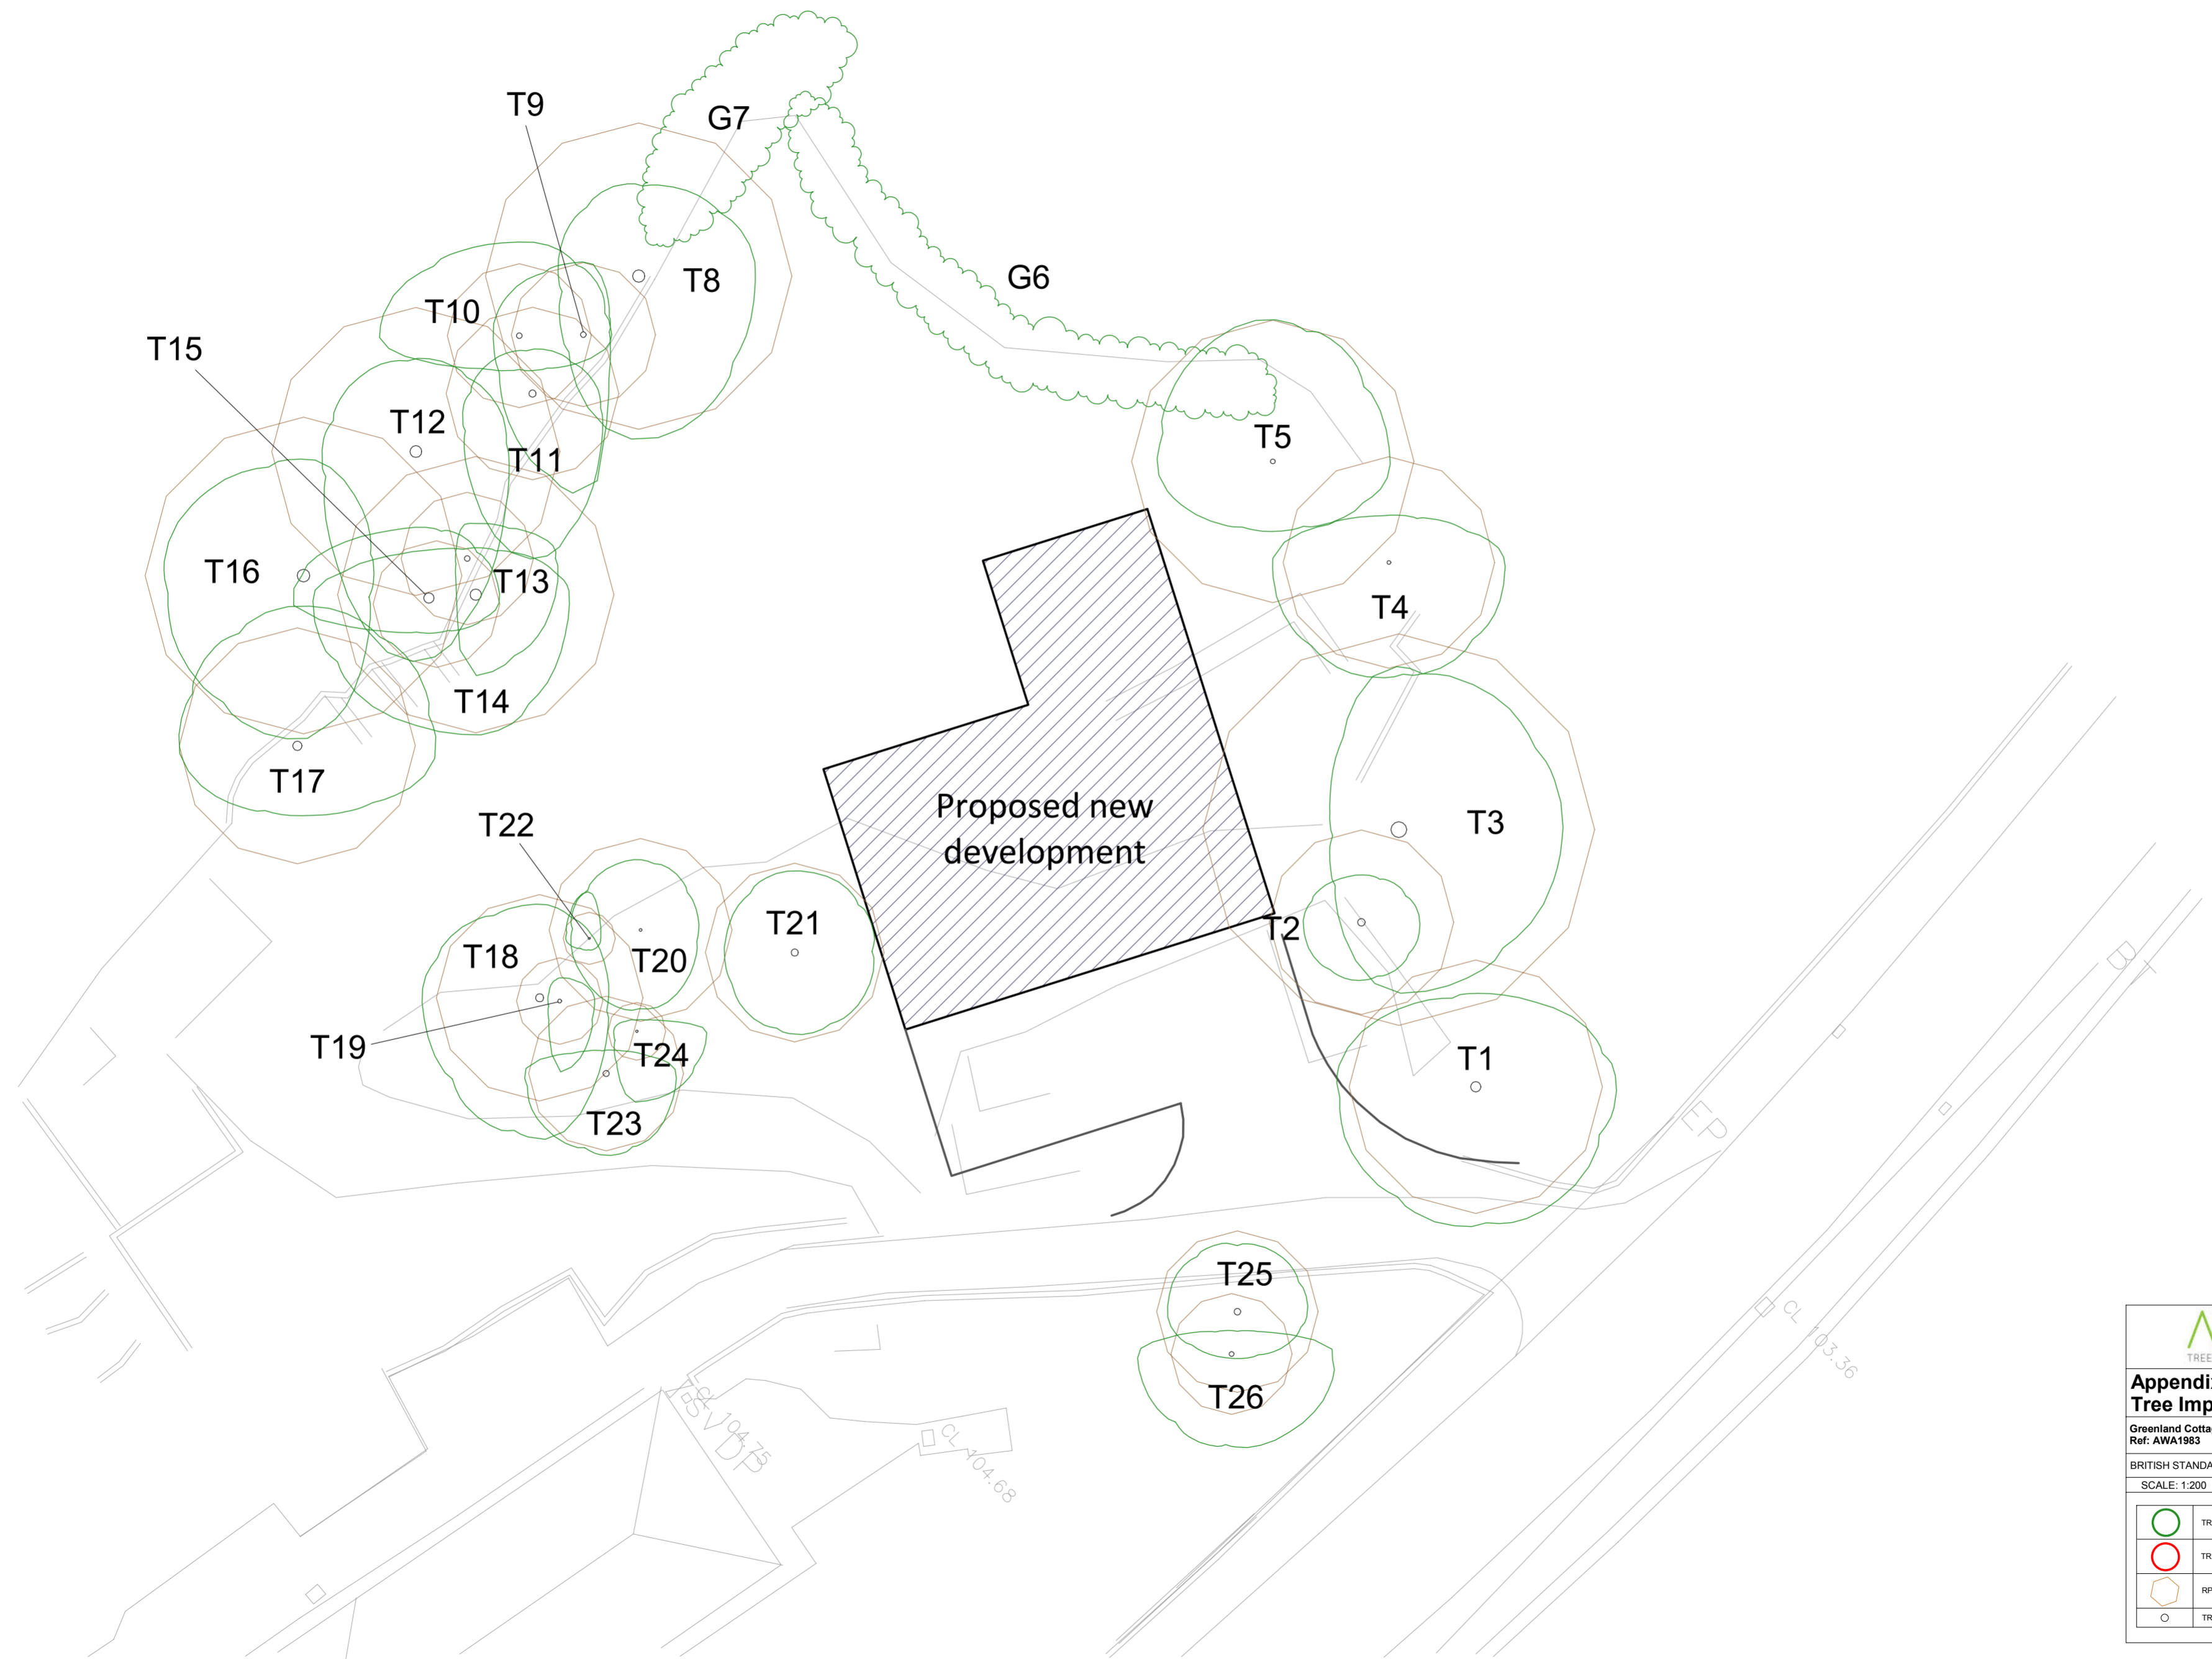
Appendix 6:
Tree Impacts Plan
 Greenland Cottages, High Hoyland, Barnsley
 Ref: AWA1983
 BRITISH STANDARD 5837:2012
 SCALE: 1:200 PAPER: A2

- 4.3.2 Potentially damaging activities are proposed in the vicinity of retained trees. The new development encroaches into the edge of the RPA of the neighbouring Oak T3. However, the solid bedrock to the west of the tree means it is very unlikely that significant roots will be within the development footprint and the retained tree should remain largely unaffected by the works, provided care is taken during construction.

- 4.3.3 The new development encroaches into the edge of the RPA of trees T2, T5 and T21. However, the encroachment is very minor, and the detailed RPA for these trees is likely to be a slightly exaggerated representation of the trees' actual rooting area. As such, it is unlikely that significant roots will be within these areas and the retained tree should remain largely unaffected by the works, provided care is taken during construction.

- 4.3.4 The new access encroaches into the edge of the RPA of trees T1 and T25. The construction of hard surfaces within the RPA can have negative impacts on tree roots. However, the potential negative impacts can often be overcome or minimised by employing a 'no-dig' type construction methods with a porous final surface.

- 4.5.1 The retained trees will require protection by fencing in accordance with BS 5837: 2012, during the development phase.
- 4.5.2 If required by the Local Planning Authority, an associated Arboricultural Method Statement, detailing protective fencing specifications and construction methods close to the retained trees can be provided.
