**Tree Impact Appraisal: Site at Guyder Bottom Farm, (Contour House)  
Cooper Lane, Hoylandswaine.**

Client: **Mr & Mrs A Jones,  
Via Steve Burlaga,  
Axis Architecture, Sheffield**

Planning application No. **Barnsley MBC; 2015/1338. 2013/0745**

File reference: Guyder Bottom Farm 02

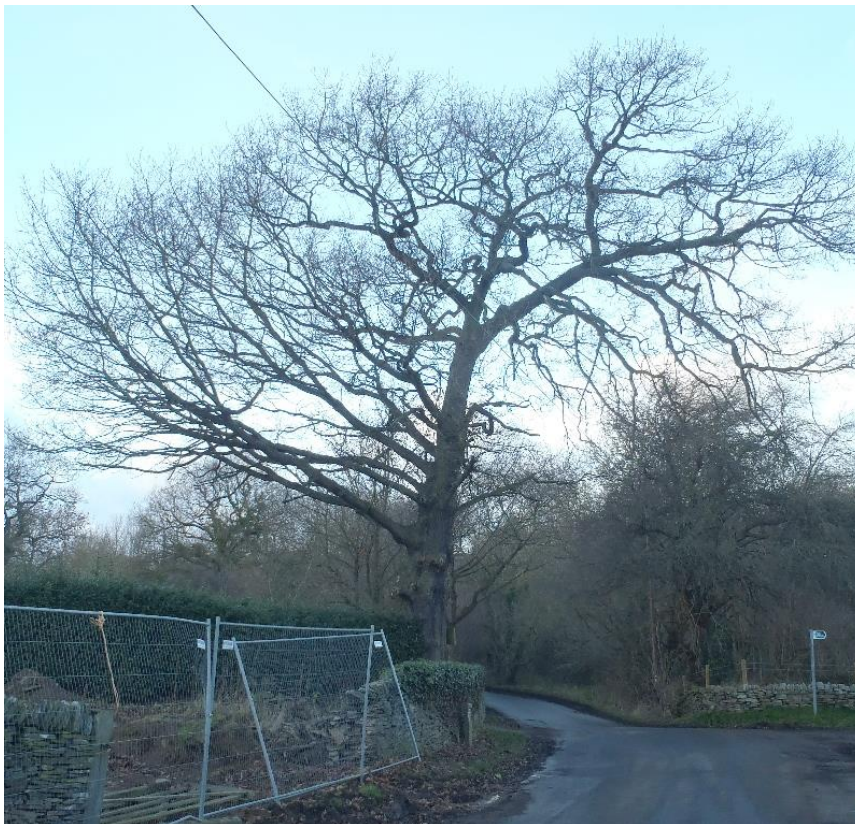
Photograph 1.

Photograph 1 shows the tree. While it is something of an untidy specimen, it is fairly typical of this sort of tree in this sort of area. It appears to be a considerable age and seems to have survived many decades of passing farm traffic, as well as the vagaries of the local climate (storm damage).

The trunk diameter is approximately 750 mm and it is approximately 16 metres tall. The crown spreads approximately 20 metres. I suspect the rather strange crown shape is due to "retrenchment."

It is not unusual to find Oak trees in agricultural areas retrenching; something causes a check in the tree's growth, perhaps drought or disease, but the tree recovers and proceeds to grow more vigorously again. In this case it looks as though a companion tree (to the left) might have been removed in the past, which might have given rise to the left hand branches (to the south) having been reinvigorated as they suddenly received more sunshine. This of course is highly speculative and I only mention it as a possibility. However it came to be this shape doesn't matter; while it's untidy it has character and will no doubt add to the neighbourhood's biodiversity, even if there's no particular shortage of biodiversity hereabouts.

The site's layout calls for the tree to be retained and while the new entrance to the site is due to be inserted where the gap in the wall has been created, it appears to have been put there deliberately to keep away from the tree. A tree of this size requires a root protection area (as defined by British Standard 5837 2012 Trees in relation to design demolition and construction – Recommendations) of radius 9 metres and it seems that the proposed site layout will accommodate this fairly comfortably.

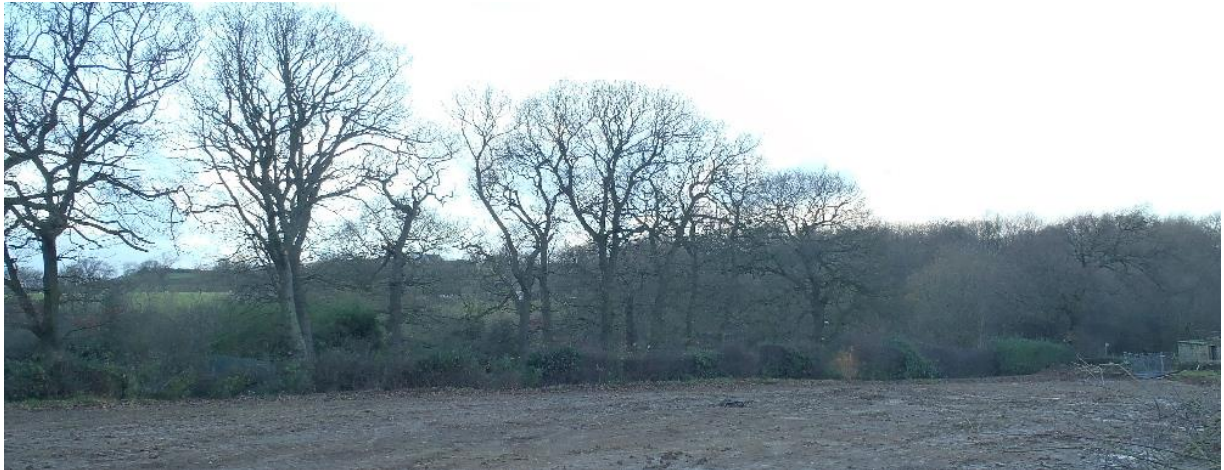
Photograph 2.

Photograph 2 is a view of the hedgerow along the western boundary. The trees beyond, Oaks, are the other side of the farm drive. The Oak in photo 1 can just be seen at the extreme right.

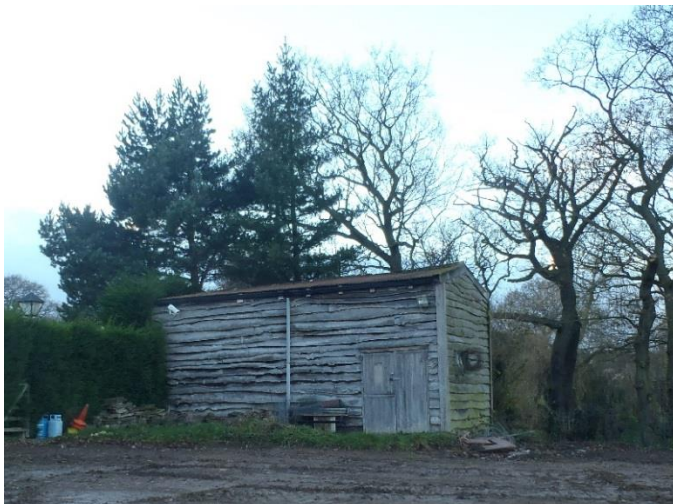
Photograph 3.

Photograph 3 is a view of the south-western corner of the site. The Pines (a Scots and a Corsican) behind the outbuilding are relatively young and should be tolerant of nearby work; they're just outside the site's boundary.

The outbuilding is to be replaced with a car port. The Oaks in the background are the continuation of the row visible in photo 2.

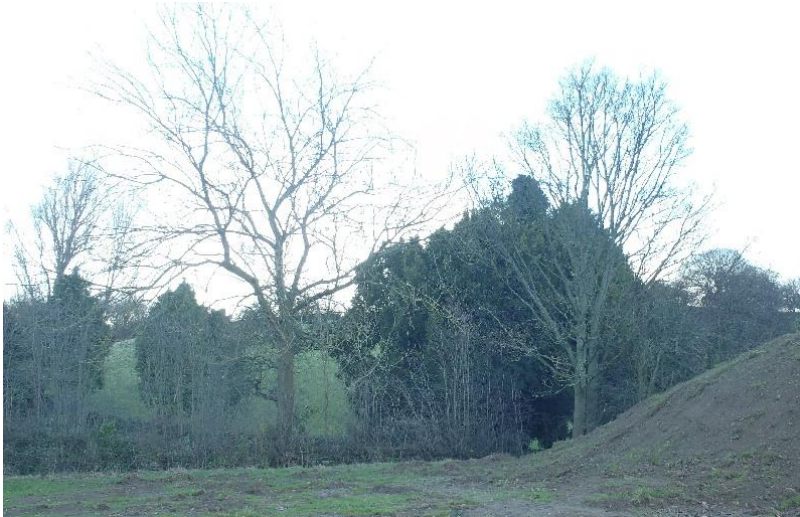
Photograph 4 is a view of two trees on the northern boundary alongside the road. The mound of topsoil is to the right. The left hand tree is an Ash, the right hand one a Sycamore.

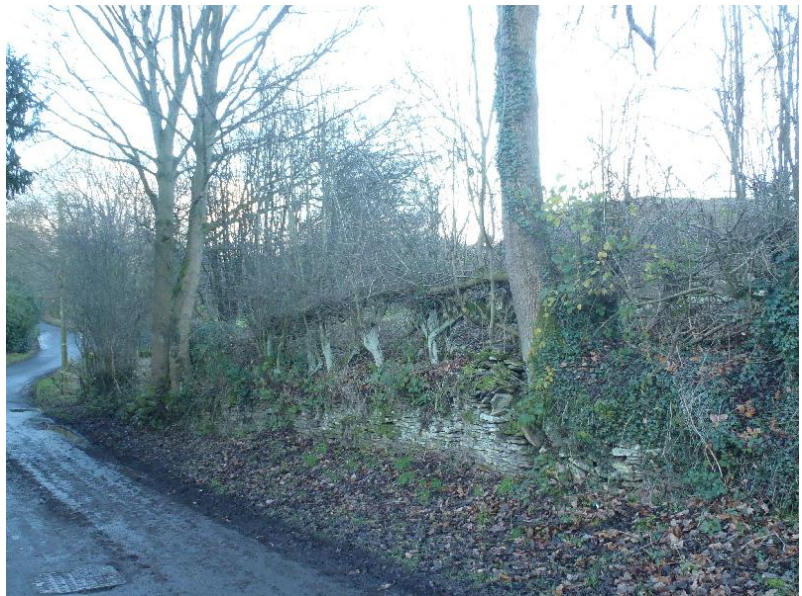
Photograph 5.

Photograph 5 is a view of the trees from the road. The Hawthorn hedge alongside the road here has not been well-maintained recently. Fortunately it is not yet beyond restorative pruning.

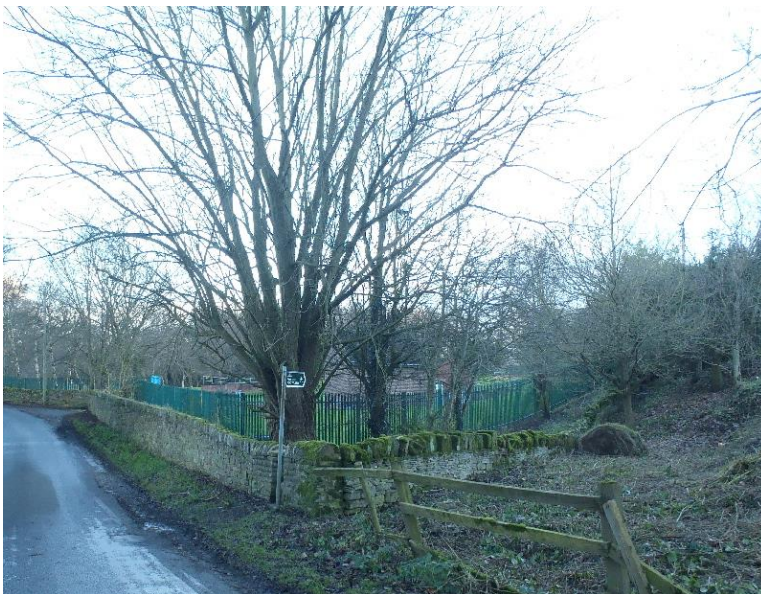
Photograph 6.

Photograph 6 is a view of the eastern corner of the site with the water treatment site in the background. The tree is a Pussy Willow, which I presume belongs to the water company.

A public footpath is routed alongside this boundary and some trees from the site overhang; they will require regular maintenance if they are not to obstruct the right-of-way.

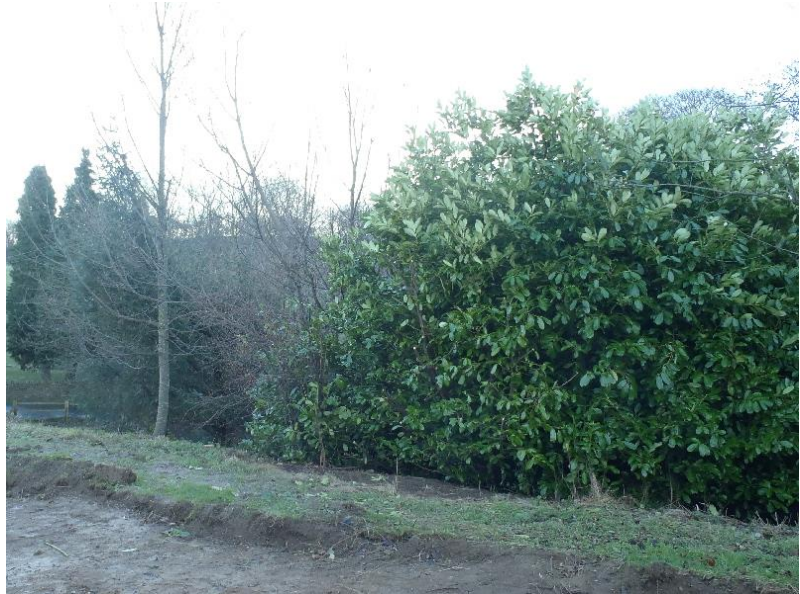
Photograph 7.

Photograph 7 shows the eastern boundary from within the site. This is only part of a group that contains young Sycamores, Sitka Spruce, Rowan and Cherry. The evergreen shrub is Cherry Laurel and while it screens the site of a view of the water treatment plant, I consider it would be best removed and replaced with something else. This is because Cherry Laurel is an invasive pest and it is almost certain to be included on the Government list of invasive species. (Usually called schedule 9, see below.)

I realise that many people still plant Cherry Laurel as there is no denying it can be a useful, fast-growing screen. Unfortunately it is becoming a pest in many woodlands almost as much of a nuisance as Rhododendron. The leaves can be toxic and it is significant that very little seems able to grow in its shade. I suggest that here it would be best removed and replaced with something else. I note that the site stripping has left it something of a Root Protection Area, but I consider it would have been better to get rid of it.
