## Design and Access Statement & Heritage Statement Combined

Elsecar Holy Trinity Primary School  
Church St  
Elsecar  
Barnsley  
S74 8HS

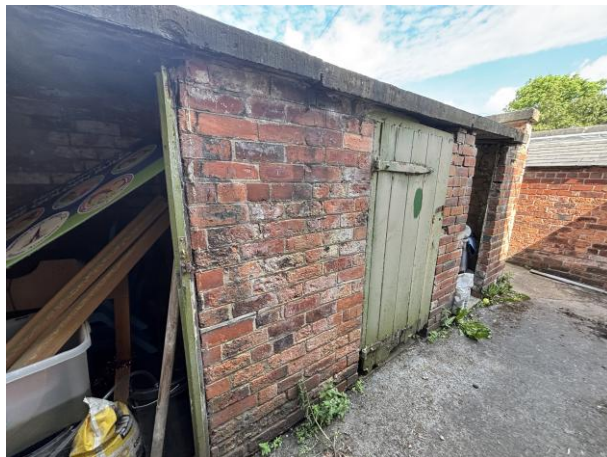
The outbuilding is in poor condition. A detailed structural inspection identified:

- movement, cracking and displacement of the masonry;
- leaning and separation within the brickwork;
- inadequate support over openings;
- an uneven and inadequately supported stone-slab roof; and
- evidence of rotation and instability within the roof and walls.

The condition of the outbuilding means that it is beyond reasonable repair and presents a potential safety risk.

Photo 2 – Outbuilding showing general condition and lack of support over openings

The proposed works comprise the careful demolition and removal of the unsafe brick outbuilding, together with the repair and retention of the adjoining stone boundary wall.

- careful dismantling and removal of the Yorkshire stone-slab roof;
- demolition of the brick-built outbuilding walls;
- removal of associated materials and debris;
- temporary removal of coping stones and localised upper masonry where necessary to enable the safe removal of embedded stone slabs;
- reinstatement of the coping stones following completion of the works;
- localised repair and making good of the retained boundary wall; and
- installation of a relieving lintel above the existing access opening.

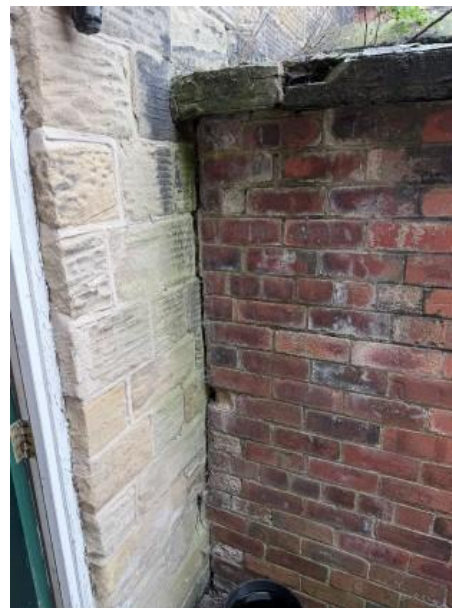
Photo 3 – Movement and separation between outbuilding and main structure

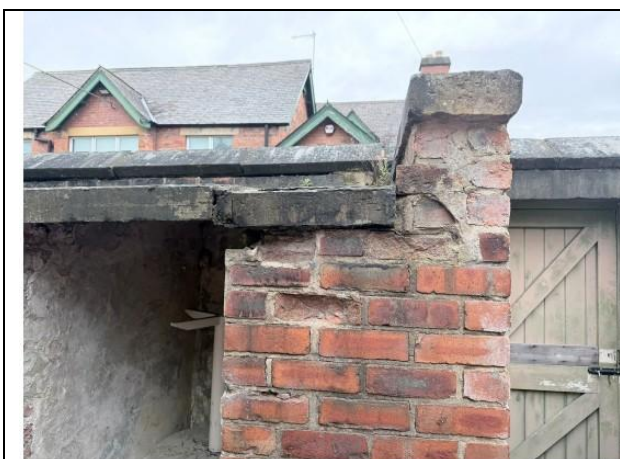
Photo 4 – Displacement and rotation of brickwork wall

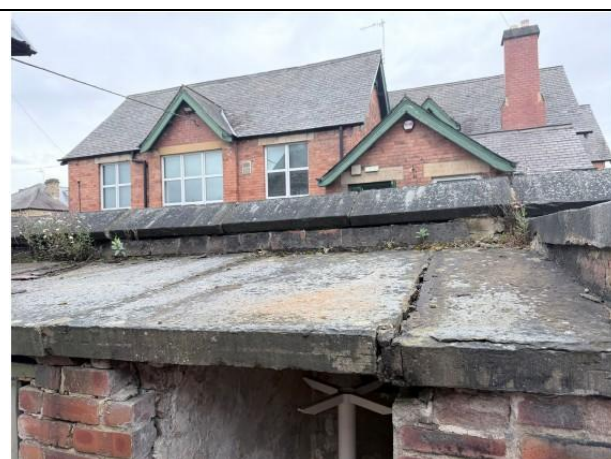
Photo 5 – Condition of stone slab roof and lack of support

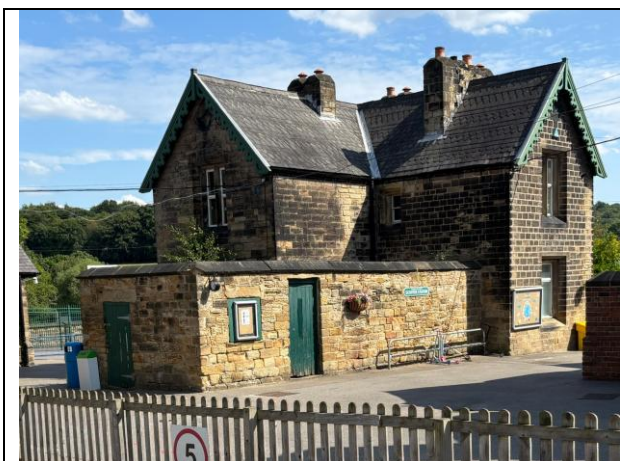
The boundary wall is generally stable but has areas of weathering, deteriorated mortar joints and localised defects to its stonework.

Photo 6 – External face of retained stone boundary wall showing differing in material

The retained stone boundary wall will be repaired and repointed using a compatible lime mortar. The proposed mortar mix is:

**1 part NHL 3.5 hydraulic lime to 3 parts well-graded aggregate or washed sand.**

The final colour, texture and aggregate content will be selected to match the existing mortar and masonry as closely as reasonably practicable.

Any localised masonry repairs will use materials matching the existing stone and brickwork in colour, texture, size and appearance. Areas of repair will be kept to the minimum necessary to ensure the stability and weather resistance of the retained wall.

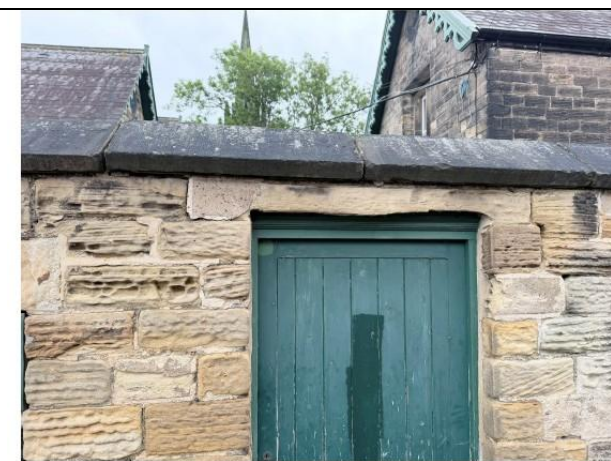
Photo 7 – Weathered stone lintel to access opening

A new relieving lintel will be installed above the existing stone lintel to provide additional structural support. It will be positioned and finished to minimise its visual impact and will not obscure significant historic detailing.
