Ecological Information  
Network Consultants

## PROPOSED REPAIRS AT NEW HALL BARN

### Wildlife Report

January 2010

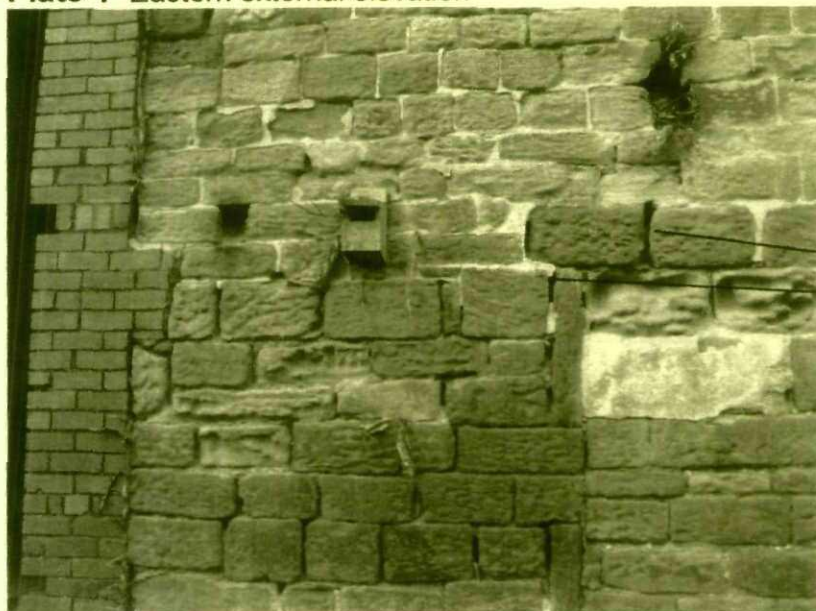
**Plate 1** Eastern external elevation

- 2.5.3 Several crevices between the coursed sandstone rubble wall of this elevation were suitable for bat entry into potential bat roosts as shown in Plate 1. However, each crevice was searched for signs of bats and none were recorded. Similarly, any crevices between the wall plate and the tops of the stone wall, between the stone wall and adjacent brick 'columns' that supported the main open door and crevices within the door lintels were all searched for signs of bats.

- 2.5.4 No signs of bats were recorded on any of the external surfaces.

Numerous  
crevices  
between the  
stonework were  
suitable for bat  
entry into  
potential bat  
roosts

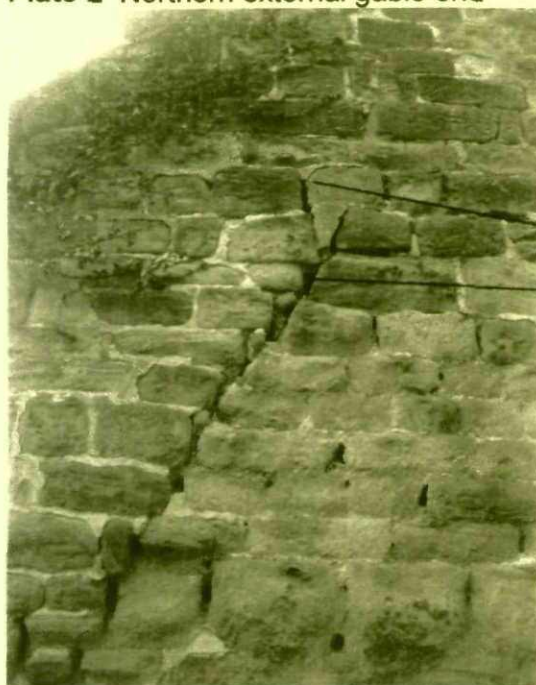
**Plate 2** Northern external gable end

- 2.5.5 A small, blocked-up, window occurred under the apex of the northern, external, gable end. Once again several crevices between the coursed sandstone rubble wall of this elevation were suitable for bat entry into potential bat roosts (Plate 2). However, once again no signs of bats were recorded on any of the external surfaces.

Numerous  
crevices  
between the  
stonework  
were suitable  
for bat entry  
into potential  
bat roosts

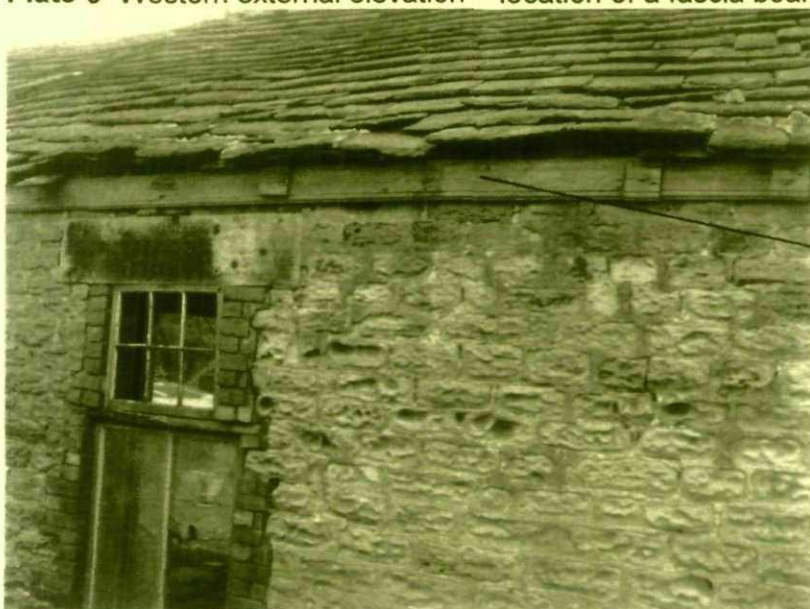
**Plate 3** Western external elevation – location of a fascia board at eaves level

- 2.5.6 This was similar in structure to the eastern external elevation, although several windows (and no doors) occurred here. The windows varied from being completely blocked to half-blocked-up to partially glass-framed. Once again, several crevices between the coursed sandstone rubble wall of this elevation were suitable for bat entry into potential bat roosts but, similarly, no signs of bats were recorded on any of the external surfaces. In addition, a fascia board occurred at eaves level along part of this elevation and several gaps suitable for bat entry were noted between the board and adjacent wall (Plates 3 and 4). However, no signs of bats were recorded.

Fascia  
board

- If possible, replace the existing fascia board recorded on the west elevation, ensuring that gaps with a width of 20mm – 25mm are maintained between the board and adjacent wall to create a series of potential bat roosts.

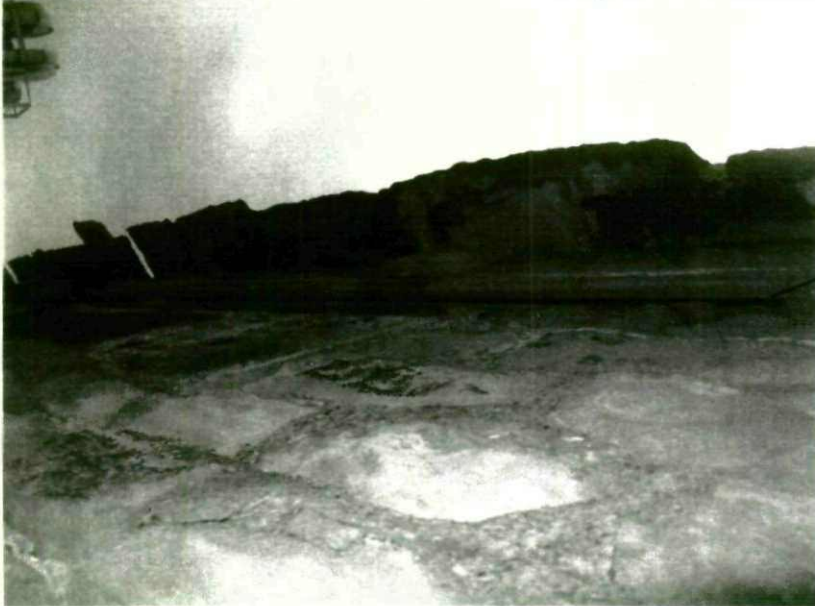
**Plate 4** Western external elevation – close-up of the fascia board

Crevice suitable for bat entry into a potential bat roost between the fascia board and the stone wall

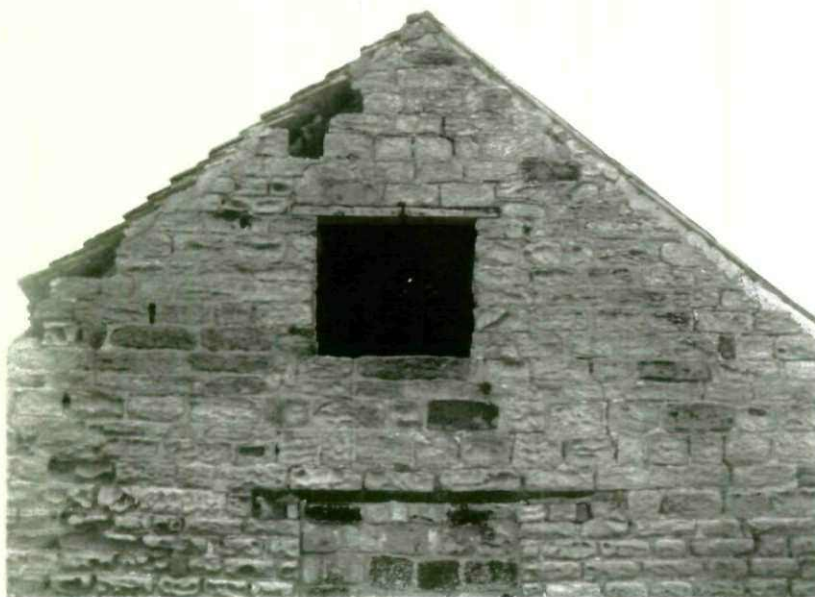
**Plate 5** Southern external gable end – the open window is one of the roosting barn owl's main entrances

- 2.5.7 An open window with a wooden lintel and stone sill occurred under the apex of the southern, external, gable end (Plate 5). In addition, the remnants of a stone-blocked window also occurred at the ground level of this elevation. Once again several crevices between the coursed sandstone rubble wall of this elevation were suitable for bat entry into potential bat roosts. However, once again no signs of bats were recorded on any of the external surfaces. Nevertheless, twigs were noted in one of the cavities within the stone wall, indicative of a bird's nest.

- 4 Long-term provision for barn owls should be created within the barn at the southern gable end of the building respectively, as this is the part of the barn that is most used by these birds. The provision should be undertaken during the proposed roof repairs as this is an ideal time to create a new entrance hole (minimum size 12cm wide x 25cm high) for barn owls through the end wall, just under the apex. The removal of one stone from the outer face beneath one of the bridging stones in the apex of the gable end should be sufficient to allow these birds to continue to roost within New Hall Barn.

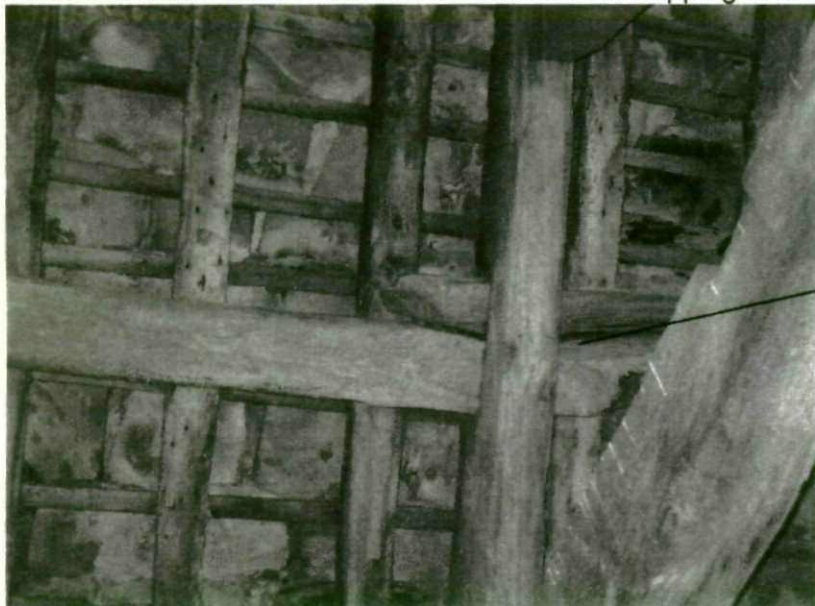
**Plate 6** Internal view of the roof to illustrate overlapping roof timbers

- 2.5.8 Many crevices suitable for bat entry into potential bat roosts were noted between the overlapping roof rafters and purlins (illustrated in Plate 6), as well as within the junctions between the various roof trusses and walls. No signs of bats, however, were recorded in any of these crevices. A swallow nest was recorded in the roof rafters above Truss E, two other birds' nests were

Crevices between the overlapping purlins were sometimes suitable for bat entry into potential bat roosts

- In some locations it is recommended that bats be allowed entry into the interior of the barn so that they can access any suitable crevices for roosting that occur between overlapping roof timbers etc. This could be achieved via the creation of small ventilation slots within the walls of the main barn and in the loft over the North room.
