# **ARBORICULTURAL REPORT & Impact Assessment to BS5837:2012 at:**

***Bloemfontein Street,  
Cudworth,  
Barnsley,  
South Yorkshire  
S72 8UN***

Prepared for:  
***WhiteAgus Partnership***

Reference: AWA3795

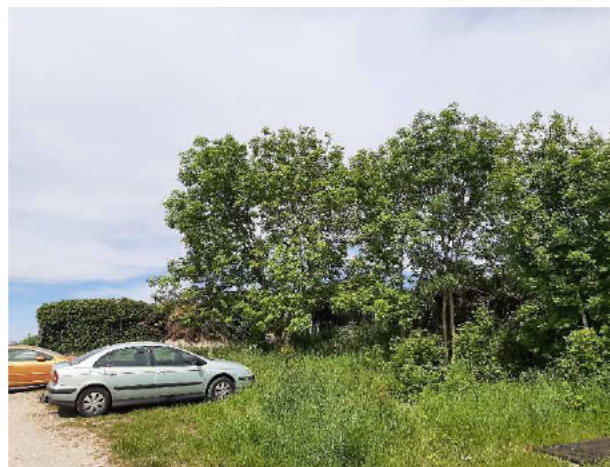
Photo 2: T1 to T4, at the northern boundary

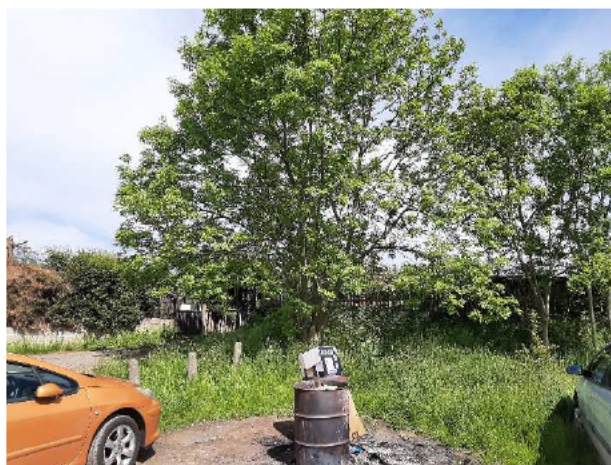
Photo 3: Fires close to T4, which have caused minor dieback in the crown

| Tree ID | Tree Species | | Maturity | Measurements | | | | Crown (m) | | | | | Tree Condition | | | | | | | Value | | Management |
|---|---|---|---|---|---|---|---|---|---|---|---|---|---|---|---|---|---|---|---|---|---|---|
| T4 | Ash | <i>Fraxinus excelsior</i> | Young | 5 | 3 | 100, 90, 60 | No | 0.5 | 1.5 | 1.5 | 1 | 1.5 | Limited access around base | Multiple stemmed at base, Slight lean, Epicormic growths | Normal | Epicormic at base prevented detailed inspection of roots | Good | Fair | 20 to 40 yrs | Low | C | Removal required to facilitate development |

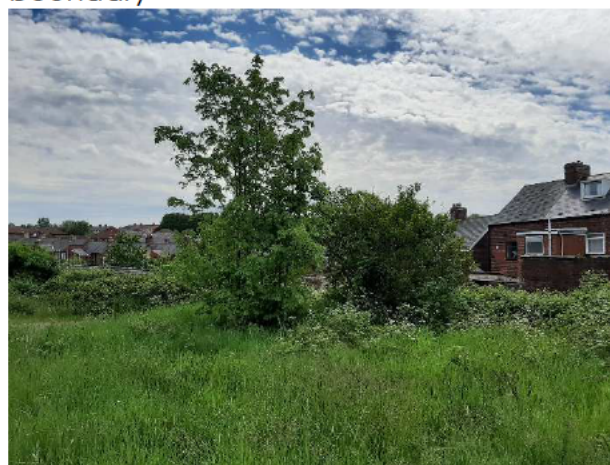
Photo 4: T8 and T9, at the eastern boundary

| Tree ID | Tree Species | | Maturity | Measurements | | | | Crown (m) | | | | | Tree Condition | | | | | | | Value | | Management |
|---|---|---|---|---|---|---|---|---|---|---|---|---|---|---|---|---|---|---|---|---|---|---|
| T8 | Sycamore | <i>Acer pseudoplatanus</i> | Semi-mature | 7 | 2 | 140, 110 | No | 1 | 2 | 2.5 | 2 | 2.5 | Limited access around base, Suckering growth | Single stemmed at base, Twin stemmed at 1m, Vertical, Tight union, Partially included bark | Normal | High understory prevented detailed inspection | Good | Fair | >40 yrs | Low | C | Removal required to facilitate development |
| T9 | Elder | <i>Sambucus nigra</i> | Semi-mature | 3.5 | 10+ | 70 avg | Yes | 0.5 | 1.5 | 2 | 2 | 2 | Limited access around base | Multiple stemmed at base, Vertical and leaning stems, Tight union | Minor deadwood | | Good | Fair | 20 to 40 yrs | Low | C | Removal required to facilitate development |

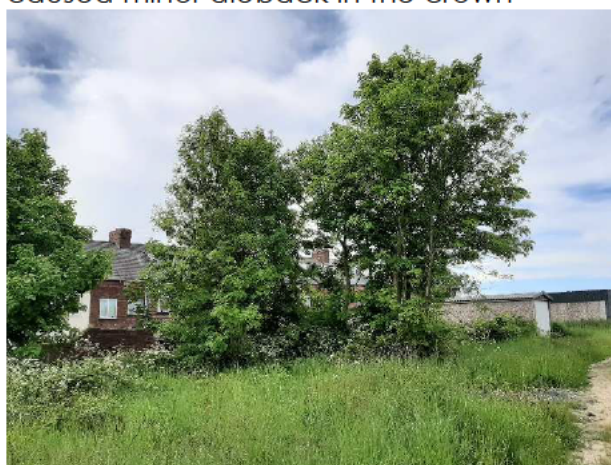
Photo 5: T10 and G11, in the centre of the site

| Tree ID | Tree Species | | Maturity | Measurements | | | | Crown (m) | | | | | Tree Condition | | | | | | | Value | | Management |
|---|---|---|---|---|---|---|---|---|---|---|---|---|---|---|---|---|---|---|---|---|---|---|
| T10 | Sycamore | <i>Acer pseudoplatanus</i> | Semi-mature | 9 | 6 | 150 avg | Yes | 2 | 3.5 | 4 | 4.5 | 4.5 | No visual defects | Multiple stemmed at base, Vertical and leaning stems, Tight union, Partially included bark | Bark damage on lower branches consistent with browsing | Occasional pruning wounds from crown lifting. Tight union in centre of stems | Good | Fair | 20 to 40 yrs | Low | C | Removal required to facilitate development |

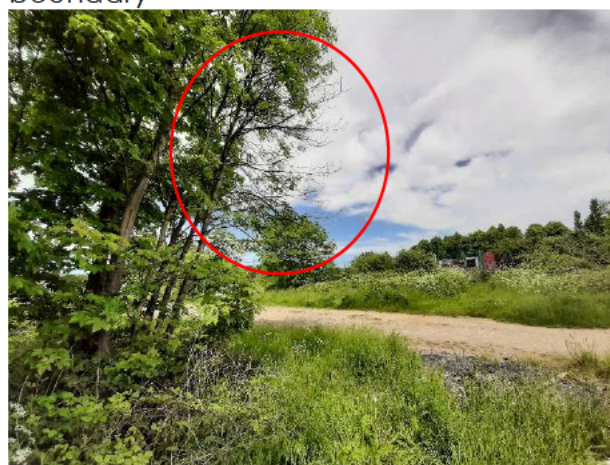
- 3.2.5 T1 and trees within G11 have been negatively impacted by nearby fires, causing some dieback. Repeated fires on the site, close to trees, are likely to impact the long-term prospects of trees.

Photo 6: Fire damage to trees in G11, circled

| | Tree Species | | | Measurements | | | | Crown (m) | | | | Tree Condition | | | | | | | Value | | Management | |
|---|---|---|---|---|---|---|---|---|---|---|---|---|---|---|---|---|---|---|---|---|---|---|
| G11 | Ash, Sycamore | Fraxinus sp.,<br>Acer sp. | Semi-mature | 8.5 | 10+ | 100 avg | Yes | 2 | See Plan | | | | Bramble understory at base of trees. Fire damage at eastern eastern aspect resulting in dieback, with northernmost Ash stem with major dieback. Some tight unions with partially included bark | | | | Fair | Fair | 10 to 20 yrs | Low | C | Removal required to facilitate development |
