41 Hoyland Road, Hoyland Common

Bat Survey Report

21st August 2025

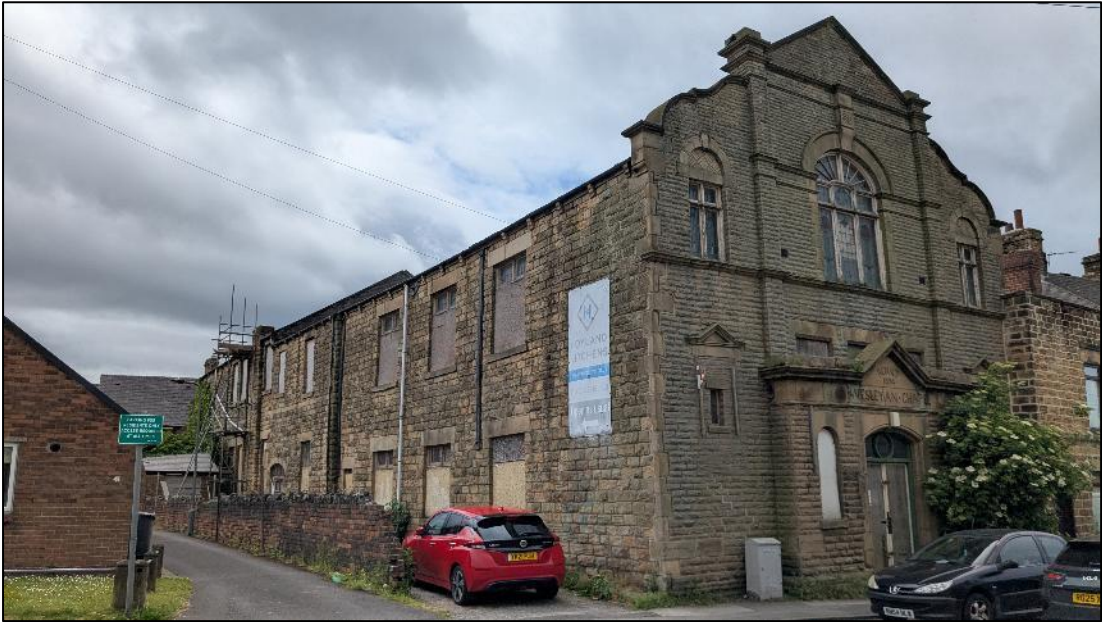
Plate 4. Building viewed from north corner

- Crevice gaps behind sections of fascia board.
- Crevice gaps between wooden window boards, glazing and adjoining masonry (Plate 8).
- Open joints in masonry on external walls (Plates 7 & 8).
- Extensive ivy cover, with thick stems on the southeast gable (Plate 5). This may present a bat roost feature in its own right, as well as potentially obscuring other building features.
- Missing verge mortar on the southeast gable.
- Narrow crevice gap behind Hoyland Kitchens sign (Plate 4)

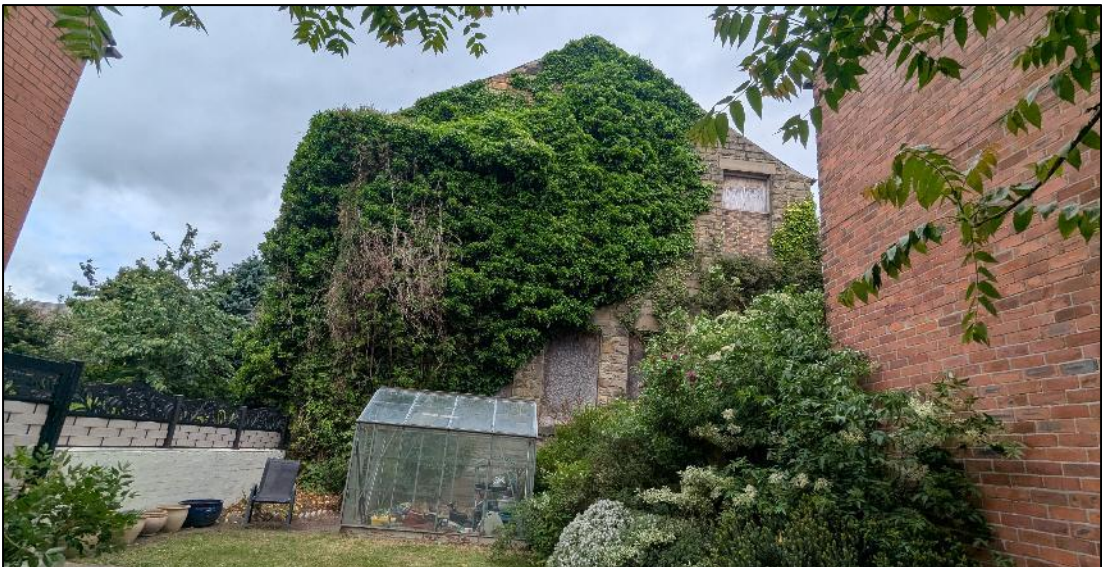
Plate 5. Southeast gable

- 6.1.4 Nocturnal surveys showed the presence of a large roost and possible nest site of house sparrow in dense ivy cover on the southeast gable. In addition, feral pigeon were recorded nesting throughout the building's roof.

- 6.3.4 It is recommended that any work to remove ivy from the southeast gable of the chapel should take place outside the main bird nesting period (March to August). Re-development of the wider chapel should either commence outside this period, or be preceded by a nesting bird check, to be undertaken by an ecologist.

- 6.4.4 It is recommended that three integrated swift boxes are installed in the southeast gable.

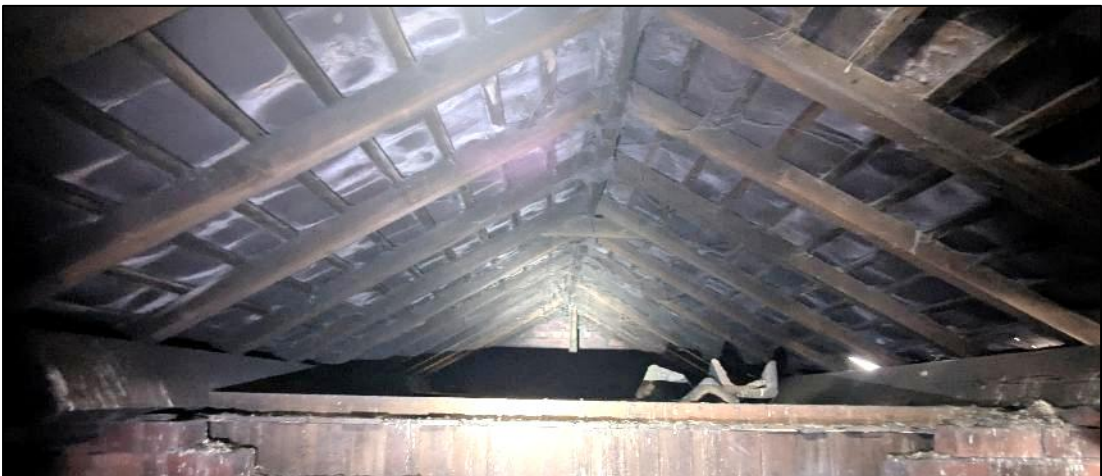
Plate 9. Section of roof void

5.2.6 The roof was unlined and suspended on a ridge beam, purlins, rafters and battens. A roof void of varying height was present across the building, with a maximum height of c.3 m. The roof void supported multiple actively nesting pigeons and was very dirty as a result.

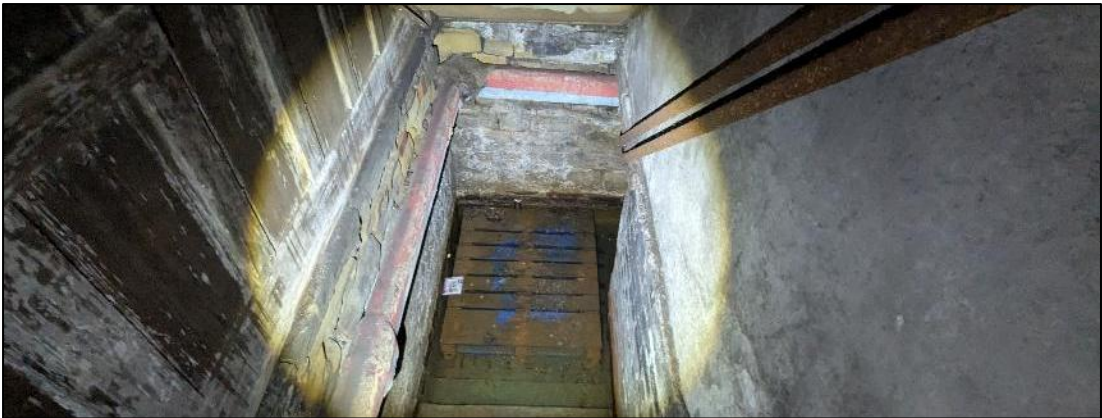
Plate 11. Looking down into flooded cellar

5.2.8 The building had a flooded cellar but this could not be accessed by bats, due to the presence of a closed and tight-fitting door.

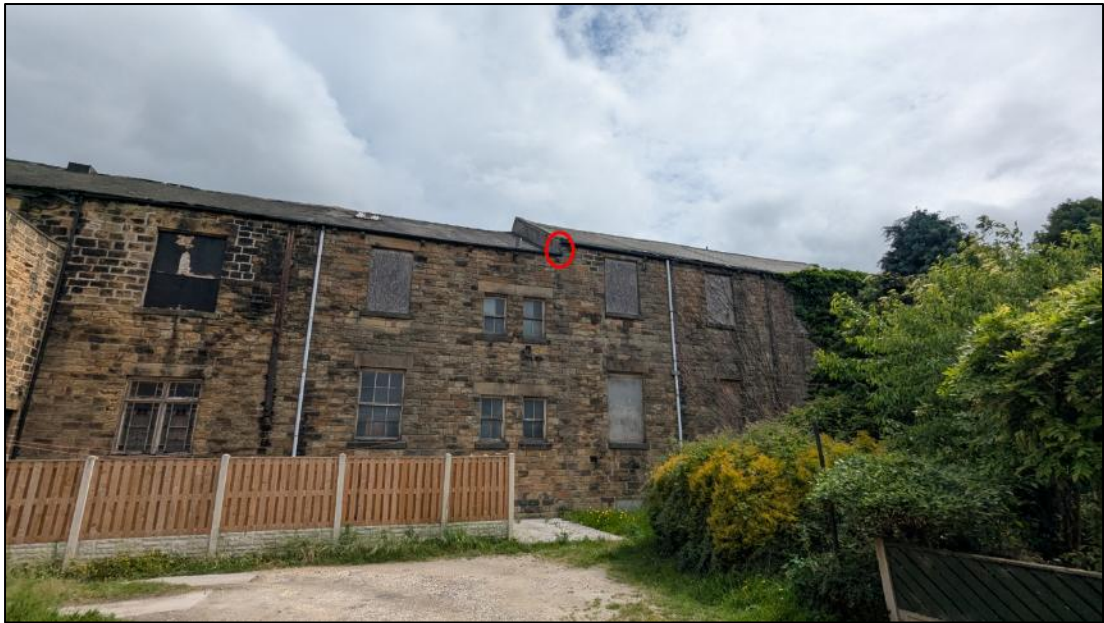
Plate 12. Location of reported bat roost on southwest elevation of the former Wesleyan Chapel

- 5.2.10 The temperature at the beginning of monitoring was 16 °C, with a light air (Beaufort Scale Force 1) and two oktas of cloud (2/8 oktas). The temperature dropped to 15 °C and the cloud cleared, with the wind remaining the same. The weather was dry throughout. Sunset was at 21:37.
- 5.2.11 Prior to the survey commencing a neighbour from 25 Hoyland Road informed the surveyors that they had previously observed a low number of bats (3-5) roosting in the former Wesleyan Chapel. The neighbour stated that they had seen bats entering the building at the location shown in Plate 12 in previous years.

- 6.3.3 The proposed Non-Licensed Method Statement is set out in Appendix 1. Once scaffold is in place, a licensed bat ecologist should attend site to check the roost location detailed in the anecdotal record (Plate 12), and to deliver a toolbox talk to the development team. If evidence of bat roosting is recorded at this stage then works should cease and the need for a bat mitigation licence should be re-evaluated by the ecologist. Assuming works may proceed, then, as a further precaution and taking into account ecological enhancement recommendations detailed in the National Planning Policy Framework (2025), it is advised that a bat safe roofing membrane should be fitted (Appendix 2), together with the installation of two integrated bat boxes (Plates 13-15) in the building’s wall. These boxes should be fitted at wall top height, away from external lighting on either the southwest or southeast elevations.

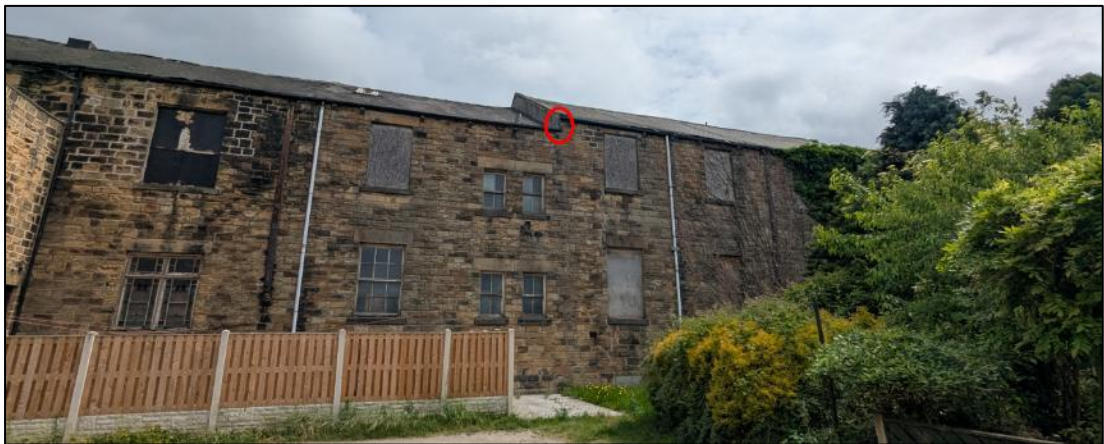
Plate A1.1. Location of reported bat roost on southwest elevation of the former Wesleyan Chapel

- An anecdotal record of roosting bats was received in relation to the former Wesleyan Chapel, with a neighbour recording a historic roost in the southwest elevation (Plate A1.1). Bat survey works undertaken in 2025 suggested this roost was not in current use.

- Prior to the works commencing a licenced bat ecologist will deliver this Toolbox Talk to the construction team and once the scaffold is in place, a bat ecologist should reinspect the reported bat roost. (Plate A1.1).

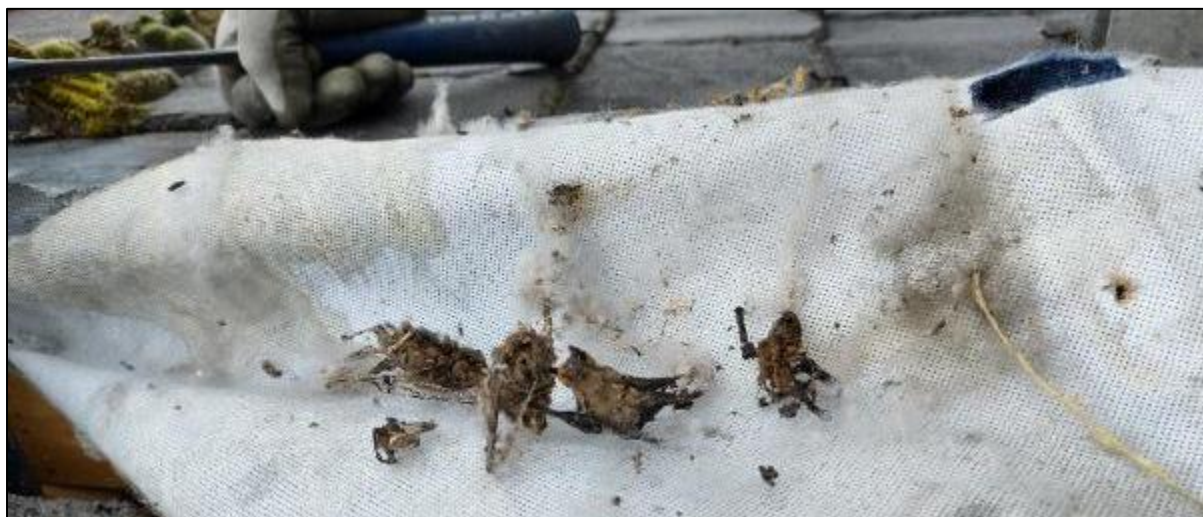
One example we have encountered comprised a pipistrelle roost which formed in a building extension constructed in 2009. Over the course of just 13 years the roofing felt degraded to the extent that it trapped and killed more than 10 bats. Fortunately, the problem in this roost was identified and remedial work was undertaken to replace the roofing membrane in 2022.

Plate A2.1. Four dead pipistrelles tangled in breathable roofing felt

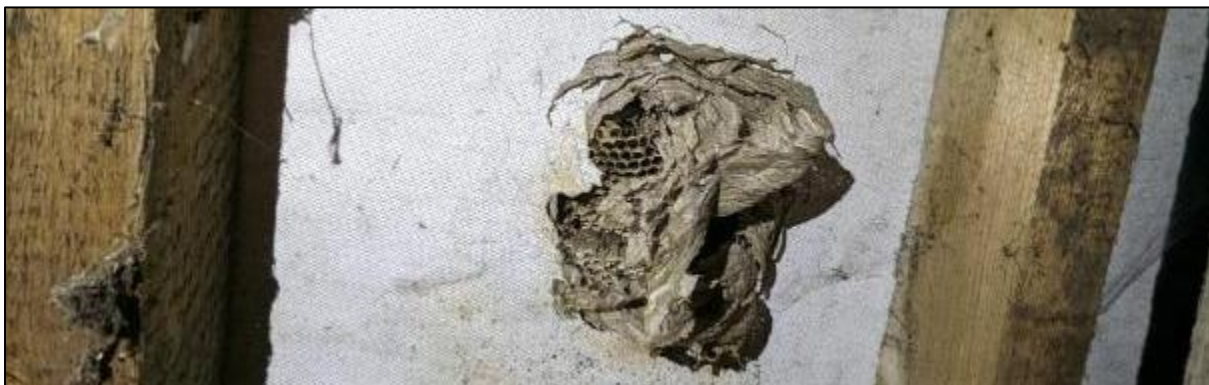
In recent years a fairly substantial proportion of the lofts we have surveyed which had existing breathable felt, were found to have been damaged by wasps (Plate A2.2). In these situations, the wasps appear to have chewed holes in the felt and formed nests in the holes. This doesn't appear to be a problem associated with the traditional bitumen coated roofing felt. Obviously, any holes within roofing felt would be likely to significantly reduce its functionality as a secondary weather barrier. Where bats or birds do come into contact with breathable roofing membranes, they can damage the membrane causing it to leak and they can also significantly reduce the breathability of the felt in that location.

Plate A2.2. Damage to a breathable roofing membrane adjacent to a wasp nest
