Our Ref: PBP/01/HMMJR

21st December 2016

Coal Mining Stability Risk Assessment  
Hollinberry Lane, Howbrook

**PB PLANNING    HOLLINBERRY LANE, HOWBROOK**  
**COAL SEAM, MINE ENTRIES AND PROPOSED LAYOUT**

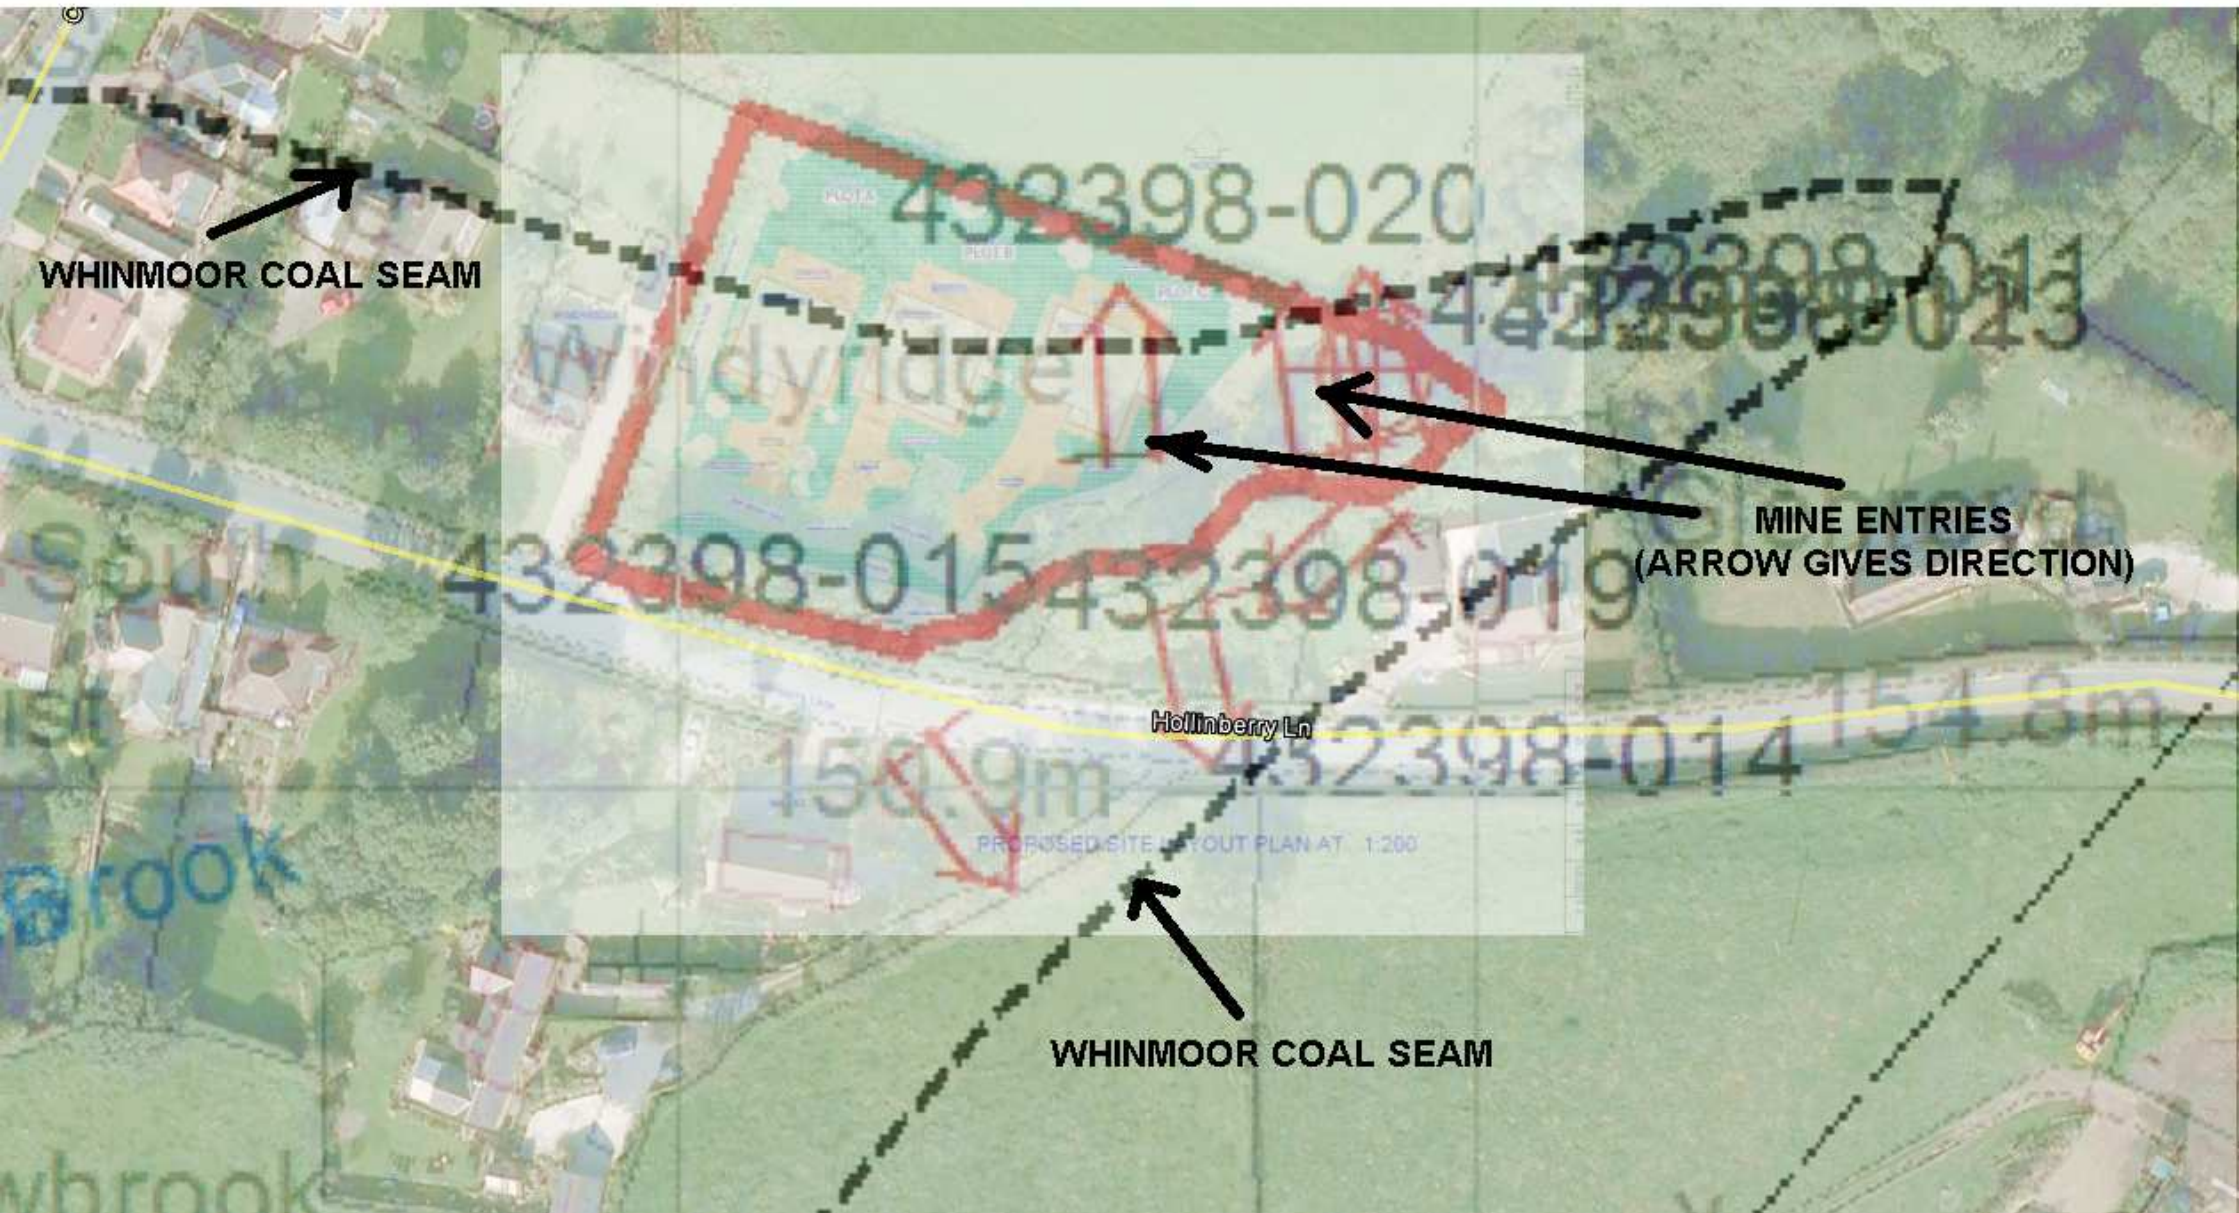
A coal seam outcrop (Whinmoor Coal) runs almost east to west through the middle of the site. The seam is indicated to be between 0.7m and 1.8m thick (including some rock partings). There are no other significant seams within 25m below the Whinmoor Coal. Three areas of infilled ground from restored opencast workings, are indicated approximately 300m to the west, 350m to the south and 400m to the northeast of the site. No faults are shown to be within influencing distance of the site. The site slopes down to the southeast. Therefore, the seam underlies the northern third of the site, north of the outcrop, and is absent on the remainder of the site.

There are seven coal mine entries on or within 20m of the site. There is no record of what steps, if any, have been taken to treat the mine entries. There is a risk of additional unrecorded mine entries in the general area. The mine entries are highlighted on the attached map. Four are on the site itself, comprising three adits heading north and one shaft in the eastern corner. Only one entry (an adit) has the potential to affect the stability of one of the three proposed houses, based on its indicated location.

Given the presence of adits on the site, the Whinmoor Coal has probably been worked by pillar and stall methods beneath the site, north of its outcrop. The indicated outcrop position would result in the rear elevations of all three proposed properties being affected. However, the outcrop position (and mine entry positions) may not be accurate, and more or less of the site may be affected in reality.

In the light of the above, it is recommended that an intrusive investigation is carried out to check for the presence and depth of workings. As they are likely to be very shallow, it will probably be more cost effective in the first instance to use an excavator rather than a rotary drilling rig. However, depending on the findings, the possibility that a rotary borehole investigation will be required cannot be discounted. Such investigations are usually carried out following the grant of planning permission, but before commencement of development. The planning permission will usually include a condition relating to the investigation and possible future treatment of mine workings.

The presence of underground workings is not a significant obstacle to development, and there are economical engineering solutions available. ARP provides advice on and designs such treatment solutions on a regular basis. If the positions of the outcrops and adits are as indicated on the maps, then remedial measures could comprise excavation and removal of the adit and surrounding workings northwards towards the boundary, and backfilling afterwards, to allow either trench fill or piled foundations to be used. However, this can only be confirmed following intrusive investigation.

A stopping of concrete or brickwork should be constructed at the mine end of any adits, sufficient to withstand the pressure of the compacted backfilling. Adits with water egress (possibly the case here – they may have drained south to the adjacent stream) should have a drain installed in the mine stopping. Any such water emerging will also need to be drained rather than left to soak away.

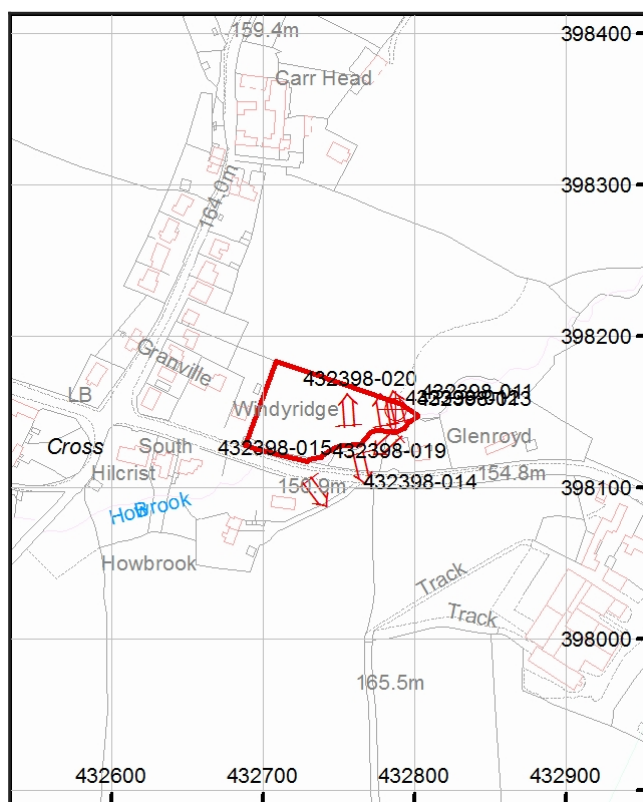
# Enquiry boundary

Within, or within 20 metres of, the boundary of the property there are 7 mine entries, the approximate positions of which are shown on the enquiry boundary plot.

There is no record of what steps, if any, have been taken to treat the mine entries.
