ARBORICULTURAL REPORT

to BS 5837:2012 at:

***Stairfoot Roundabout,
Stairfoot,
Barnsley,
S71 5DS***

Reference: *AWA7043*

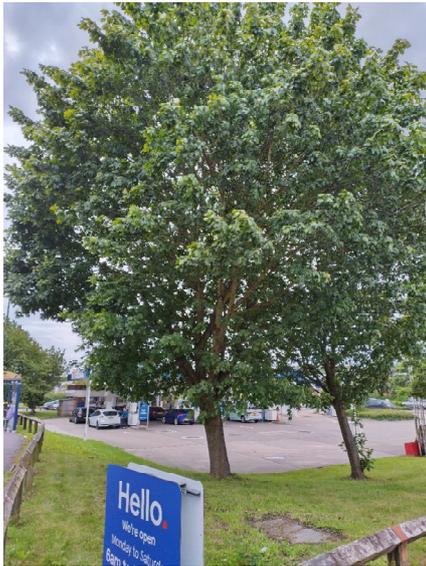
Photo 1: T6 from north.

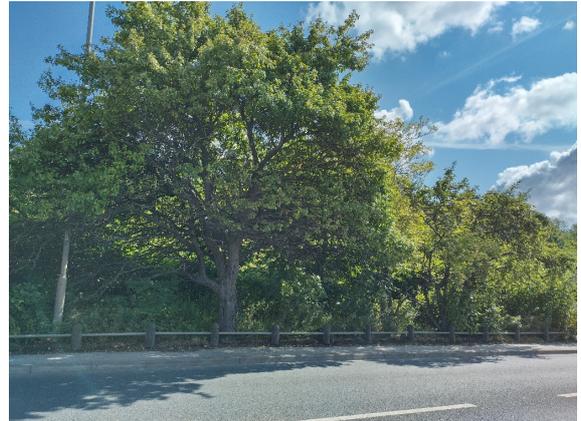
Photo 2: T21 from west.

T21	Apple	<i>Malus domestica</i>	Mature	7	1	480	No	1.5	4.5	4.5	4	4	No visual defects	Single stemmed. Epicormic growths. Old pruning wounds. Stubs. Tight union. Partially included bark. Minor cavities. Minor decay	Minor dieback. Moderate deadwood	Road and pavement to southwest. Crown raised over road. Lower crown over pavement mostly dead.	Fair	Fair	20 to 40 yrs	Moderate	C	No works required in current site context
G22	Elder, Apple	<i>Sambucus nigra, Malus domestica</i>	Semi-mature	5	6	150 avg	Yes	0.5	See plan				Group of Elder and Apple. Pavement 1m to southwest.				Fair	Fair	10 to 20 yrs	Low	C	No works required in current site context

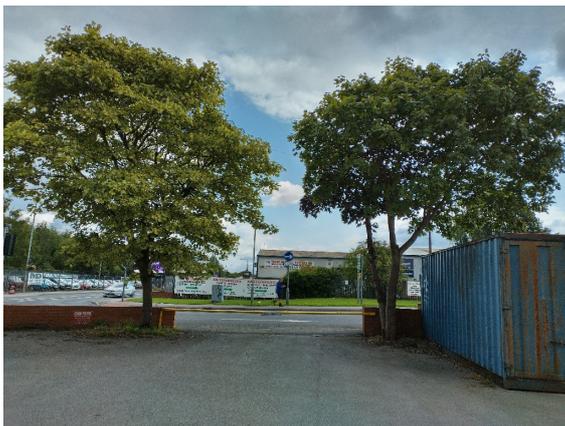
Photo 3: T41 and T42 from northwest.

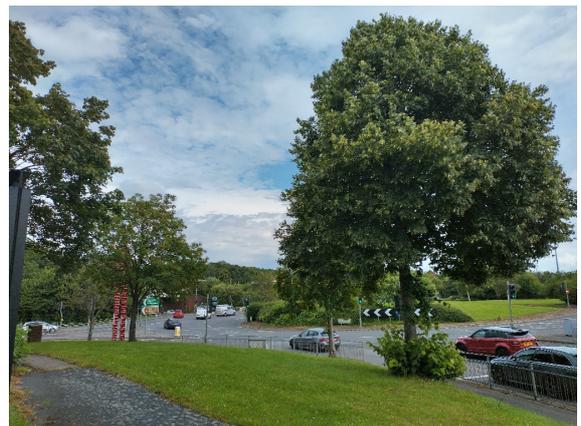
Photo 4: T45, T46 and T47 from southwest.

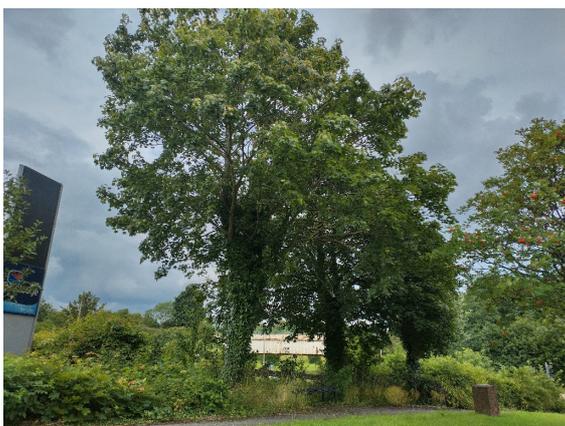
Photo 5: T49 and T50 from south.

T50	Norway Maple	<i>Acer platanoides</i>	Semi-mature	9	1	470	No	2	5	4.5	4.5	4	No visual defects	Single stemmed. Vertical. Ivy covered	Ivy covered. Minor deadwood	Overhanging pavement to south. Carpark 0.5m to north.	Good	Good	>40 yrs	Moderate	B	No works required in current site context
T51	Whitebeam	<i>Sorbus aria</i>	Early-mature	6	1	280	No	2	3	3	2.5	0.5	Limited access around base	Single stemmed. Slight lean. Ivy covered	Ivy covered	Ivy prevented detailed inspection. Slight lean to east.	Good	Fair	10 to 20 yrs	Low	C	No works required in current site context

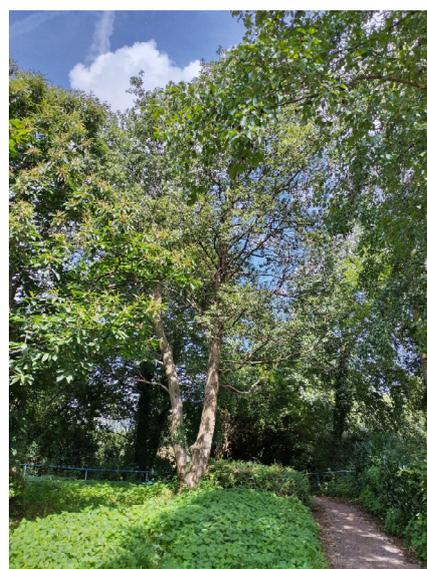
Photo 6: T71 from south.

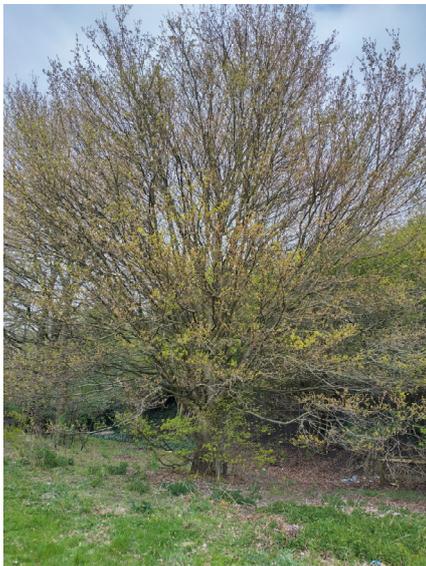
Photo 3: T226 from south

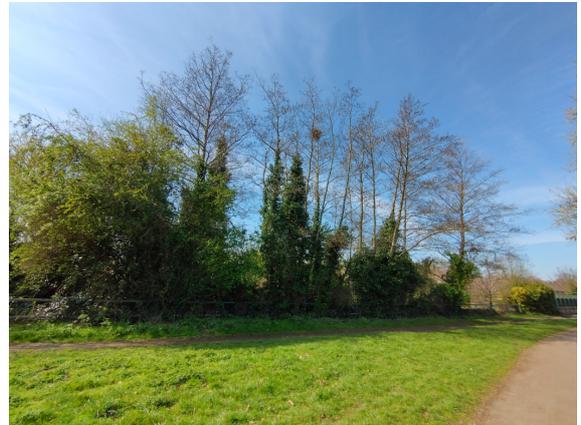
Photo 4: G77 from southeast.

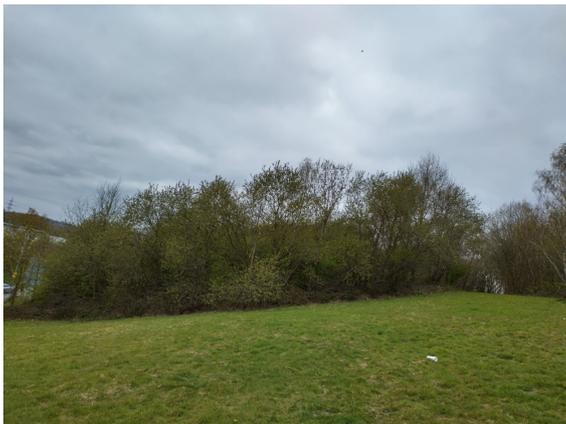
Photo 5: G247 from south.

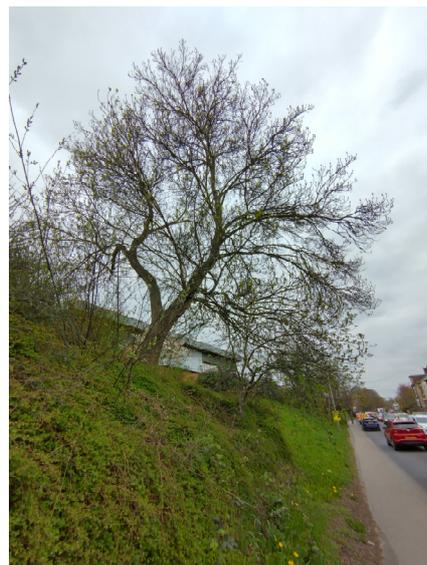
Photo 6: T242 from south.
