**PLAN NO: 10/13853/BR/1**

**EXTENSION TO EXISTING BUNGALOW AT THE ROOKERY, 57A DARTON LANE,  
MAPPLEWELL, BARNSLEY, S75 5AL**

**BUILDING REGULATIONS 2000  
APPROVED DOCUMENT A - STRUCTURE (2004 EDITION)  
REQUIREMENT A2(b) - SUBSIDENCE**

Application No: B2010/13853/BR1

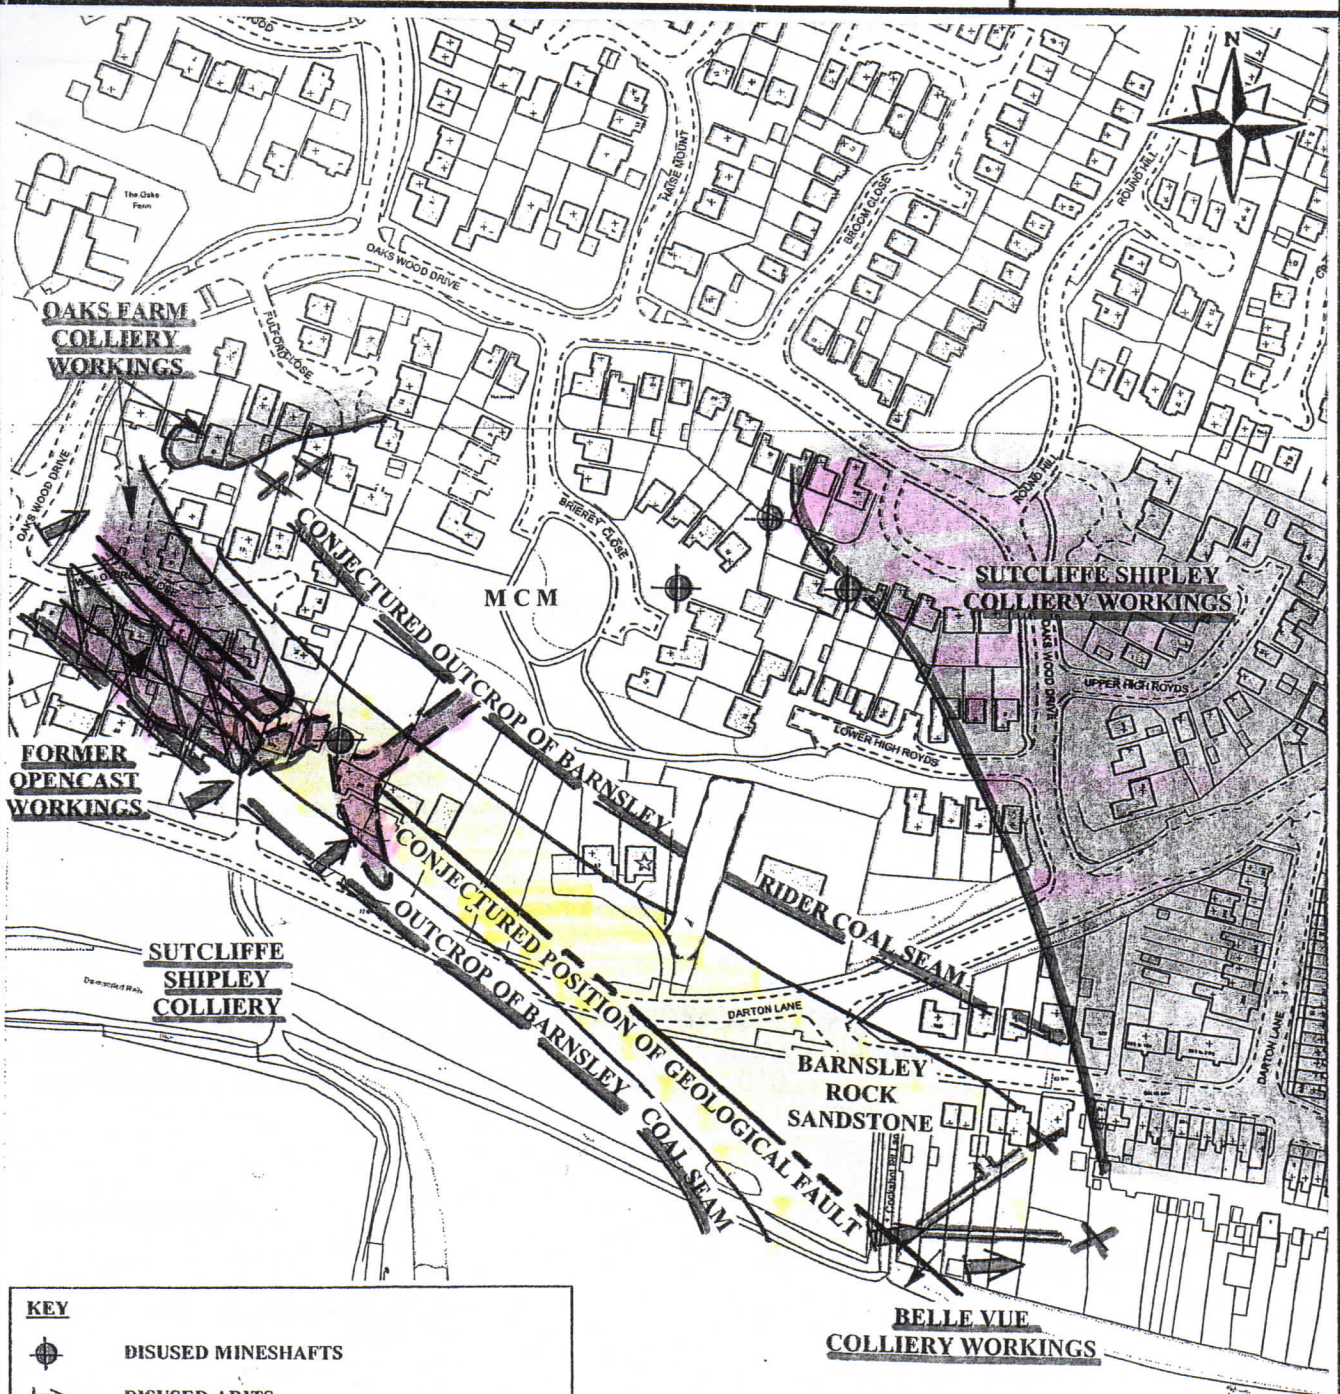
10/13853/BR1

| The conjectured surface position of geological faulting crosses the area as shown on the attached plan. | A3<br>✓ |
| The conjectured outcrop of the coal seam marked on the attached plan may be exposed in the foundations. | A5<br>✓ |
| The coal seam shown on the plan may be under the proposed development at a shallow depth. | A6<br>✓ |
| Shallow mineworkings in the coal seam marked on the attached plan may be present under the site. | A7<br>✓ |
| The mine shaft/adit marked on the attached plan is recorded within/adjacent to the site boundary. | A8<br>✓ |

ACCORDING TO SYMAS RECORDS THE PROPERTY LIES ADJACENT TO MINE ENTRIES, BACKFILLED OPENCAST AND MAY BE ABOVE SHALLOW MINE WORKINGS. NO RECORDS ARE AVAILABLE WITH REGARD TO ORIGINAL FOUNDATION DESIGN AND ANY PRIOR SITE INVESTIGATION. IT IS NOT KNOWN IF ANY GAS PRECAUTION MEASURES ARE INCORPORATED INTO THE EXISTING PROPERTY.

| Where fault/fissure problems are encountered, the foundations should be suitably designed. | B1<br>✓ |
| Any coal exposed by building work should be blinded off to prevent spontaneous combustion. | B2<br>✓ |
| The necessity for an investigation should be balanced against size and type of proposed development/extension. Boreholes to a depth of 15m would be recommended in this instance. (Prior consultations with the Coal Authority would be required). | B3<br>✓ |
| The nature and suitability of any made ground should be investigated. | B7<br>✓ |
| Precautions may be required should development be located over the highwall of the former opencast/quarry site due to the potential for differential settlement occurring. | B8<br>✓ |
| Although it is not a consideration of the A2(b) requirement all the usual safety precautions and monitoring procedures in respect of fugitive gases (associated with shallow coals, mine entries, made ground or landfill) should be employed during future excavations. | B9<br>✓ |
