# SOAKAWAY LETTER REPORT

**Location:** **The Crescent**  
Barnsley Road, Cudworth, Barnsley, South Yorkshire, S72 8SY

**For:** Barnsley Metropolitan Borough Council

**Report No.** C5255/26/E/9063 **Report Date:** February 2026

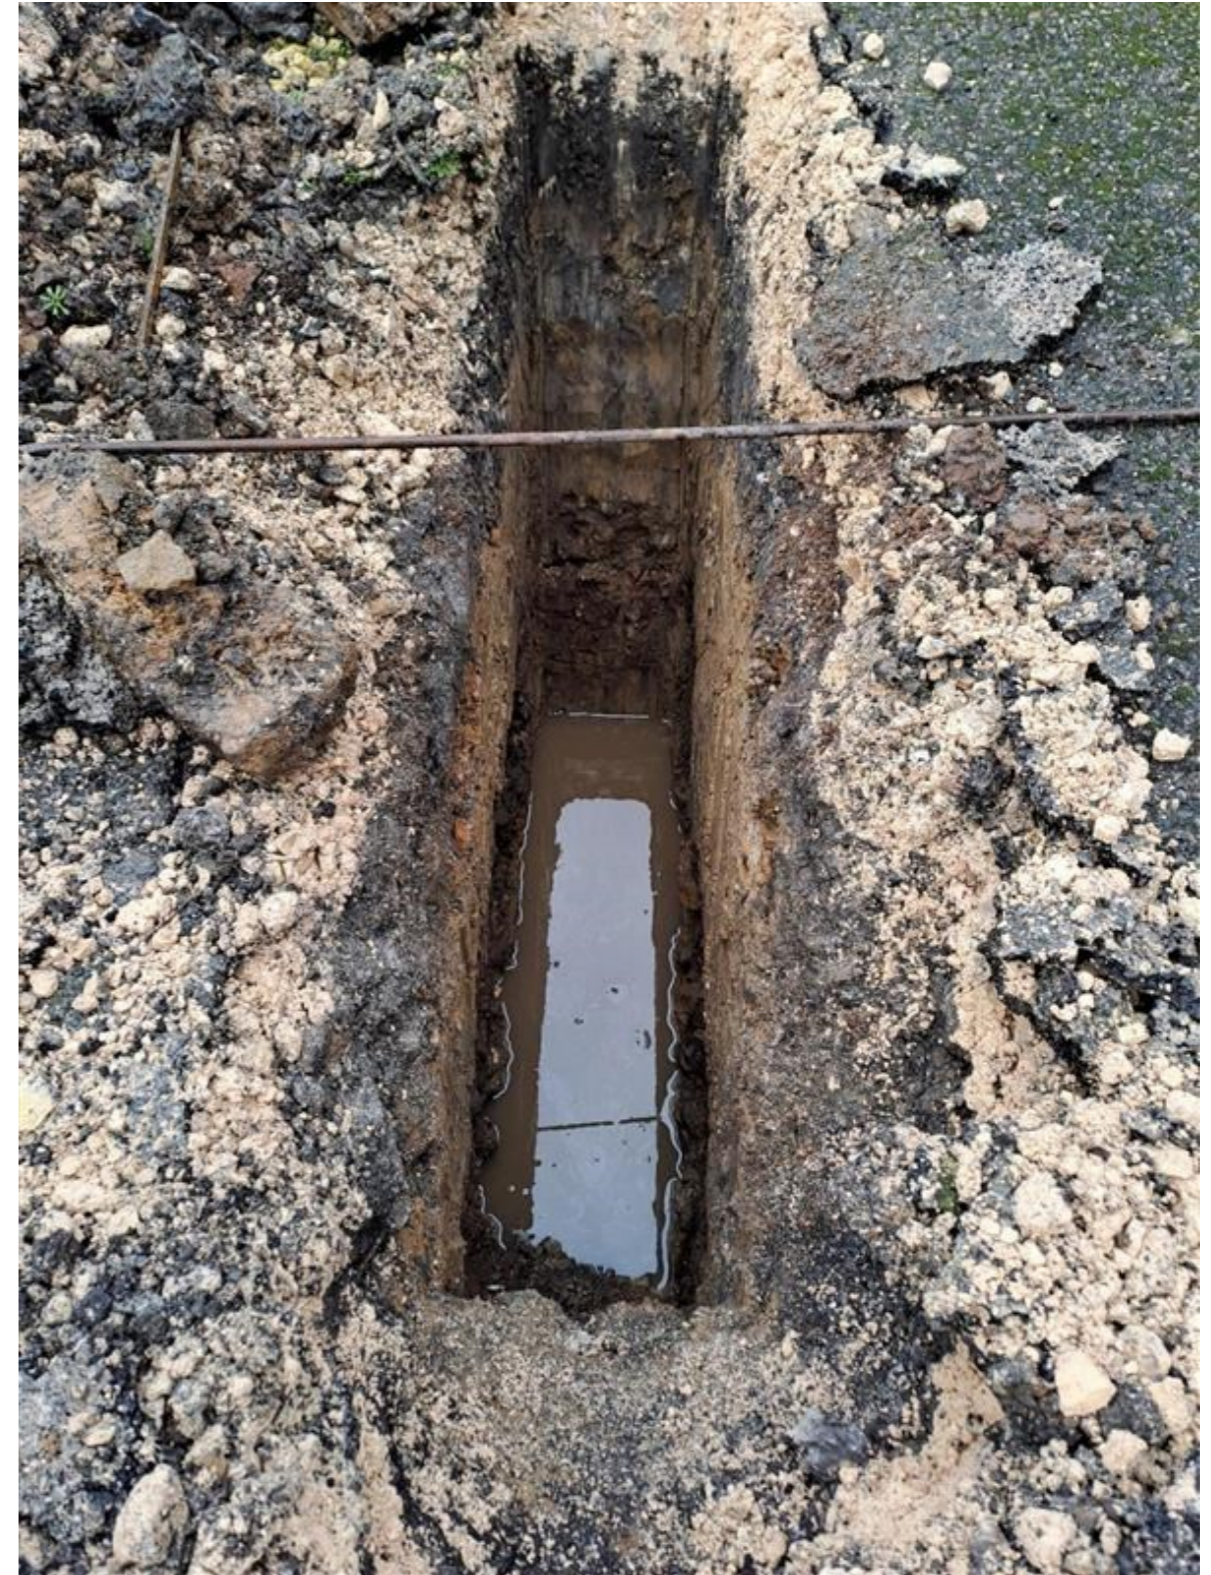
Photo 2: SA02 during testing

During the soakaway tests the water level did not achieve a fall from 75% to 25% of the effective depth of the storage volume within SA02. During the test, a negligible amount of movement was monitored within the first 10 minutes, after which no further movement was recorded. It is considered that the initial movement was observed as water filled any gaps and fissures within the made ground at the side of the pit. On this basis, the tests could not be completed within the scope of the method provided in BRE Digest 365 due to the poor soakage rate of the exposed soils. Due to the negligible water movement it was not possible to extrapolate the results obtained in order to obtain a soil infiltration rate.

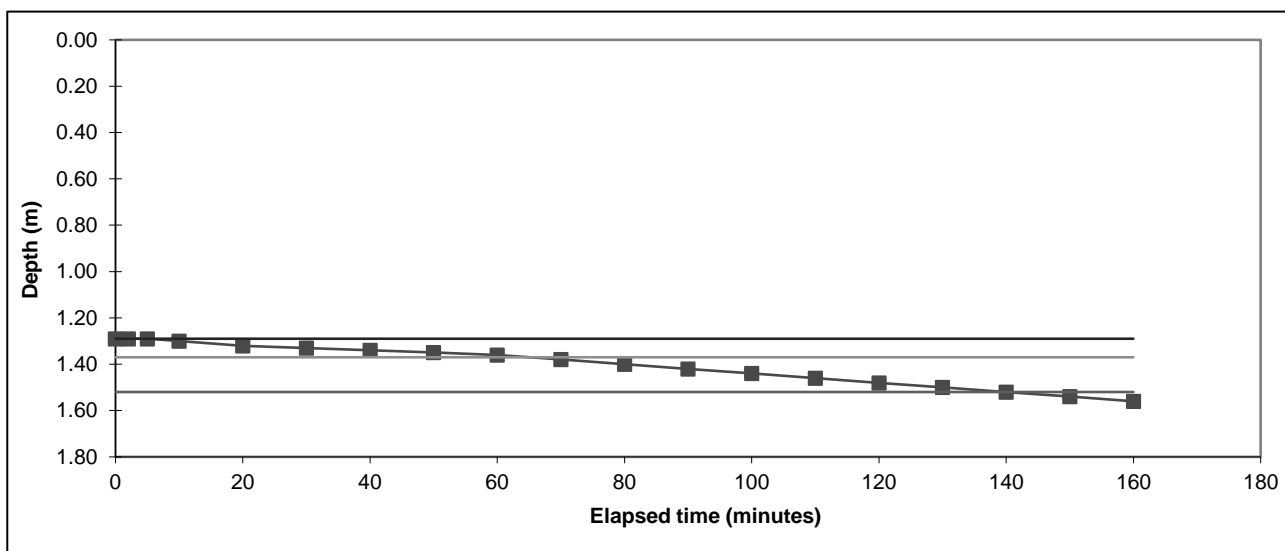
Trial Pit No:	SA01	Test No:	1	Date:	16.02.2026
Length (m):	2.000	Datum Height:		0.00 m agl	
Width (m):	0.30	Granular infill:	None		
Depth (m):	1.60	Porosity of infill:	1	(assumed)

Start water depth for analysis (mbgl):	1.29	Elapsed time (mins):	
75% effective depth (mbgl):	1.37	Elapsed time (mins):	65.0
50% effective depth (mbgl):	1.45	Elapsed time (mins):	140.0
25% effective depth (mbgl):	1.52		
Base of soakage zone (mbgl):	1.60		
Volume outflow between 75% and 25% effective depth (m <sup>3</sup> ):			0.090
Mean surface area of outflow (m <sup>2</sup> ):			1.29
(side area at 50% effective depth + base area)			
Time for outflow between 75% and 25% effective depth (mins):			75.0

<b>Soil infiltration rate (m/s):</b>	<b>1.6E-5</b>
--------------------------------------	---------------

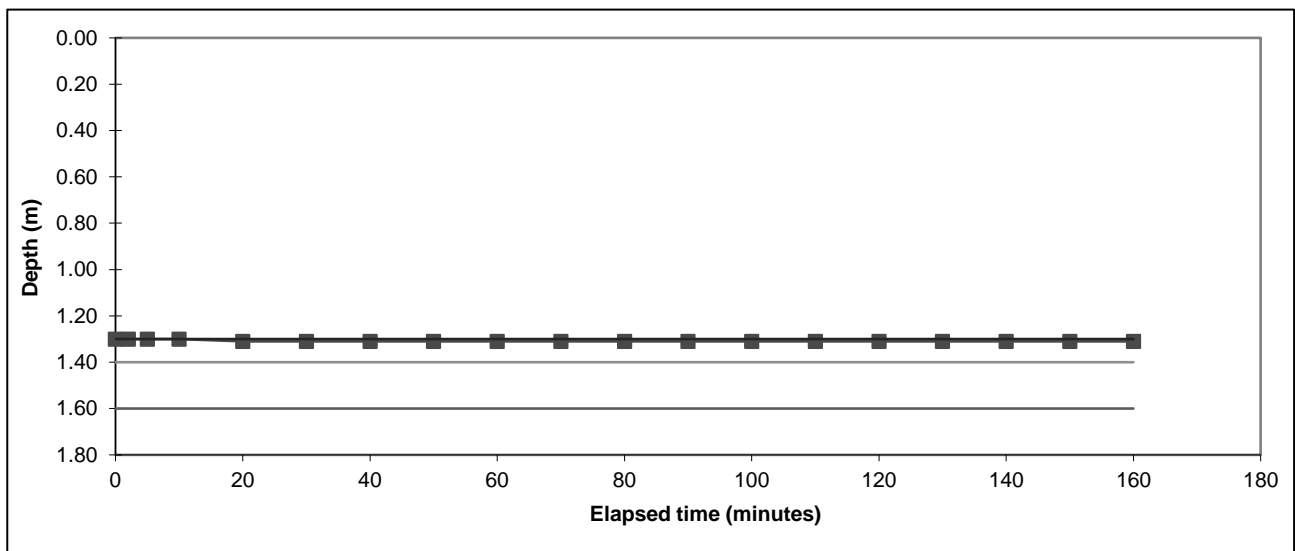
Trial Pit No:	SA02	Test No:	1	Date:	16.02.2026
Length (m):	2.000	Datum Height:		0.00 m agl	
Width (m):	0.30	Granular infill:	None		
Depth (m):	1.70	Porosity of infill:	1	(assumed)

Start water depth for analysis (mbgl):	1.30	Elapsed time (mins):	#N/A
75% effective depth (mbgl):	1.40	Elapsed time (mins):	#N/A
50% effective depth (mbgl):	1.50	Elapsed time (mins):	#N/A
25% effective depth (mbgl):	1.60	Elapsed time (mins):	#N/A
Base of soakage zone (mbgl):	1.70		
Volume outflow between 75% and 25% effective depth (m <sup>3</sup> ):			
Mean surface area of outflow (m <sup>2</sup> ):		1.52	
(side area at 50% effective depth + base area)			
Time for outflow between 75% and 25% effective depth (mins):

<b>Soil infiltration rate (m/s):</b>	<b>Test incomplete as 25% effective depth not achieved. Unable to reliably determine soil infiltration rate.</b>
--------------------------------------	--
